TECHNICAL REPORT
TR-NAVFAC-EXWC-PW-1303
SEPTEMBER 2013

**BUILDING INTEGRATED PHOTOVOLTAIC (PV)
ROOFS FOR SUSTAINABILITY AND ENERGY
EFFICIENCY**

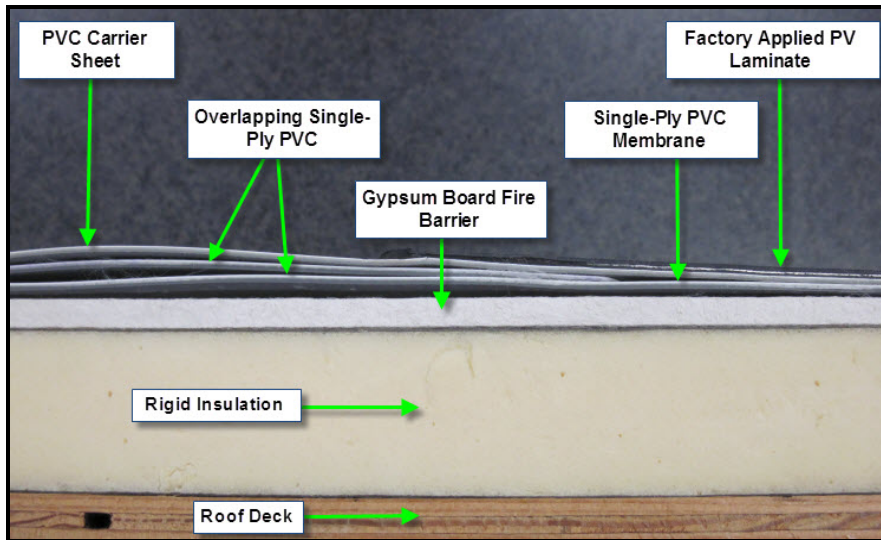
Figure-2: Cross-section of BIPV roof assembly without the conduit.

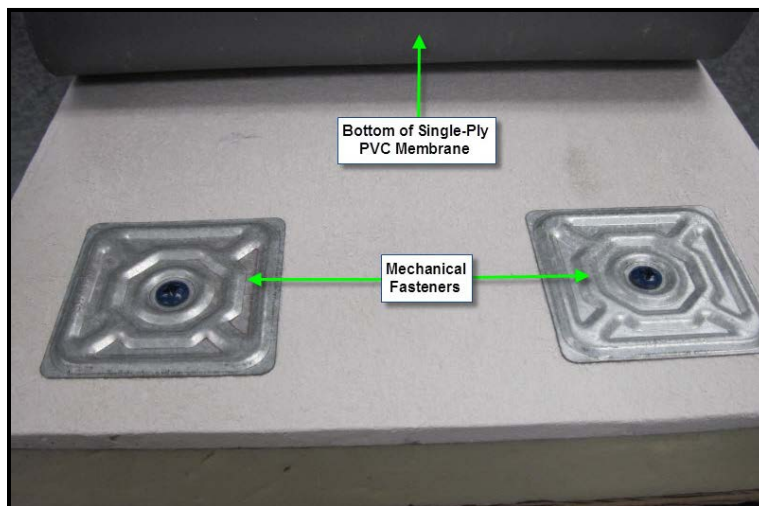
Figure-3: The mechanical fasteners under the single-ply PVC membrane

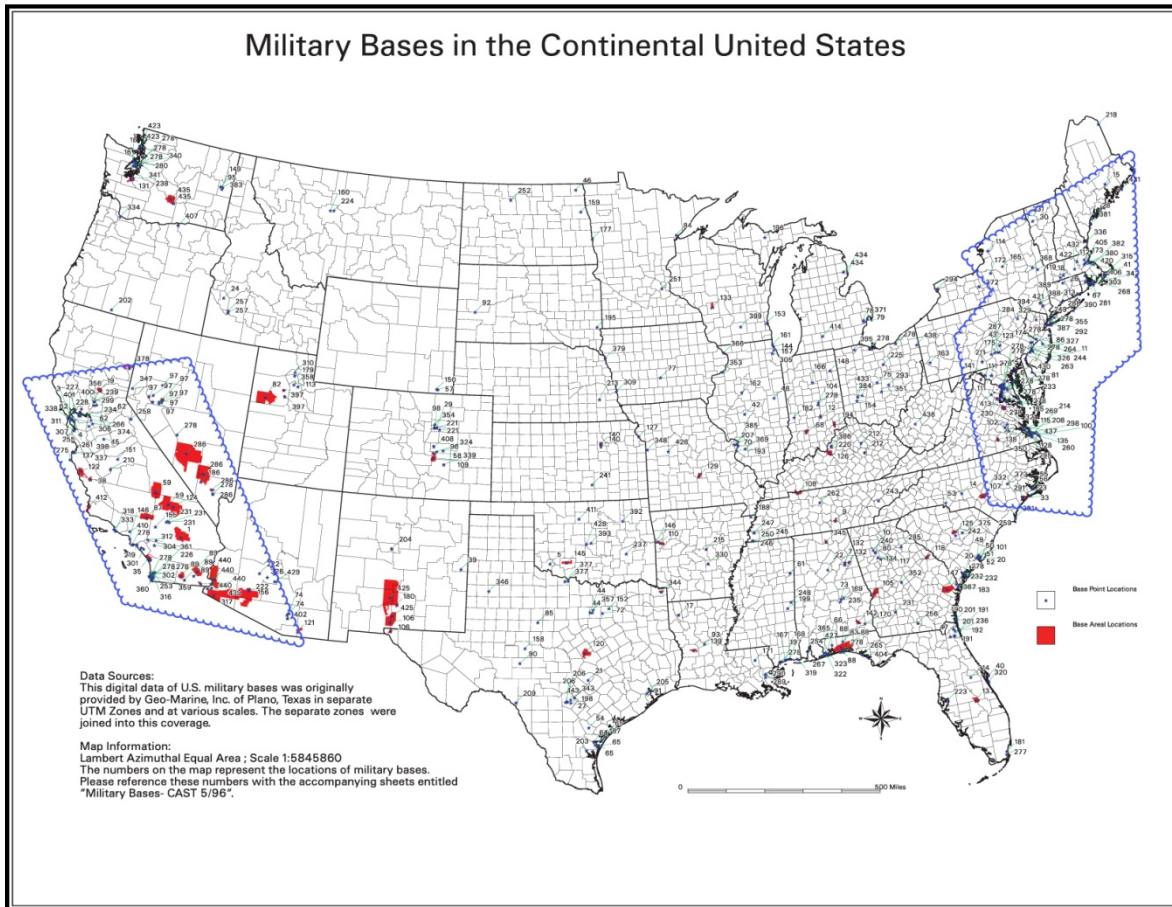
Figure-6: Map of U.S. military bases from the National Park Service website. The two areas with the greatest number of bases are as marked.

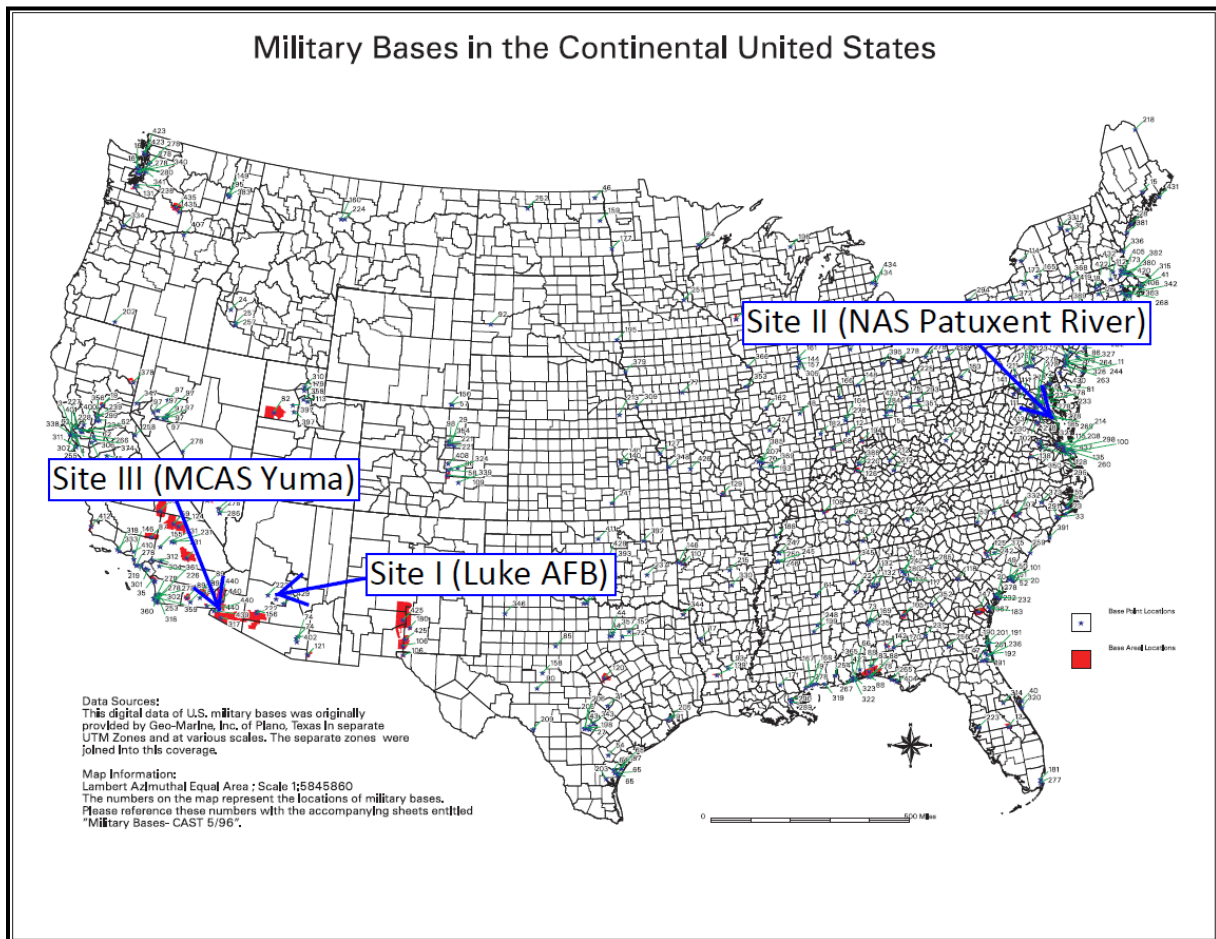
Figure-7: The three locations of the demonstration. Map is from the National Park Service website.

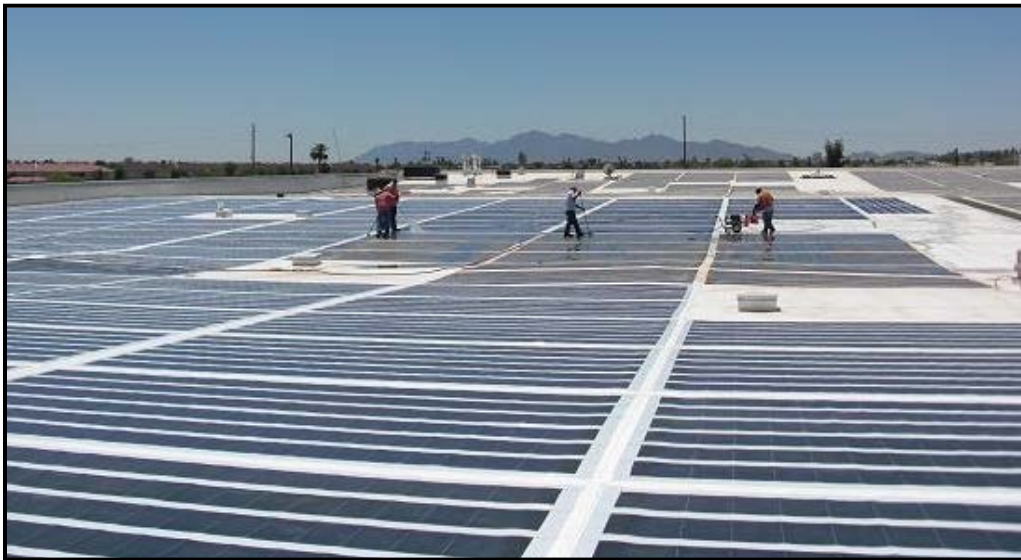
Figure-8: Luke AFB BIPV roof being cleaned during adhesive-failure fix.

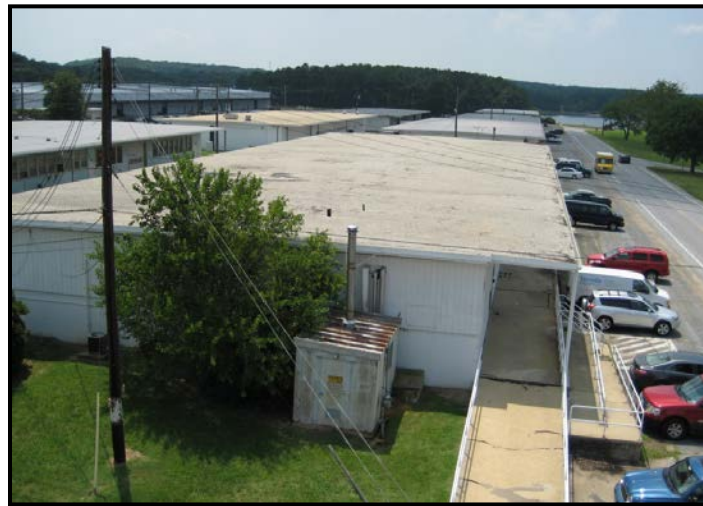
Figure-9: Photo of Building 515 at NAS Patuxent River prior to BIPV installation.

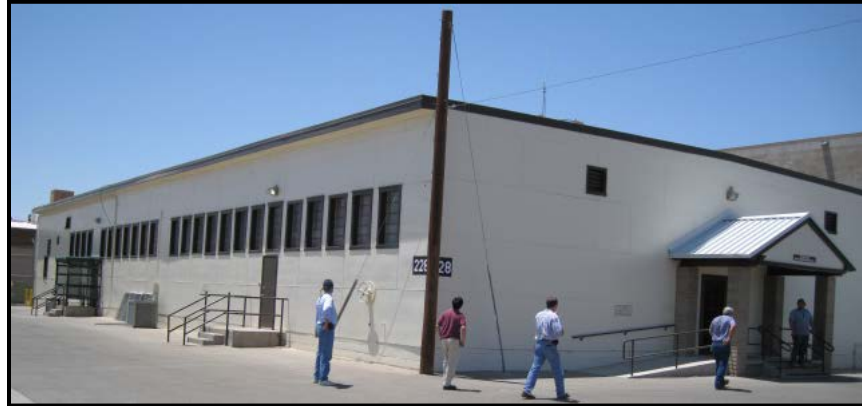
Figure-11: Building 228 at Site III (MCAS Yuma).

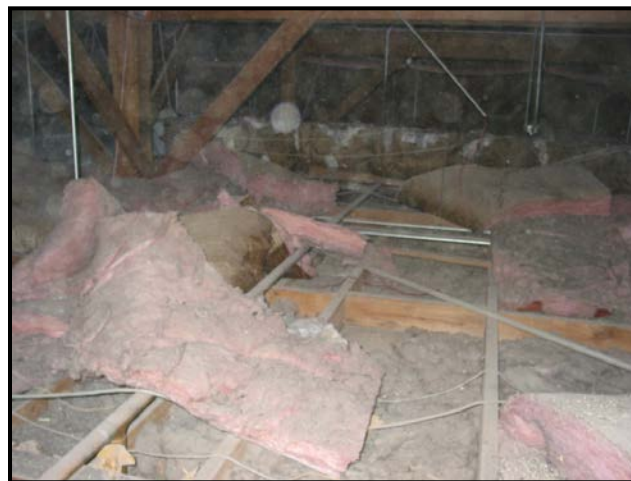
Figure-12: Attic space of Building 228 at Site III (MCAS Yuma) showing poor insulation.

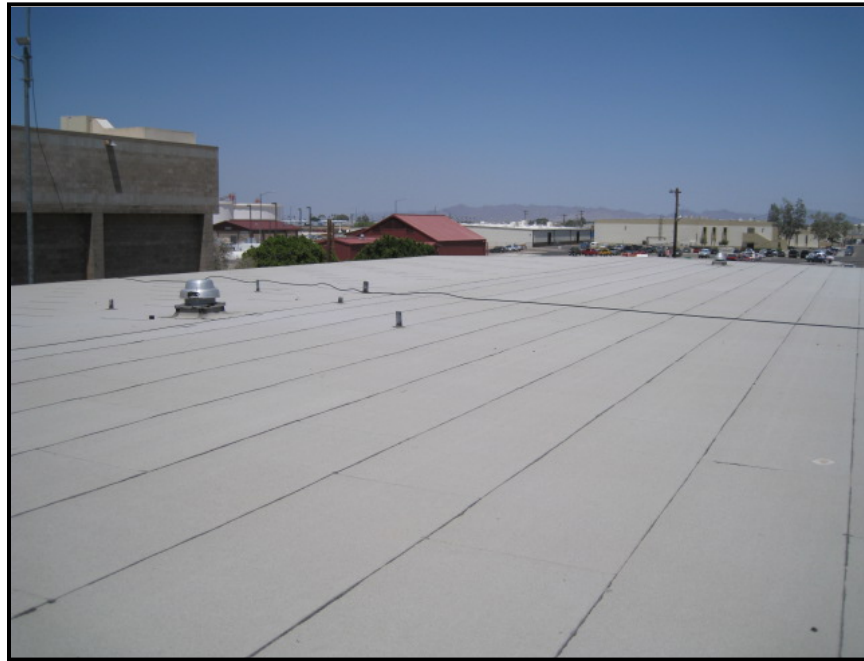
Figure-13: Rooftop photo of Building 228 at Site III (MCAS Yuma) prior to BIPV installation.

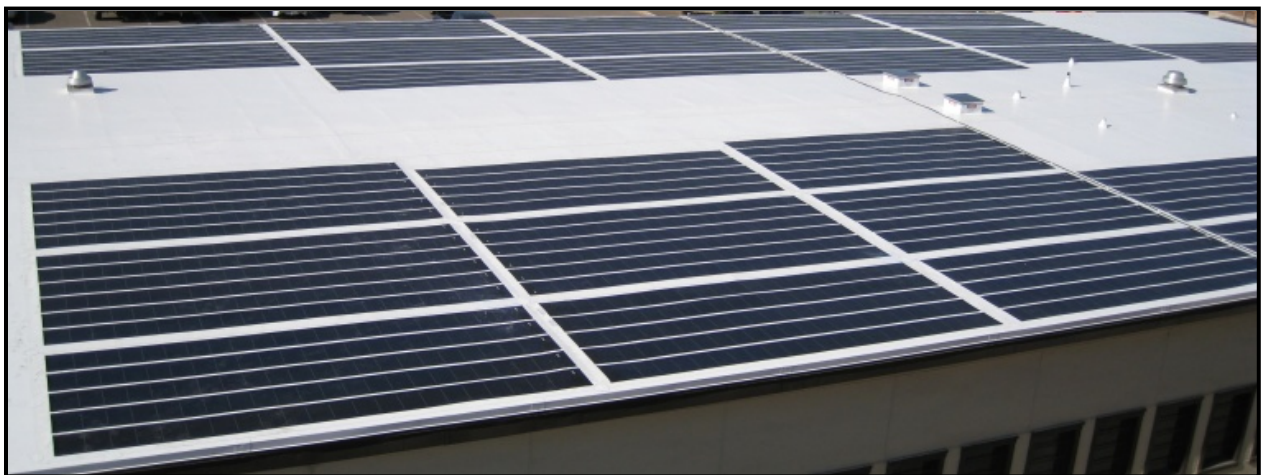
Figure-14: Rooftop photo of Building 228 at Site III (MCAS Yuma) after BIPV installation.

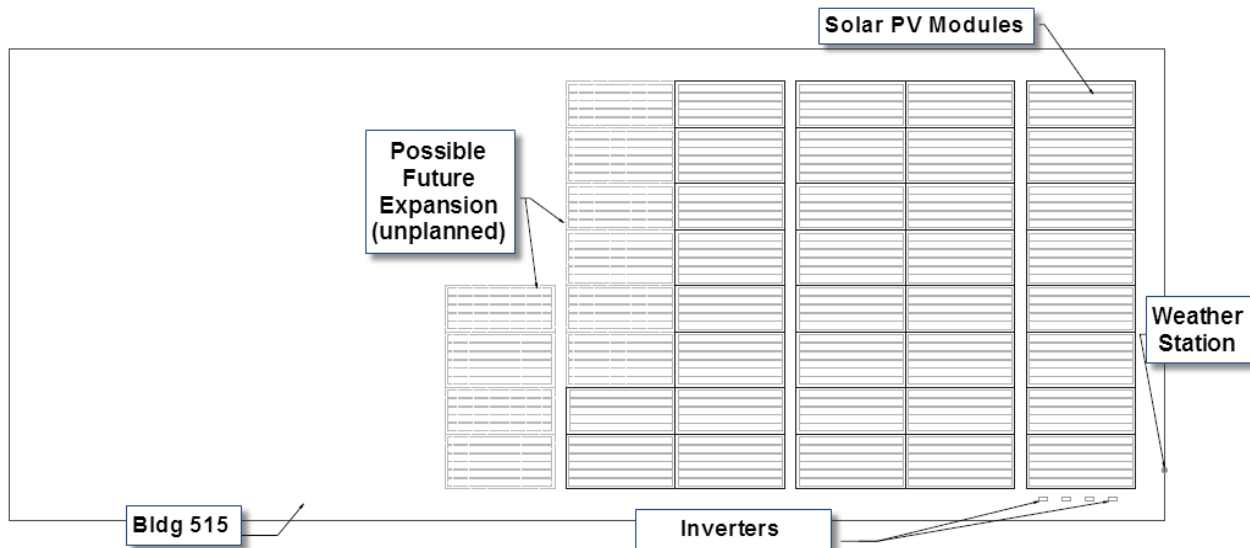
Figure-15: Diagram of major components on Building 515 at Site II (NAS Patuxent River).

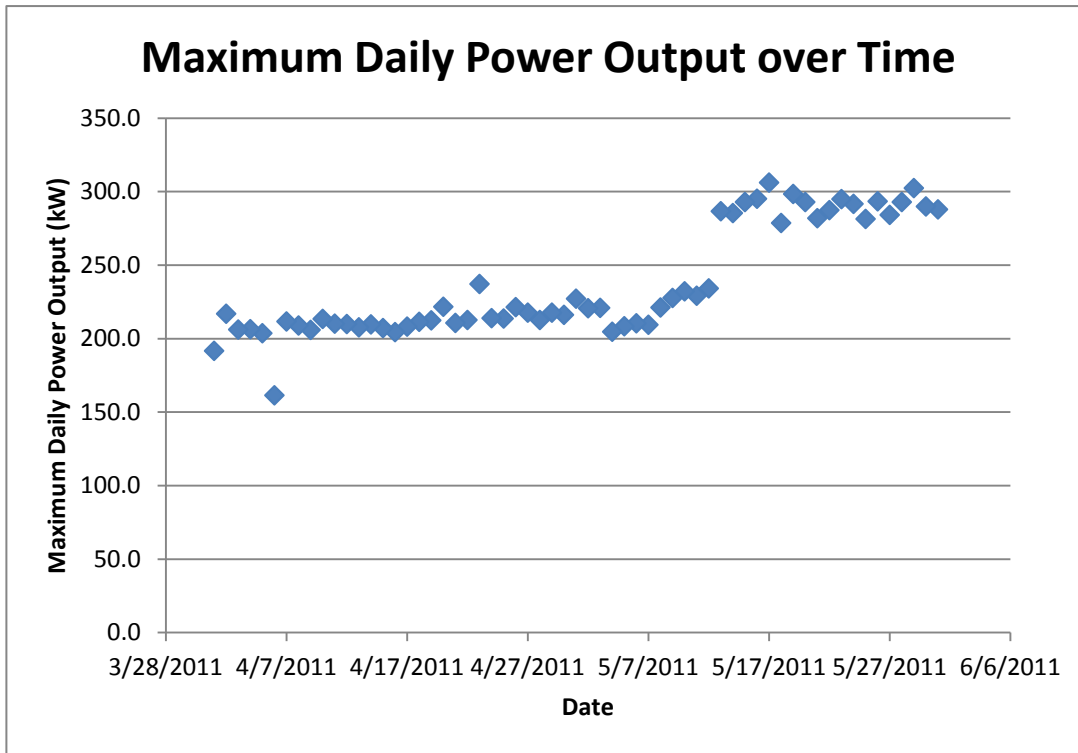
Figure-19: Maximum daily power output for April-May 2011 at Site I (Luke AFB)

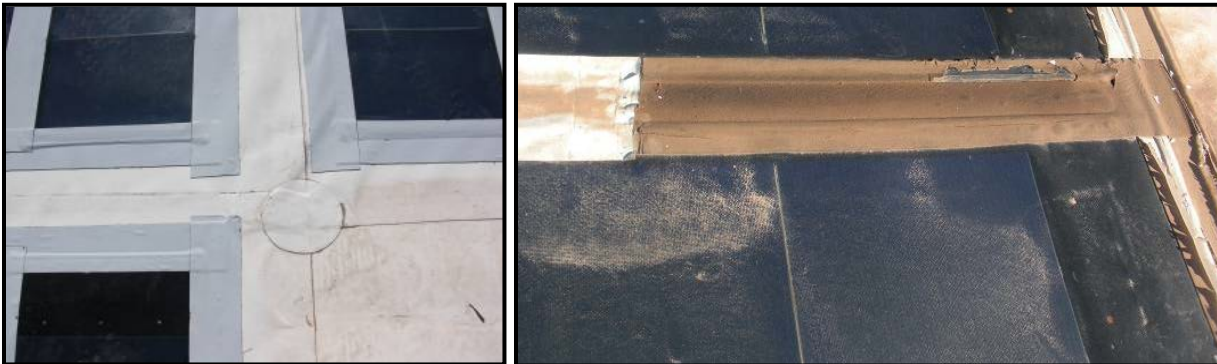
Figure-21: Tape solution soon after it was applied (left) and deterioration later that year (right) Site I (Luke AFB).

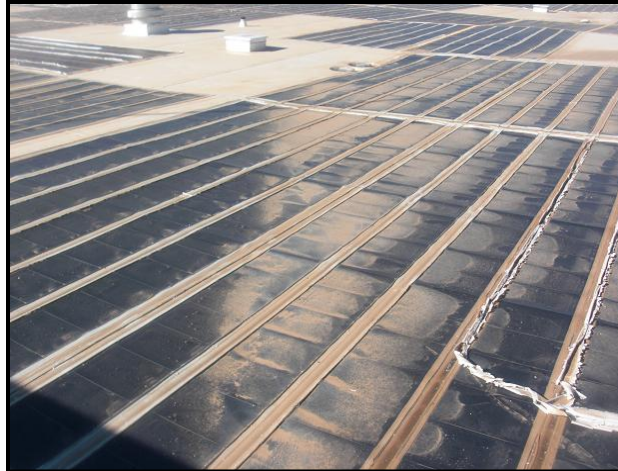
Figure-22: Tape deterioration and soiling of the PV system at Site I (Luke AFB).

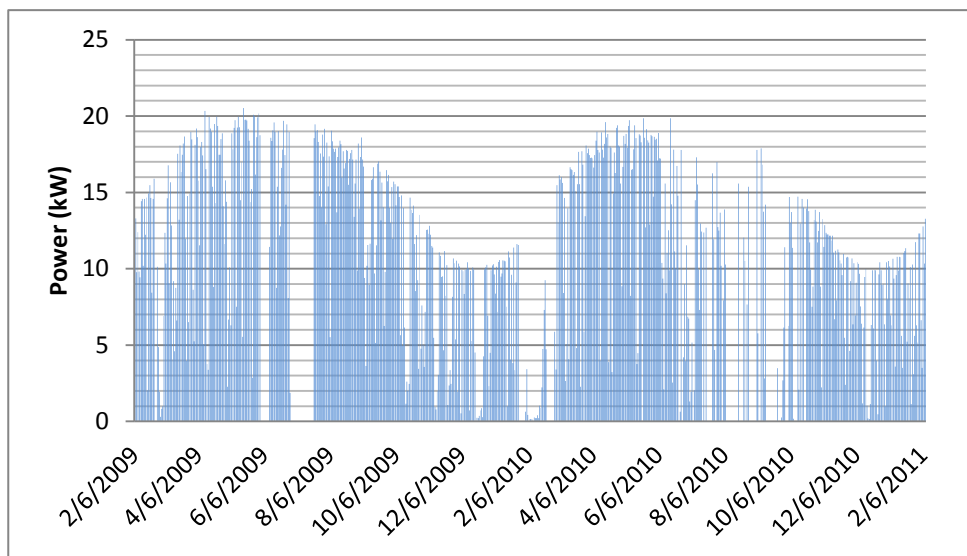
Figure-23: Power output over time at Site II (NAS Patuxent River).

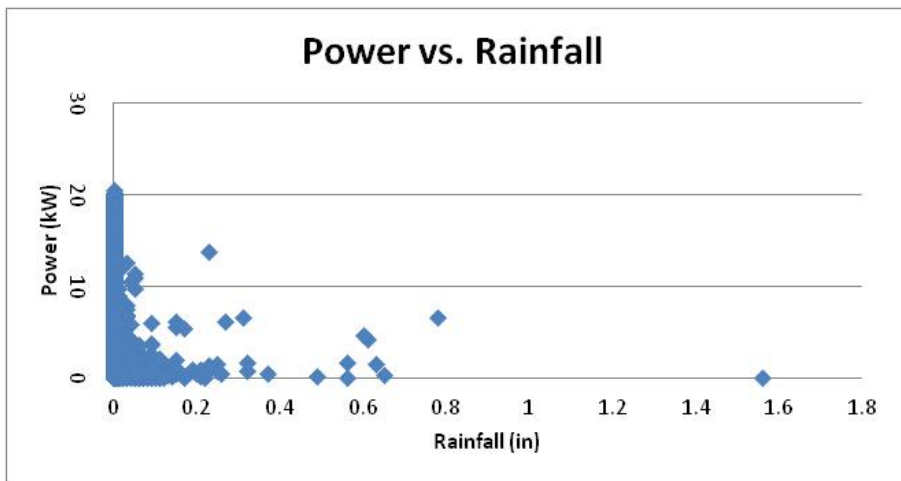
Figure-27: Total PV power vs. rainfall at Site II (NAS Patuxent River).

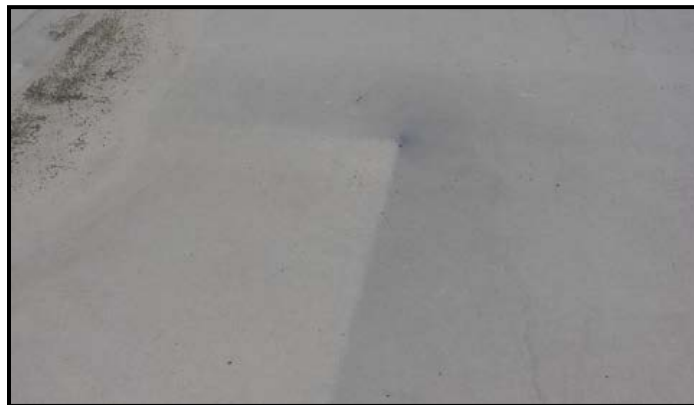
Figure-28: Mold growth (upper left corner) and warping dens-deck (center) at Site II (NAS Patuxent River).

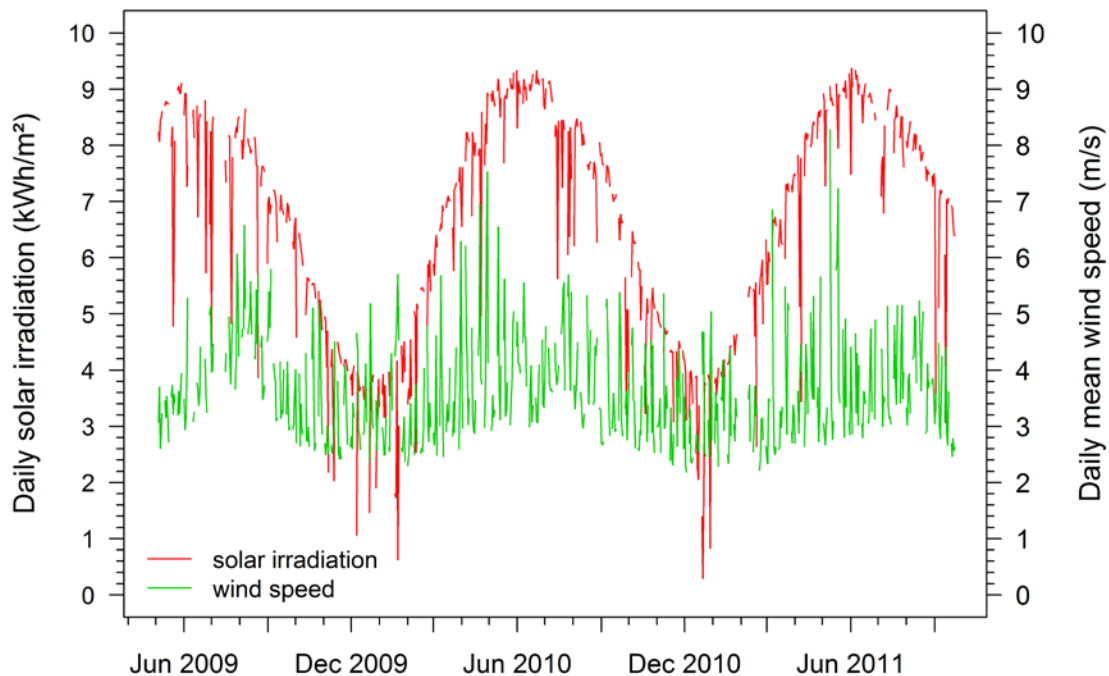
Figure-30: Weekday solar insolation and wind speed during the course of the study at Site III (MCAS Yuma).

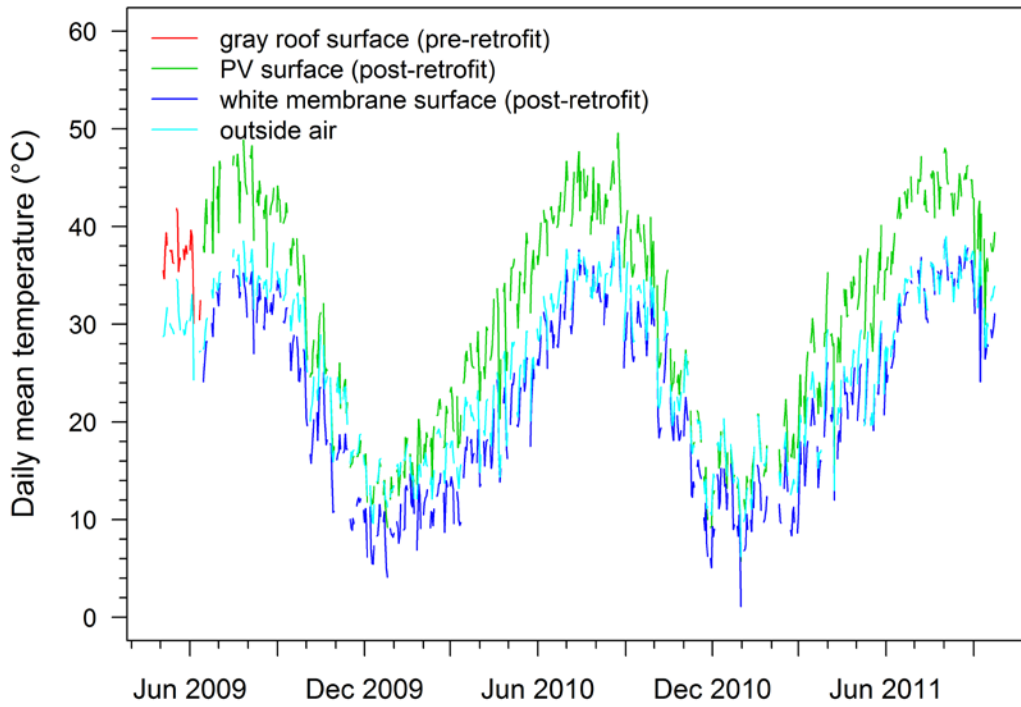
Figure-31: Site III (MCAS Yuma) daily, weekday, spatial-average surface temperature of pre and post-BIPV roof.

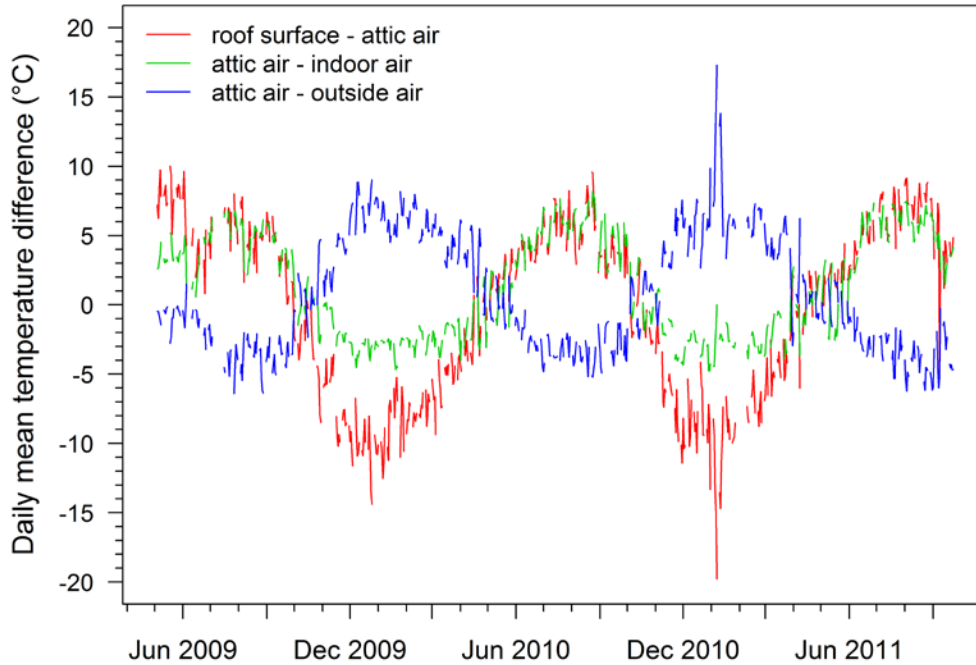
Figure-33: Daily, weekday, spatial-average roof surface, attic, and outdoor temperature of pre and post-BIPV roof retrofit at Site III (MCAS Yuma).

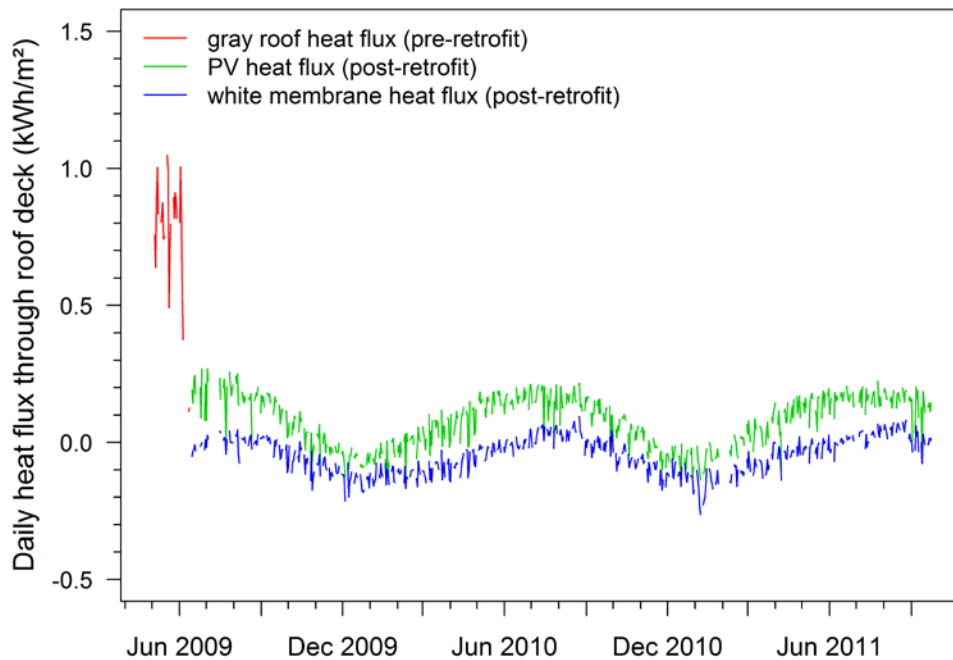
Figure-34: Site III (MCAS Yuma) daily, weekday heat flux through roof surface in pre and post-BIPV roof phases.

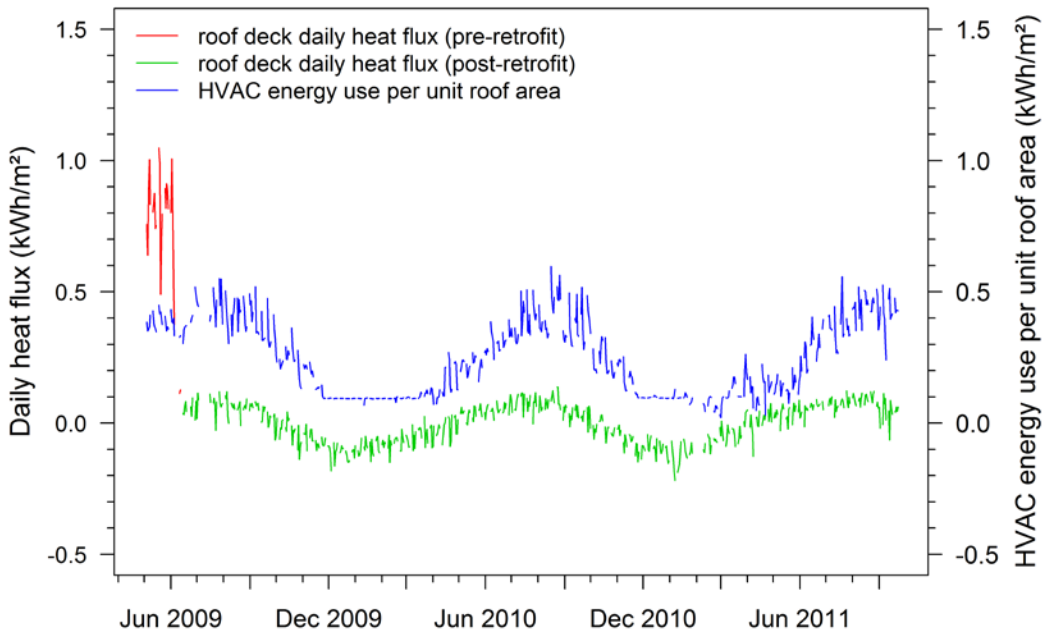
Figure-35: Daily, weekday heat flux through roof deck in the pre and post-BIPV roof phases and A/C energy use at Site III (MCAS Yuma).

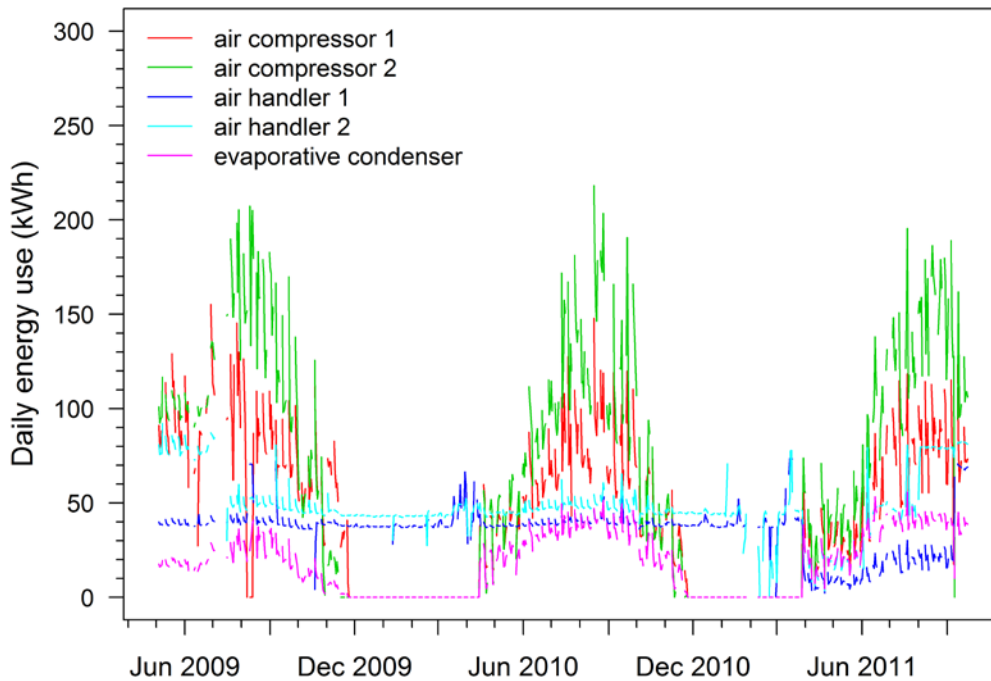
Figure-36: Daily, weekday energy use of the five A/C components at Site III (MCAS Yuma).

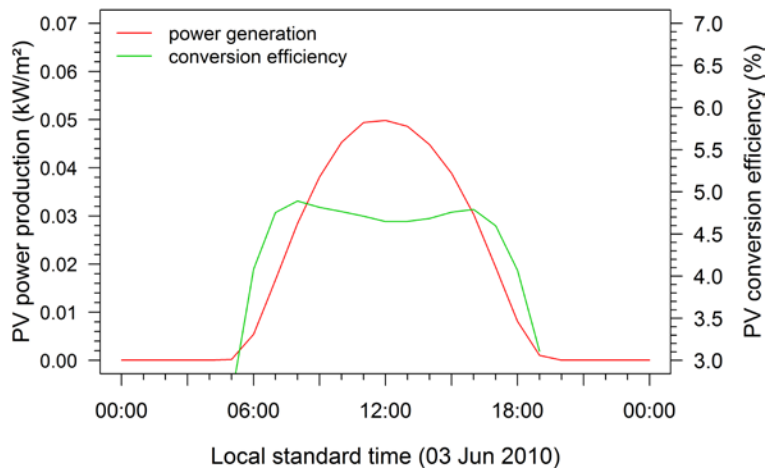
Figure-41: A typical summer diurnal cycle for hourly mean PV power production per unit PV area and conversion efficiency at Site III (MCAS Yuma).

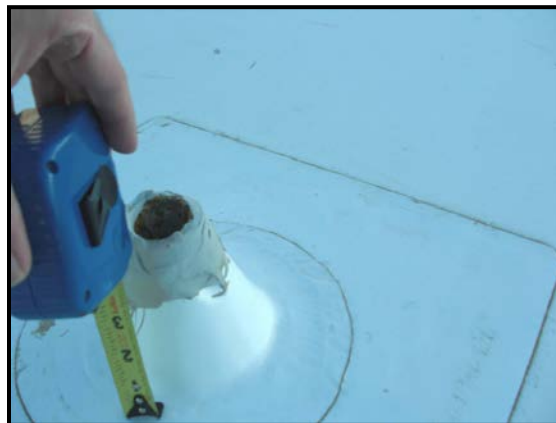
Figure-44: Photo of Site III (MCAS Yuma) air vent with insufficient flashing height.

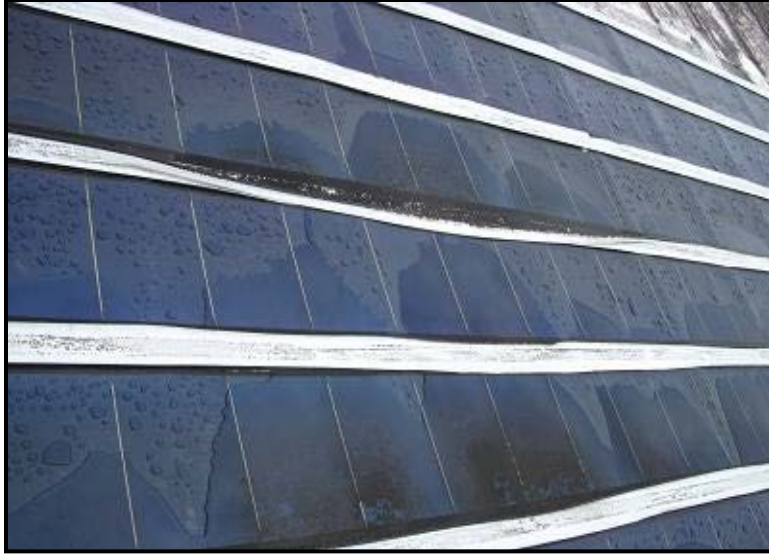
Figure-45: Water ponding due to the failing tape and PV module orientation. Mold growth in the upper right corner.

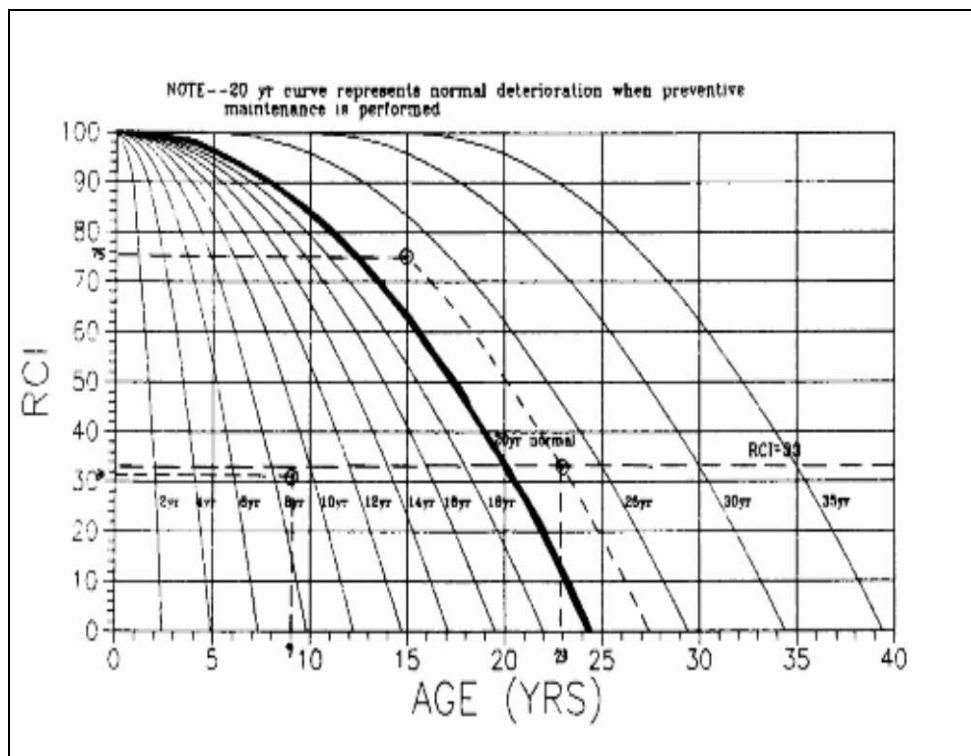
Figure-48: Roof deterioration curves used to predict the remaining life of the roof.

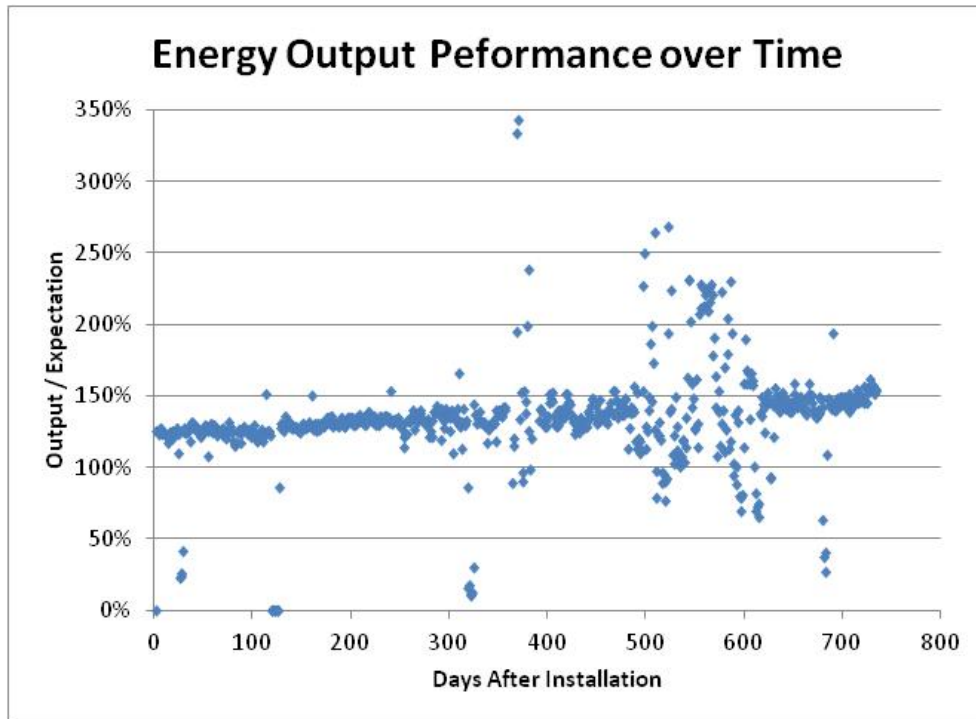
Figure-49: Site II (NAS Patuxent River) performance compared to estimates based on available solar resource.

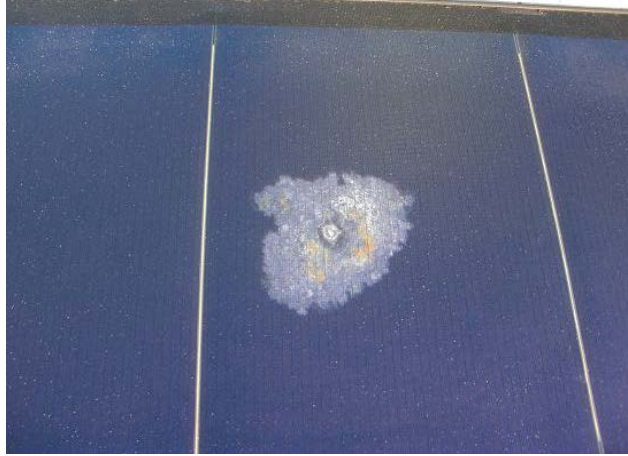
Figure-50: Corrosion of PV material due to a pin-size hole at Site II (NAS Patuxent River).

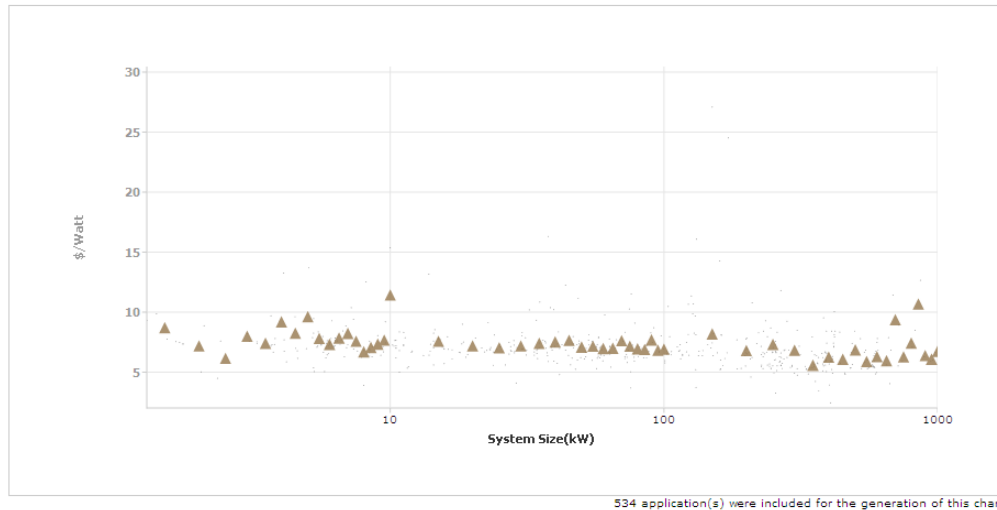
Figure-53: Graph from California Solar Statistics website showing the installed cost of non-residential PV systems against the system size for just 2007.

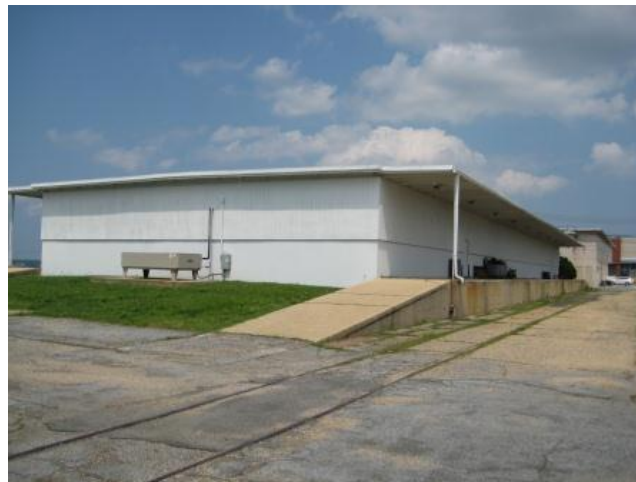
Figure 1 Building 515

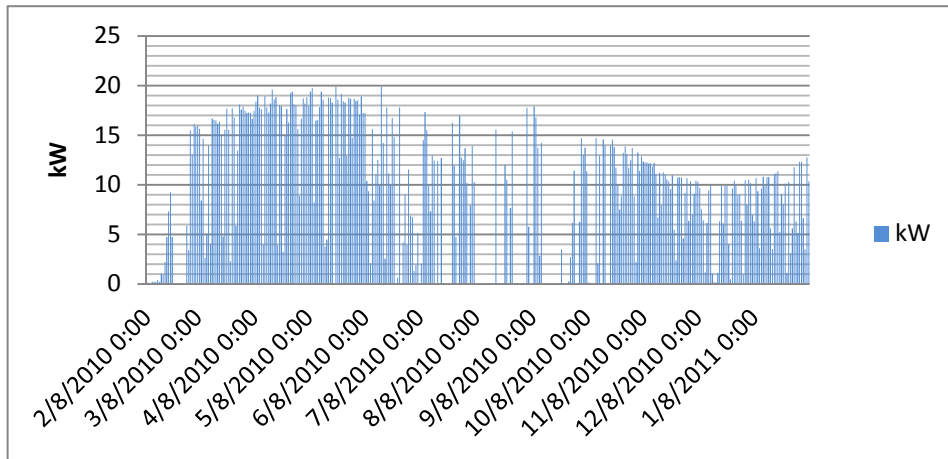
Figure 8 Energy Monitoring for Year 2 (10/11)

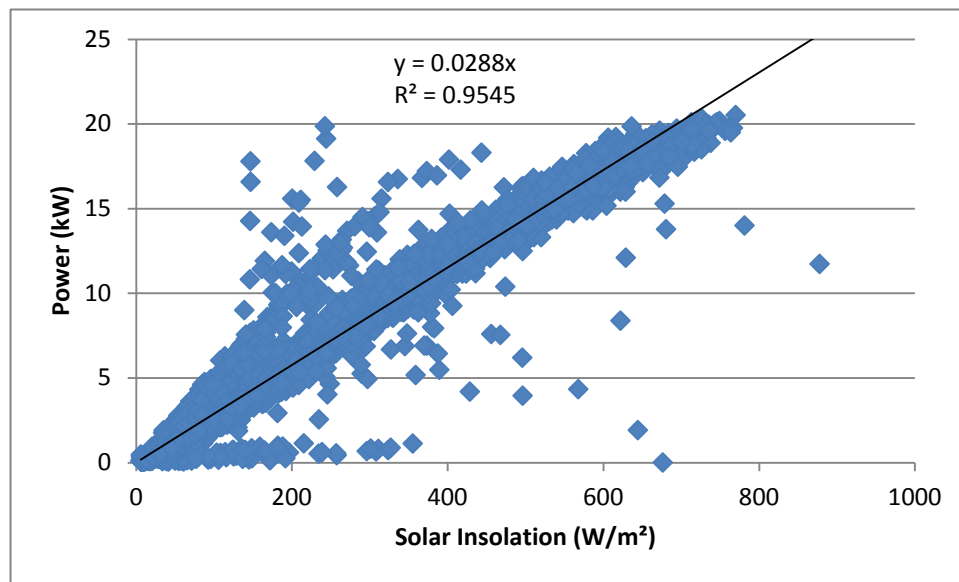
Figure 9 Energy Produced vs. Solar Irradiance

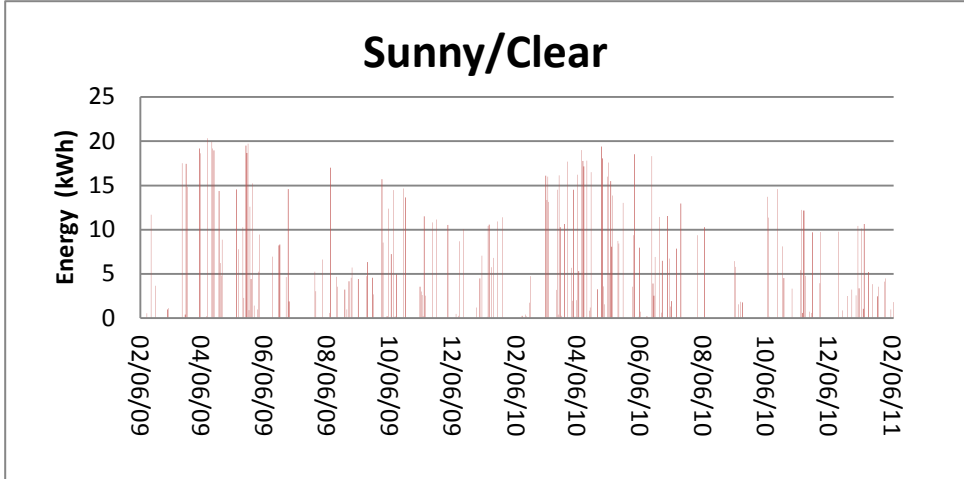
Figure 10 Energy Production on a Sunny Day

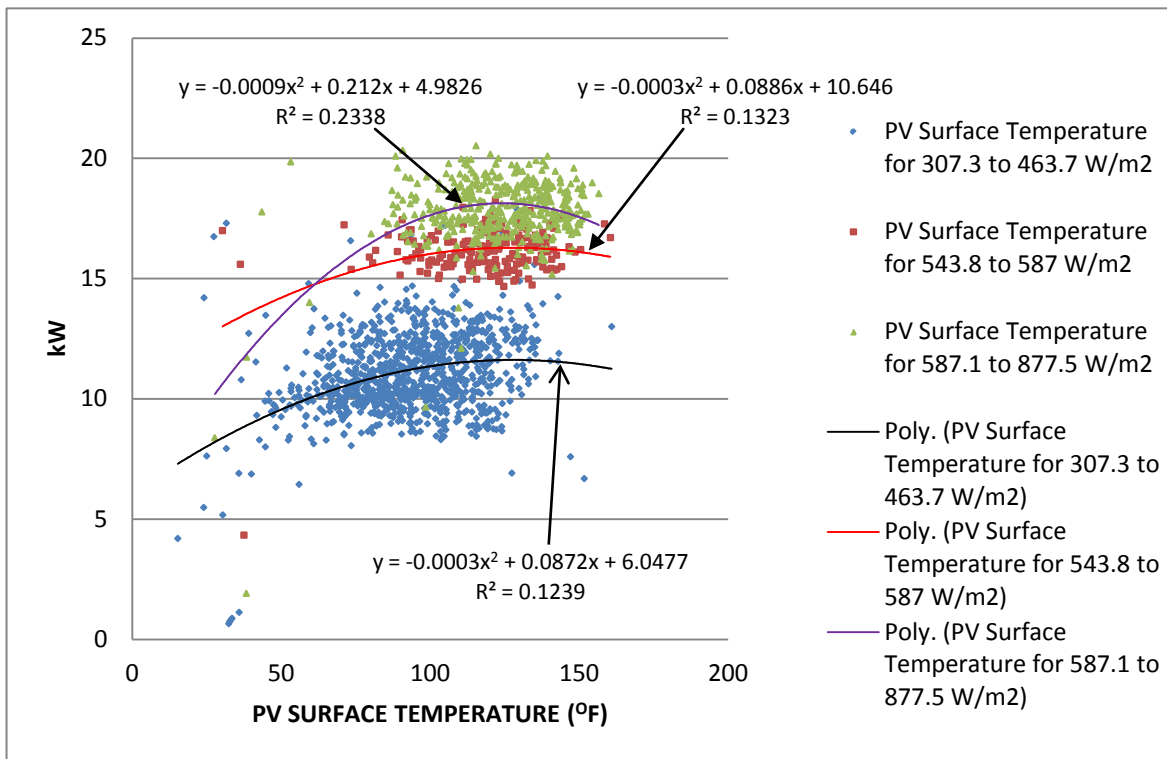
Figure 13 Energy vs. PV Surface Temperature

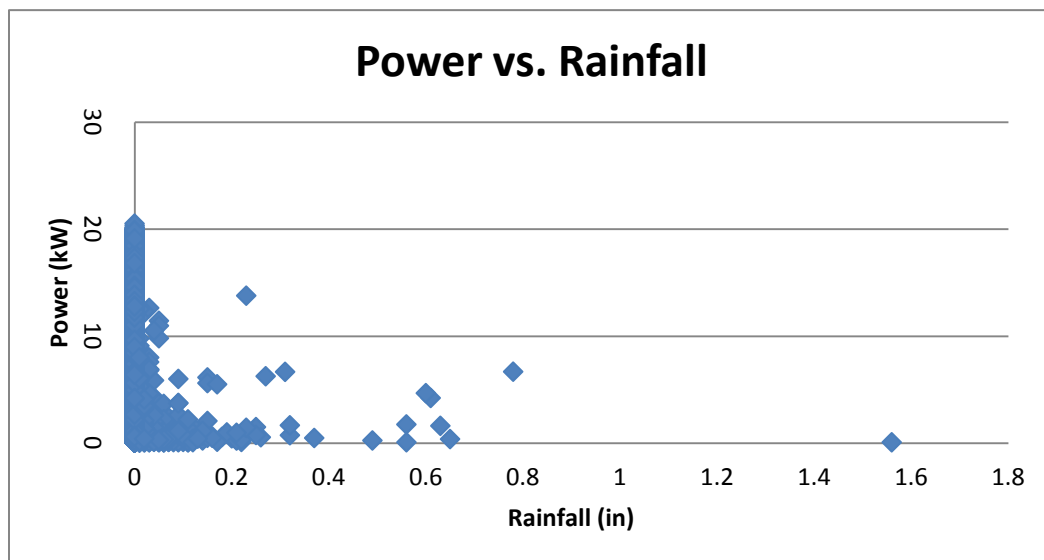
Figure 14 Energy Produced vs. Rainfall

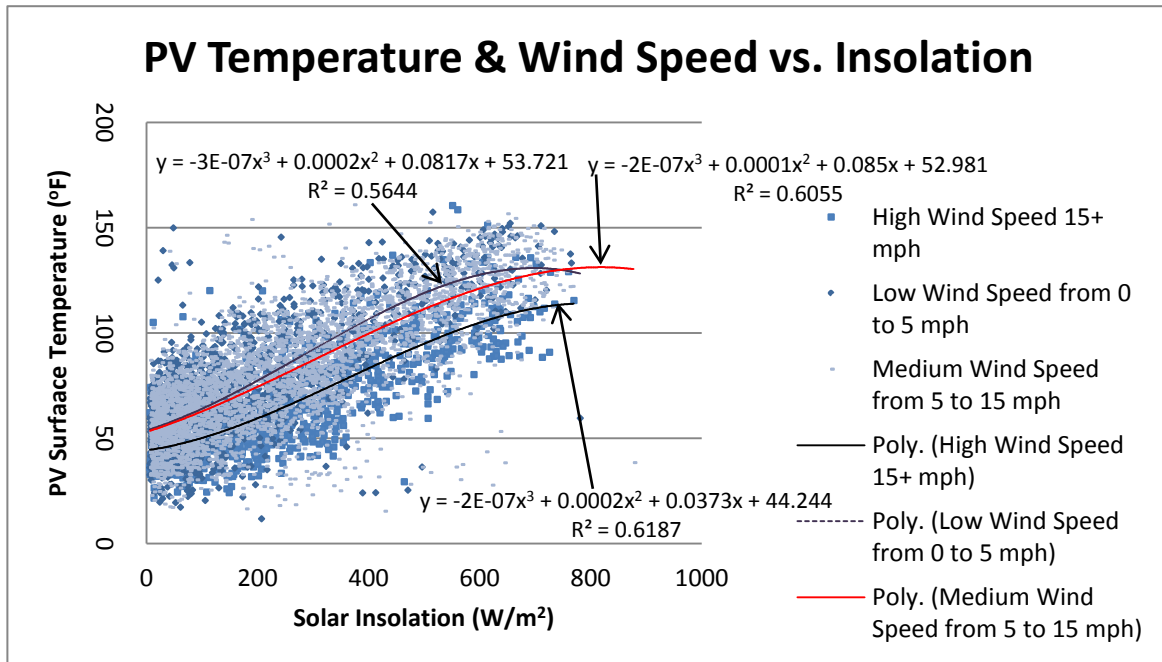
Figure 15 Energy vs. Solar Insolation for Multiple Wind Speeds
