TECHNICAL REPORT
TR-NAVFAC-EXWC-PW-1303
SEPTEMBER 2013

**BUILDING INTEGRATED PHOTOVOLTAIC (PV)
ROOFS FOR SUSTAINABILITY AND ENERGY
EFFICIENCY**

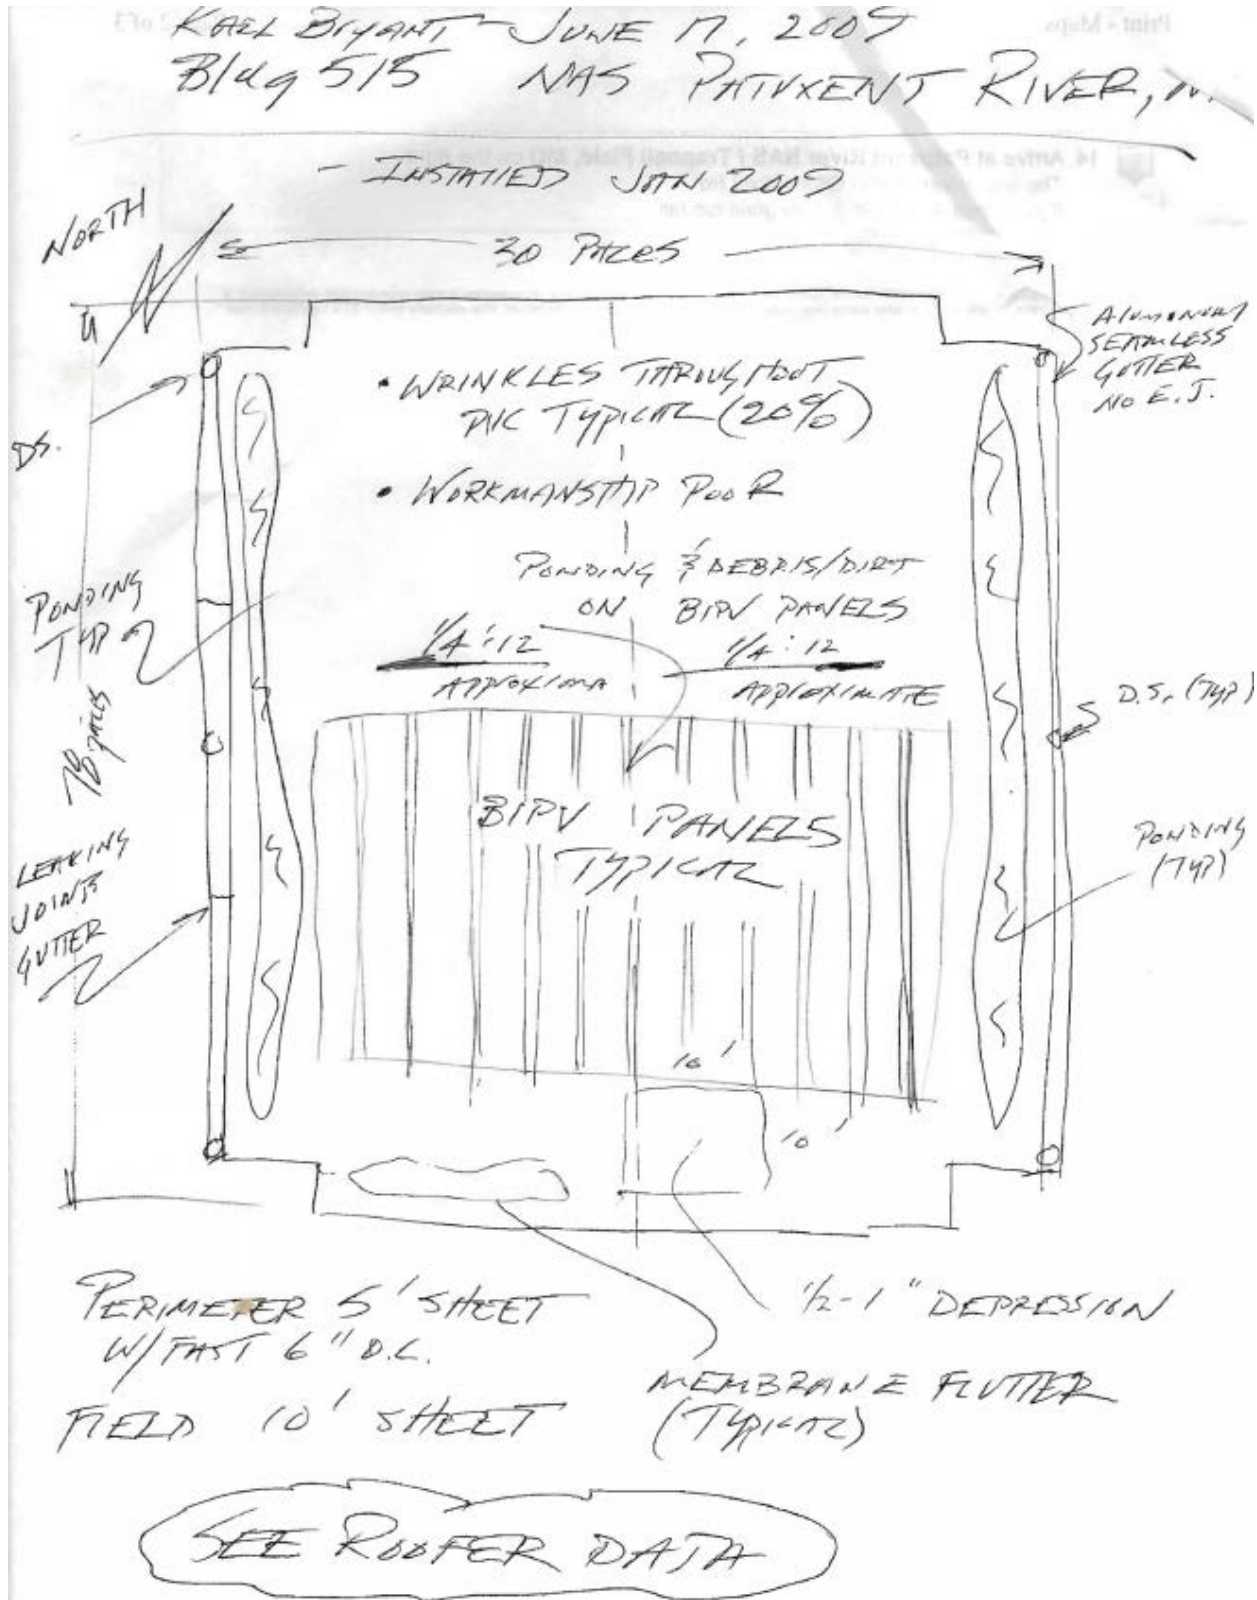
2010 ROOFER Assessment
