# **CERTS Microgrid Mechanical Switch Test Report**

**D. Klapp, R. Zimmerly, J. Howard**  
*AEP Dolan Technology Center*  
*Groveport, OH*

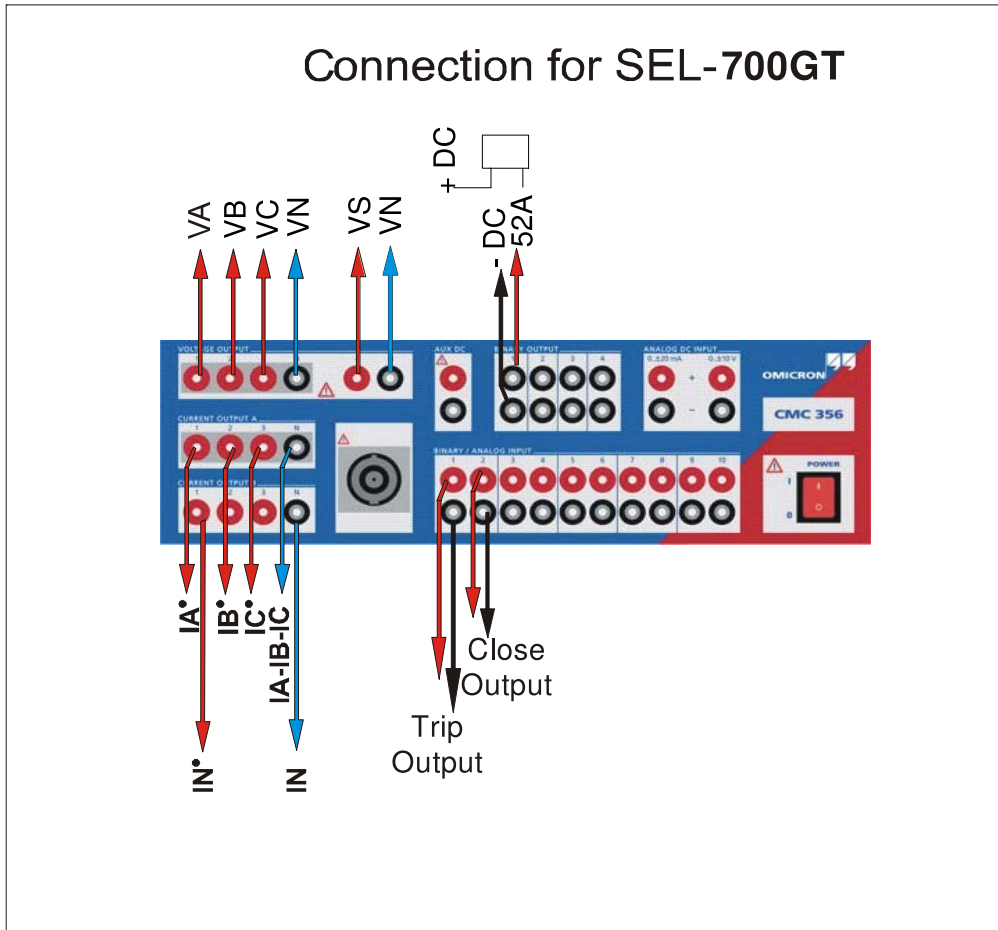
To test that the relay will function as programmed, an Omicron 256 test set and Omicron Test Universe software were used. This unit is designed to perform low level secondary stimulation of the actual voltage and current signals associated with various protection and control events. It contains two sets of current outputs, one set of voltage outputs, and an extra voltage channel for synchronism check. Therefore this set is ideal for testing the necessary IEEE 1547 compliance points. It also features binary inputs and outputs, which were used to simulate the actual feedback from the power breaker, as though it were installed in the field. This feedback loop was completed by programming trip and close logic to outputs on the relay that would send signals to the binaries on the test set, and therefore act as triggers for the tests. The following diagram displays the test setup used:

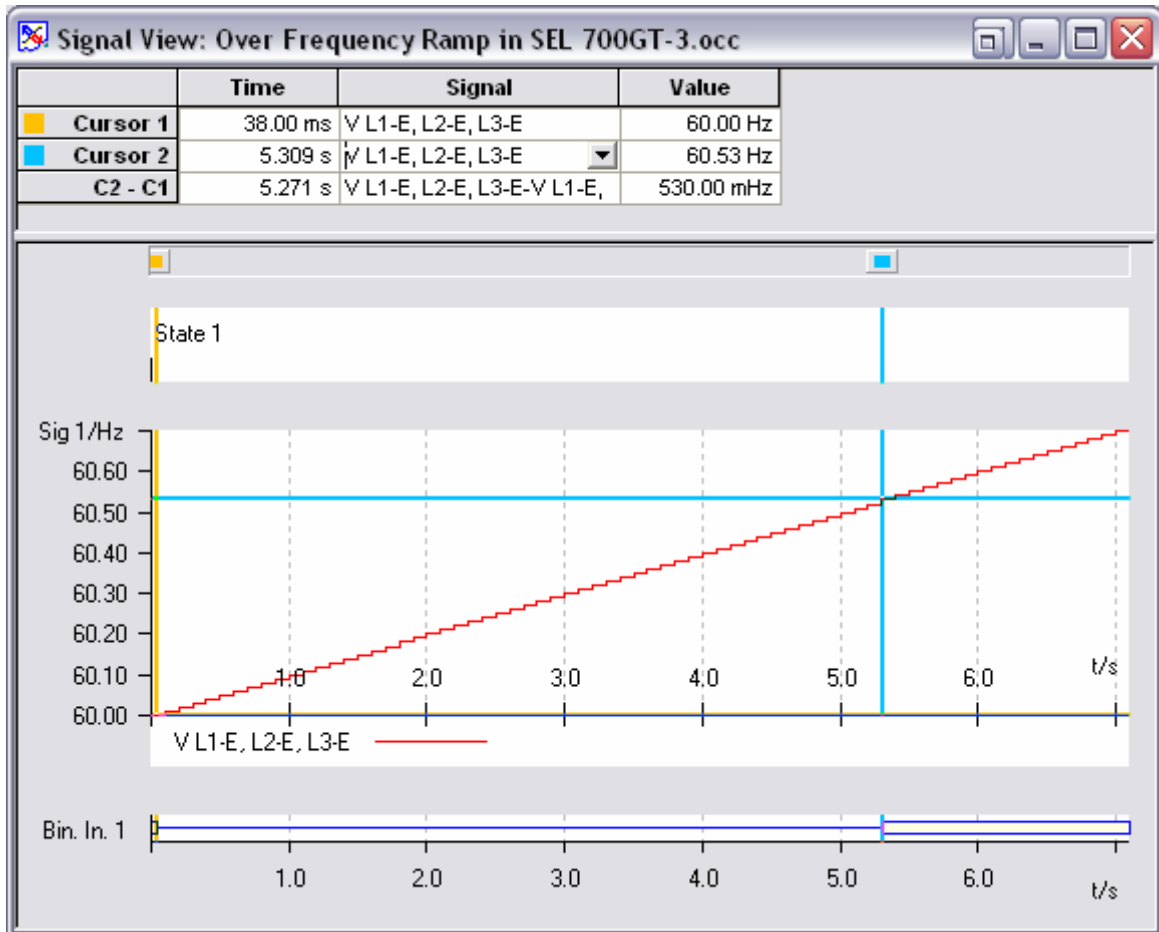
Figure 1: Overfrequency ramping results

The following screenshot, Figure 1, displays an over frequency ramping test that was performed. The system was started in steady state with a frequency of 60 Hz, and then slowly ramped up to 60.7 Hz. The binary input representing the breaker status, a '0' (Closed), demonstrates the breaker remains closed until 60.53 Hz, when the input returns a '1' (Open). A deviation of 0.5Hz was given for margin of error, with an actual margin of 0.03 Hz.

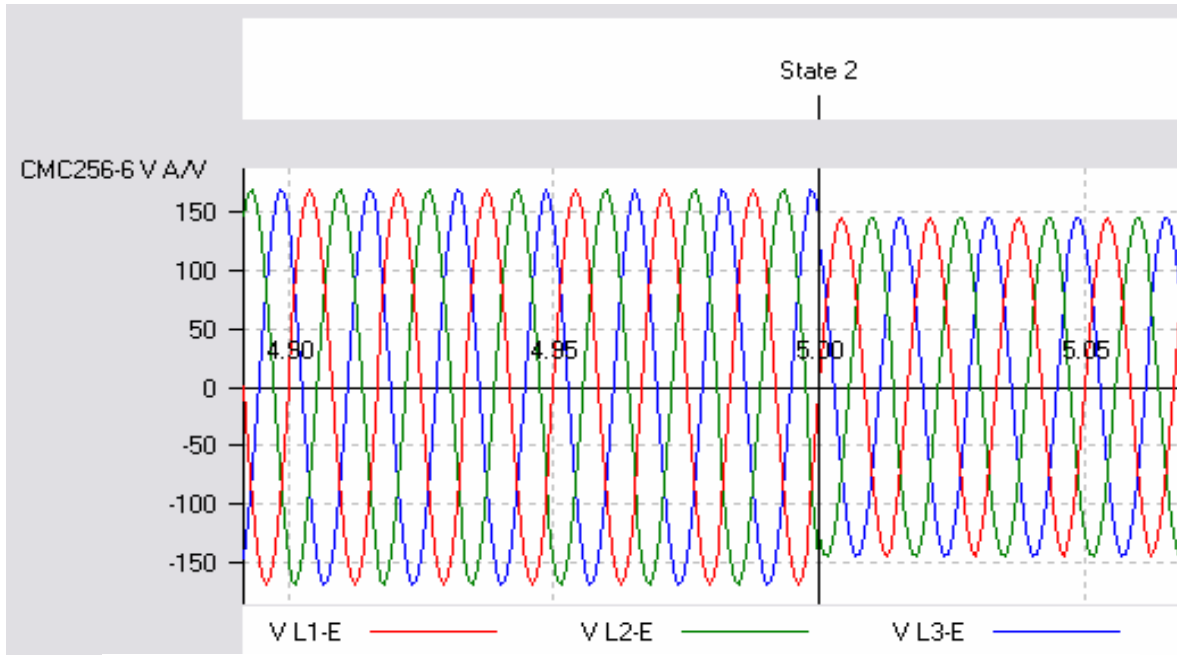
Figure 3: Undervoltage state sequencer voltage waveform

The following screenshot, Figure 2, displays a state sequencer module for an undervoltage element. Its prefault state lasts for 5 seconds and brings the system into steady state, with a small amount of current flowing so the reverse power element is satisfied, and a signal is sent to the test set that simulates the breaker status as ‘closed’. The second state reduces the voltage on all 3 phases from 120V to 103V, which is below the trip threshold, with the breaker status still ‘closed’. State 2 is set to terminate when the trip element of the relay operates and triggers the final state, State 3 after a 60ms delay to account for the maximum trip time of the mechanical switch. In state 3 the simulated breaker status is ‘open’, thus demonstrating the relay trip when coupled with the under voltage condition. Figure 3 is a voltage waveform during the change in voltage from State 2 to State 3.

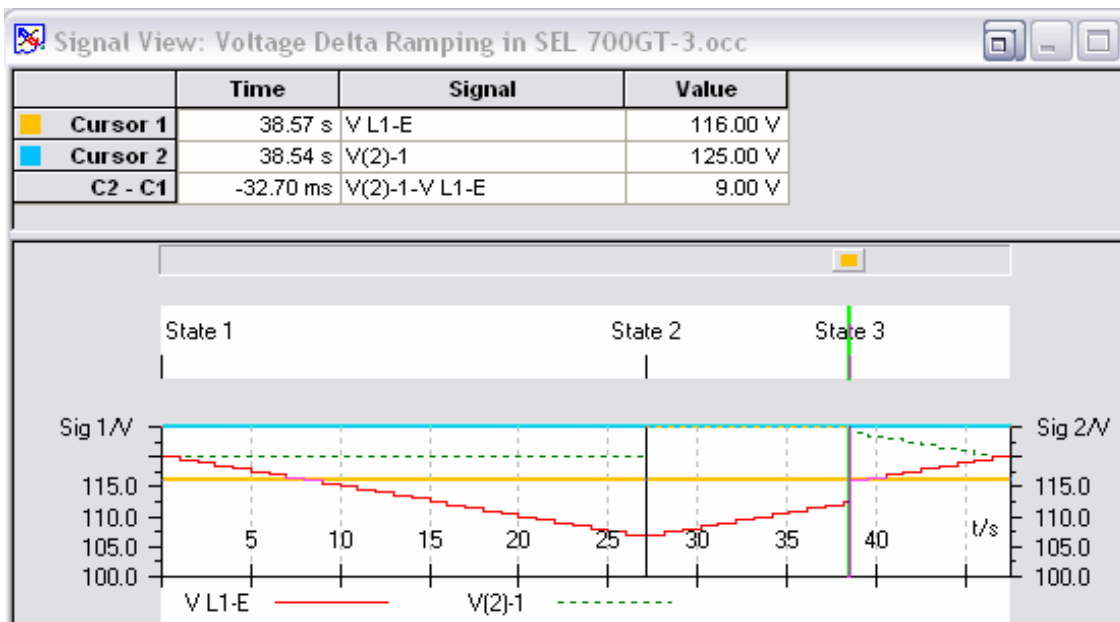
Figure 9: Synchronized close tests, VL1-E=grid, V(2)-1=microgrid

Figure 9 shows a similar test, but instead the microgrid voltage was raised above 120V to show that the grid voltage will also increase by the same amount before synchronized closing will be allowed. IEEE 1547 requires that voltages on either side of the paralleling device have a maximum difference of 10% of base voltage. In this test the grid voltage was 116V and the microgrid voltage was 125, both of which are within synchronization range of each other.

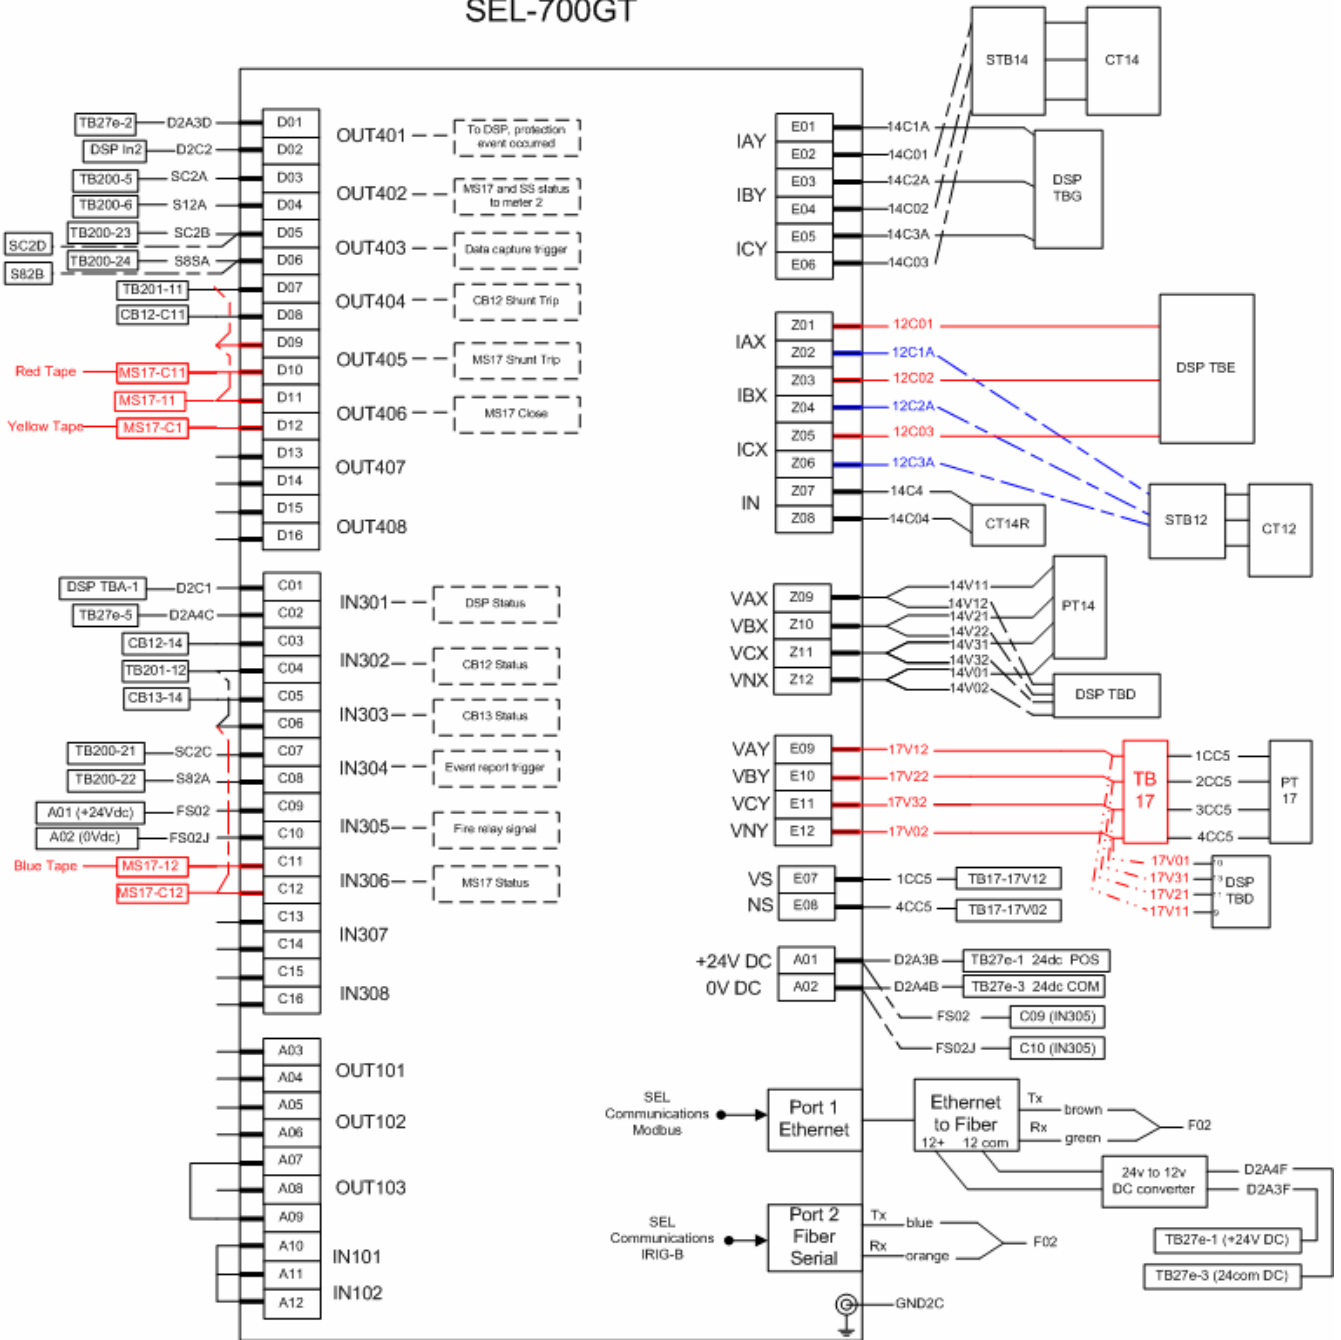
## SEL-700GT

RELOCATED WIRE

As mentioned in the introduction, an existing SEL-351 relay was originally connected to the static switch DSP controller. The I/O configuration of the SEL-351 is similar to the SEL-700GT, only with fewer options. Therefore, we were able to relocate all the existing wiring from the SEL-351 to the new relay, and allow the SEL-700GT to take over the protection functions performed by the SEL-351. The SEL-351 was left in place so that it may be utilized in the future should the need arise. New wiring was needed between the SEL-700GT and the mechanical switch, which is located in the adjacent static switch cabinet, for trip and close operations and supply voltage to spring wind motor within the switch. A mounting apparatus and panel were fabricated for the mechanical switch located in the existing cabinet which also houses the semiconductor switch due to its proximity to the existing bus and available space. The following picture displays an overhead view of the test bed, and figures 10-13 show pictures of the installation of the relay and switch in the test bed

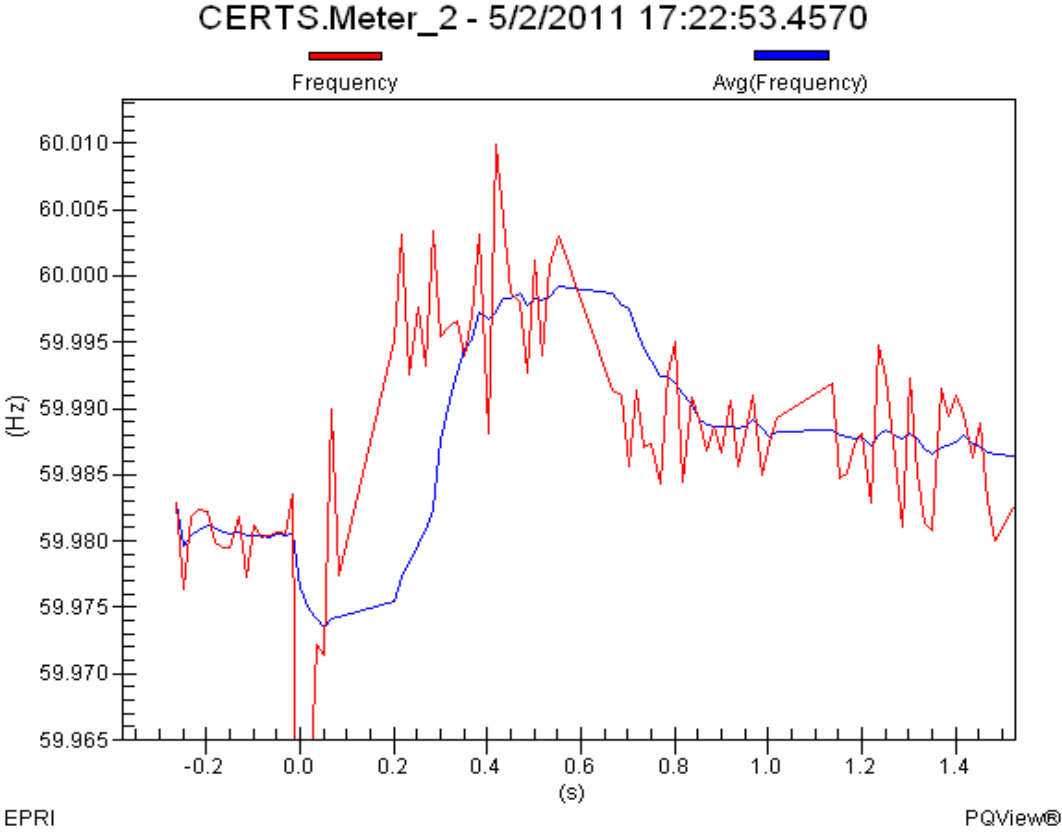
Figure 14a: Grid frequency during synchronized closing event

Figure 14a shows the grid frequency at meter 2 prior to closing was 59.98Hz and remained at 59.986Hz after closing. This displays that the grid frequency was largely unaffected by this event.

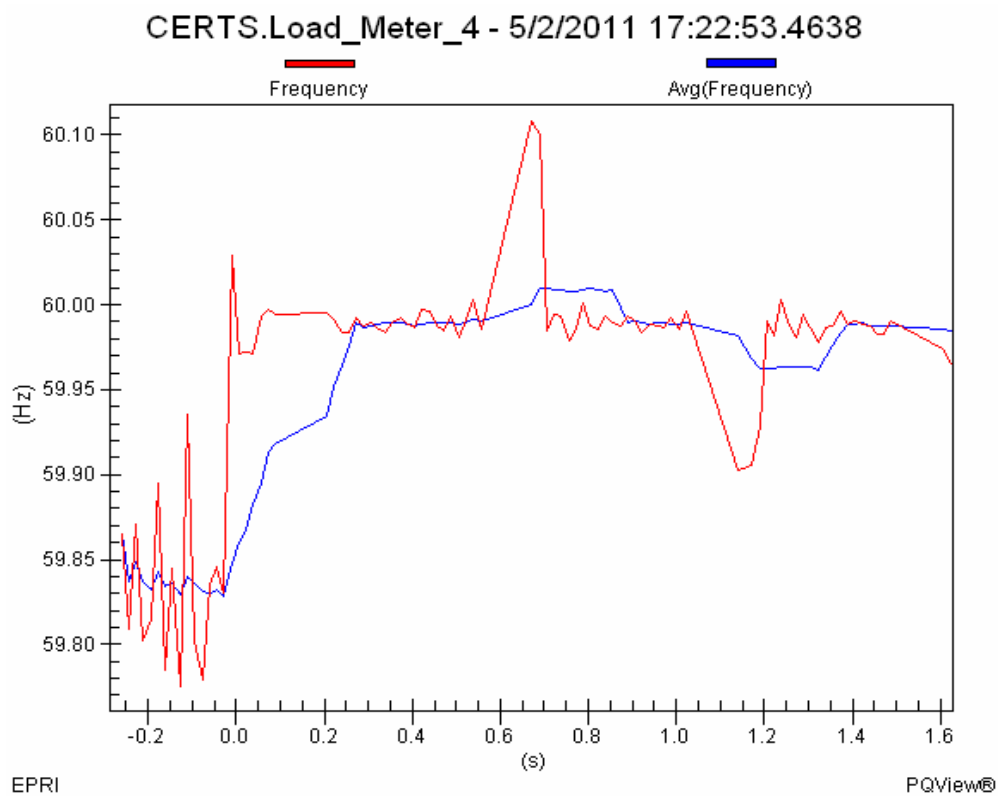
**Figure 14b: Microgrid frequency during synchronized closing event**

These results are similar to those obtained from testing the semiconductor static switch. In both situations the microgrid frequency reached 60Hz after synchronized closing.

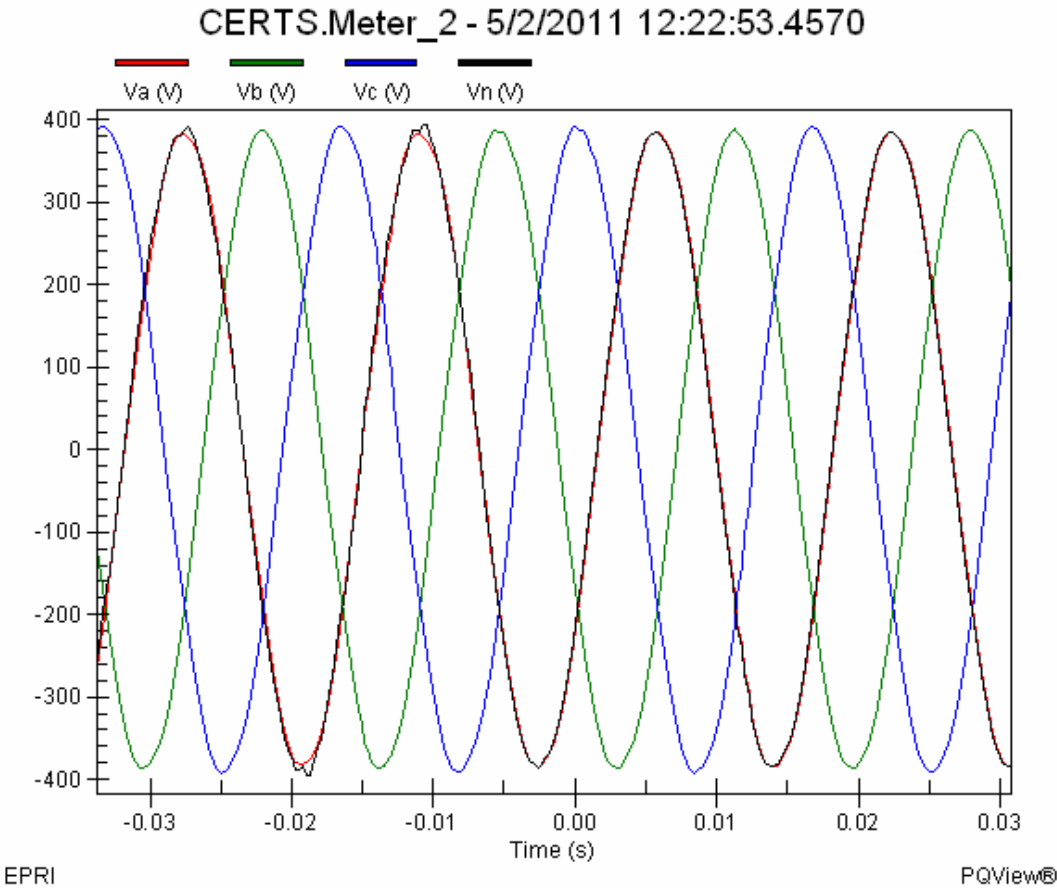
**Figure 15a: Grid voltage waveform data during synchronized closing event**

A similar waveform was obtained from the semiconductor static switch tested under the same conditions.

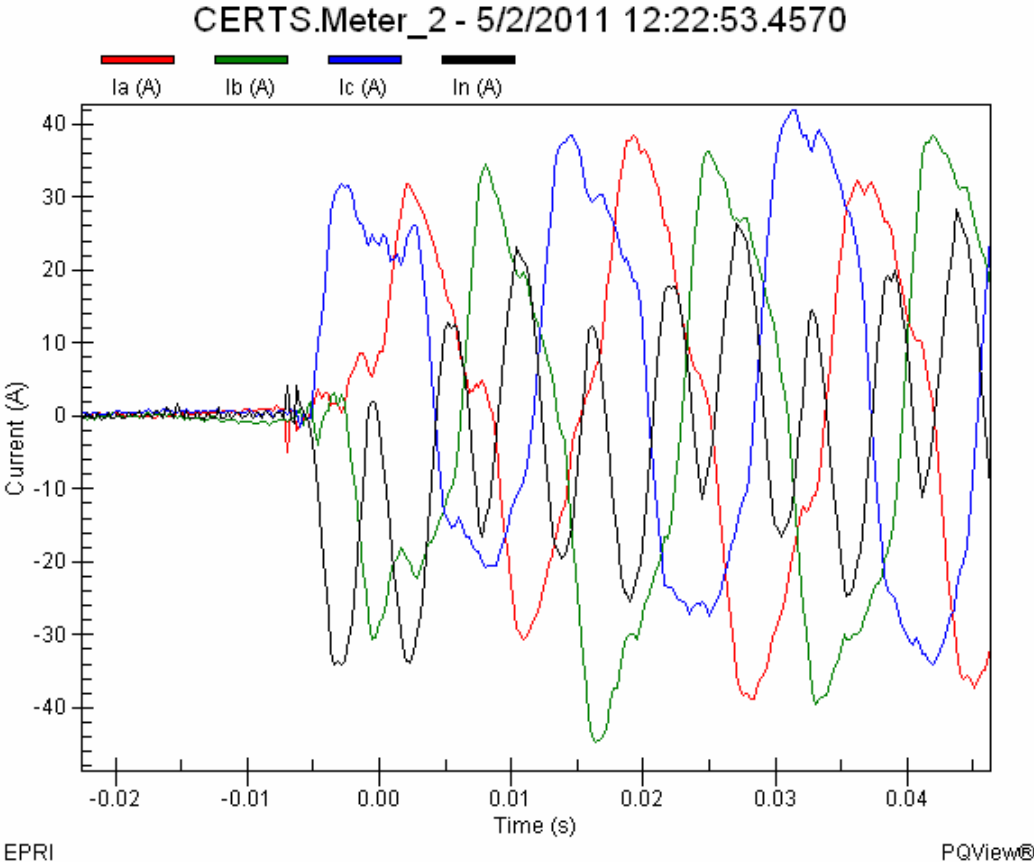
Figure 15b: Grid current waveform data during synchronized closing event

The transition from islanded to utility-connected mode occurred within 0.01s, which is comparable to the transition time achieved by the semiconductor static switch.

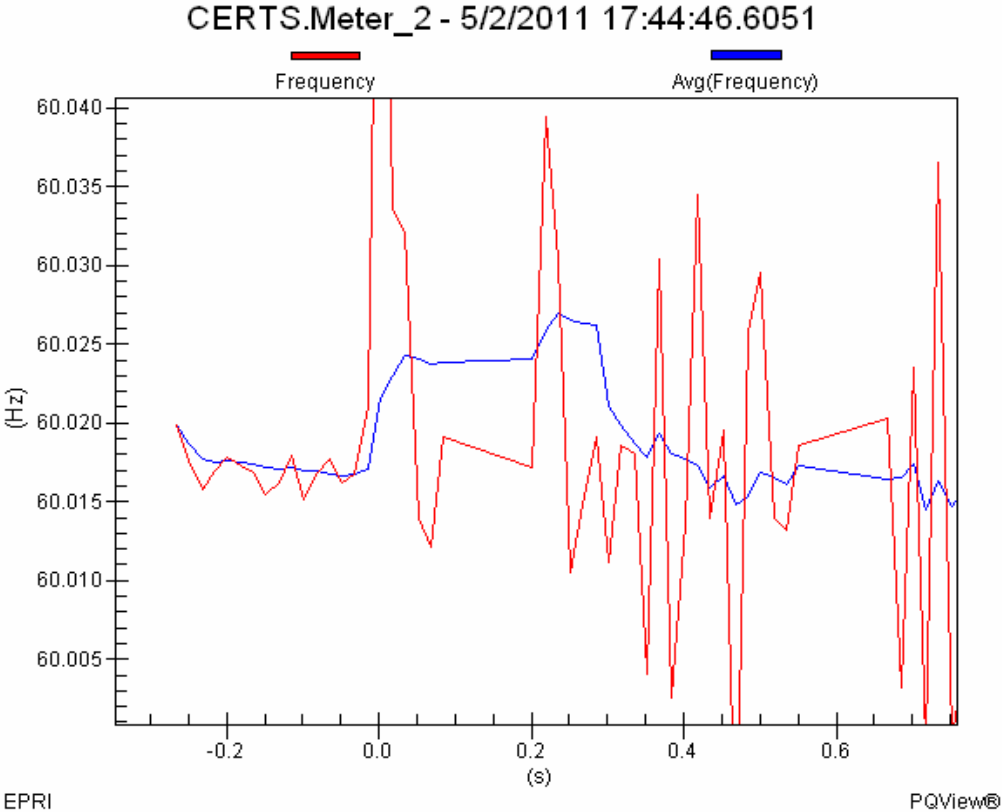
Figure 16a: Grid frequency during synchronized close

The same test was performed again, except with the genset dispatched to 60kW. Since the dispatched load was greater than the islanded load, the frequency within the protected zone of the microgrid is 60.16Hz prior to synchronized closing. Figure 16a shows grid frequency from meter 2 at 60.017Hz prior to closing and 60.015Hz after closing. This again displays minimal change in grid frequency during the event.

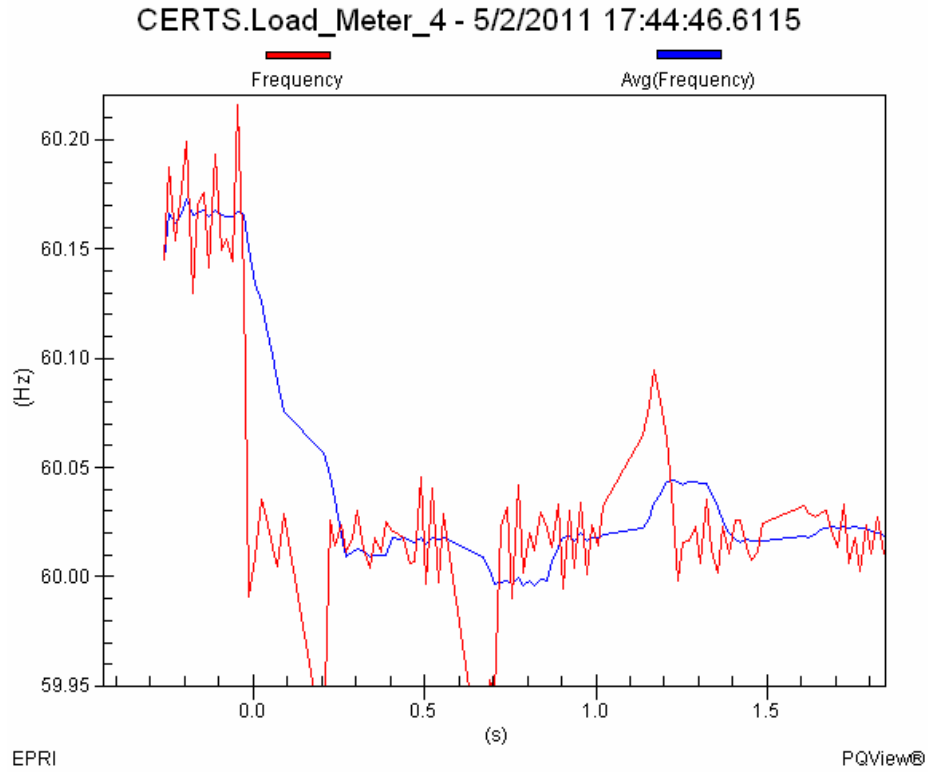
**Figure 16b: Microgrid frequency during synchronized close**

Figure 16b shows microgrid frequency from load meter 4 at 60.16Hz prior to closing and 60.01Hz after closing. This displays that although the microgrid frequency was roughly 0.16Hz more than the ideal 60Hz, it was still within the 0.3Hz synchronism range. And after closing occurred the frequency adjusted to a value that was nearly ideal.

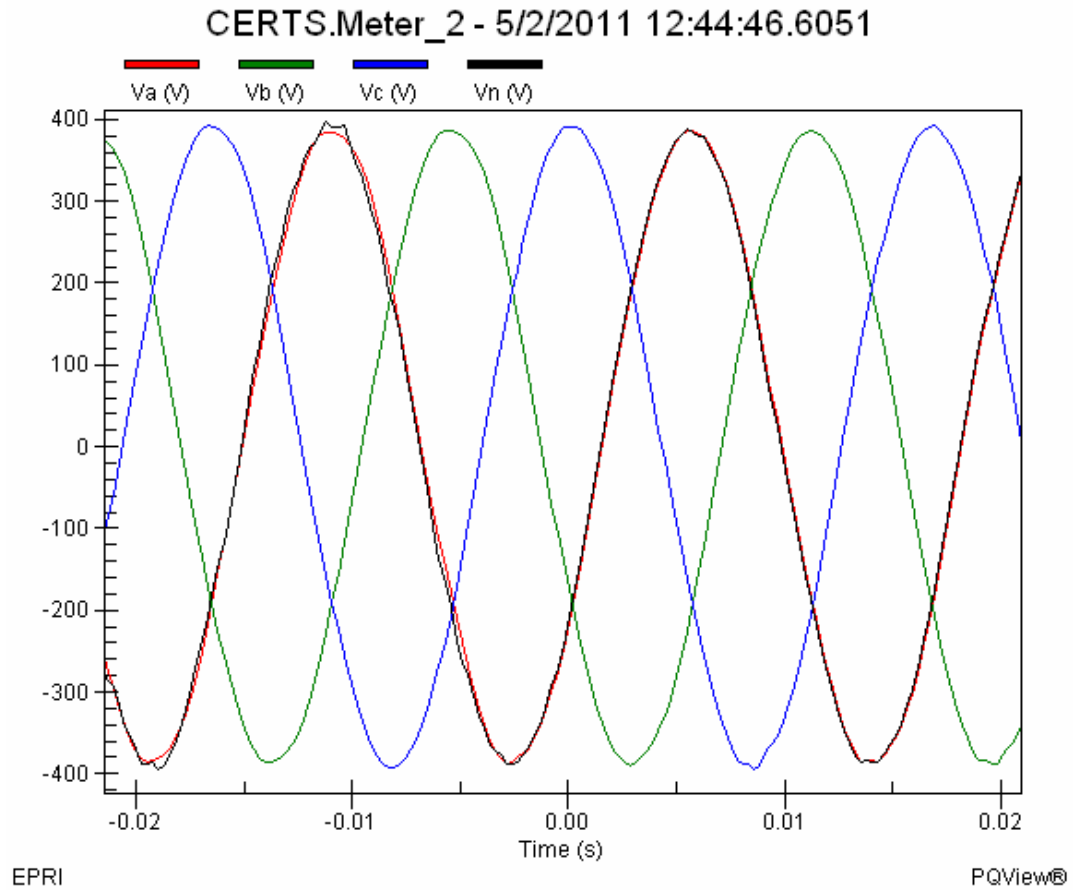
**Figure 17a: Voltage waveform data during synchronized closing event**

Figure 17a displays voltage waveform data for the same event at meter 2 on the grid.  $V_a$  represents the voltage on the utility grid and  $V_n$  represents voltage on the protected zone of the microgrid. Near the time of closing at  $t=0$  seconds there are no transients present indicating a smooth transition when the mechanical switch closes.

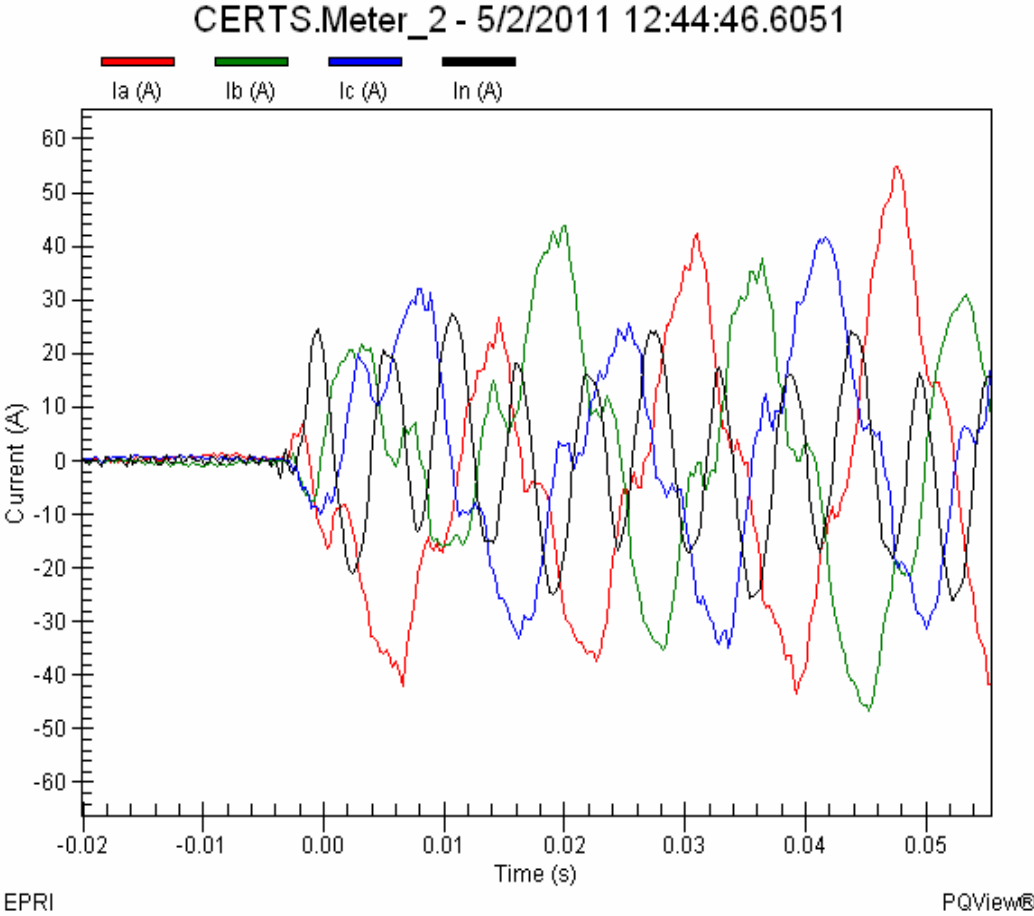
Figure 17b: Grid current waveform data during synchronized closing event

Figure 17b shows current waveform data for the same event. Again, there was no current flowing prior to closing. After the switch closed, the current increased as the genset increased its output to the dispatched amount. Although the current increases rapidly, it does not reach the levels traditionally seen when distributed generation connects with a frequency deviation.

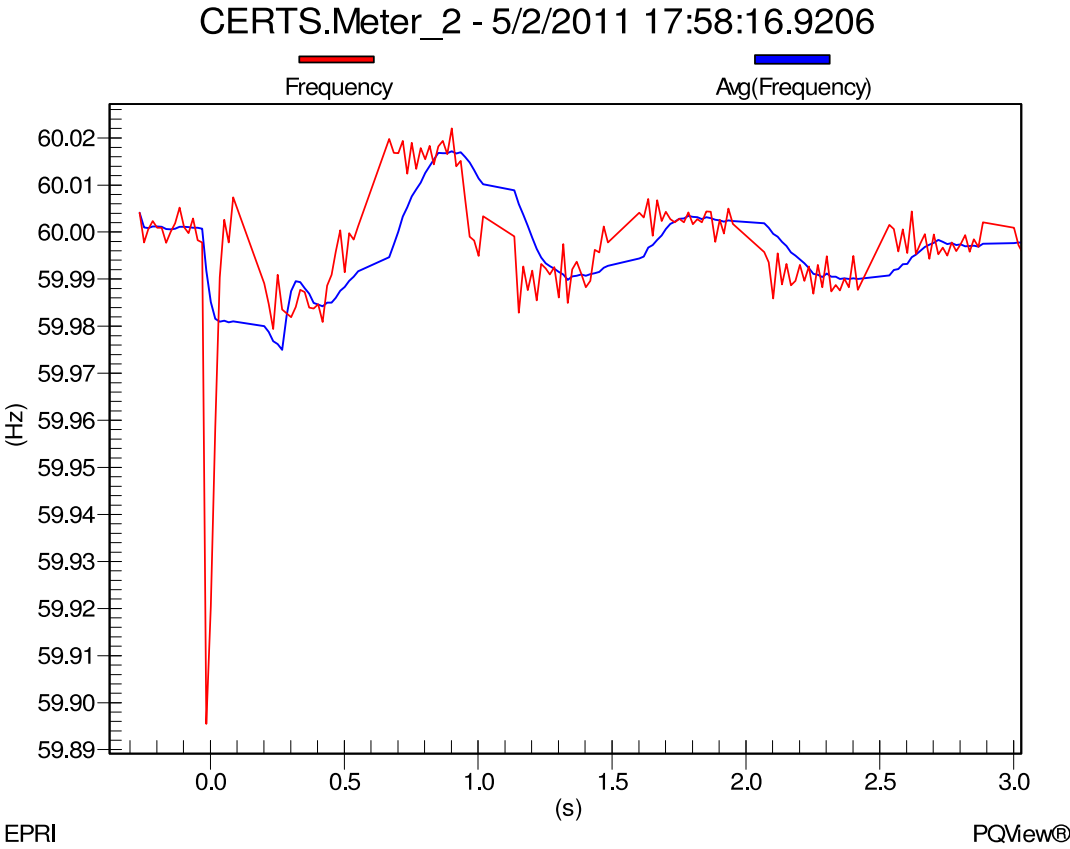
**Figure 18a: Grid frequency during synchronized closing event**

For the next test, to get an initial frequency of 59.5Hz in the protected zone of the microgrid prior to closing the genset was dispatched to 0kW. Also, 60kW of load was added to the protected zone of the microgrid and 40kW was added to the unprotected zone. Figure 18a shows the grid frequency at 60.1Hz prior to closing and 59.998Hz after closing. This indicates the grid frequency was affected by the closing event more than the previous test.

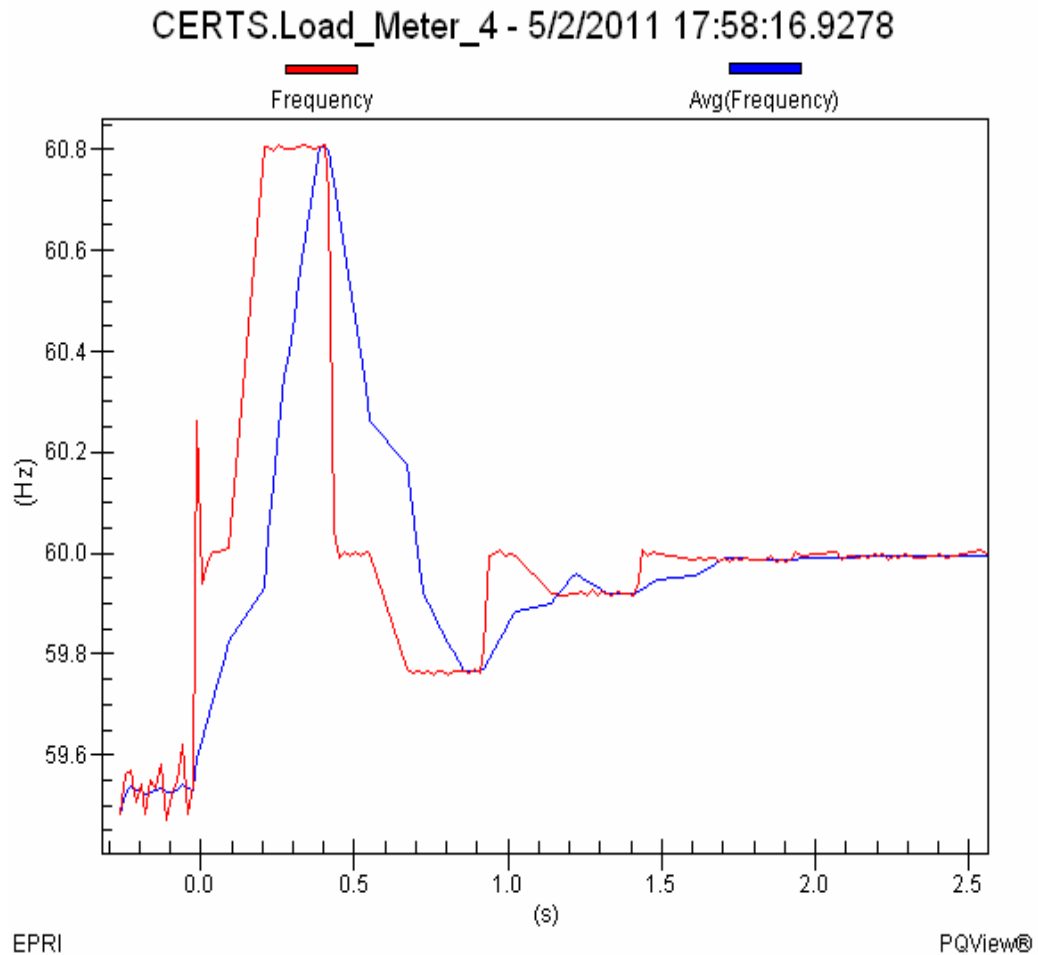
**Figure 18b: Microgrid frequency during synchronized closing event**

Figure 18b shows the microgrid frequency at 59.5Hz prior to closing and 60Hz after closing. This displays that although the frequency on the microgrid was at the maximum synchronism range, the switch was able to close in and the frequency was adjusted to the ideal value.

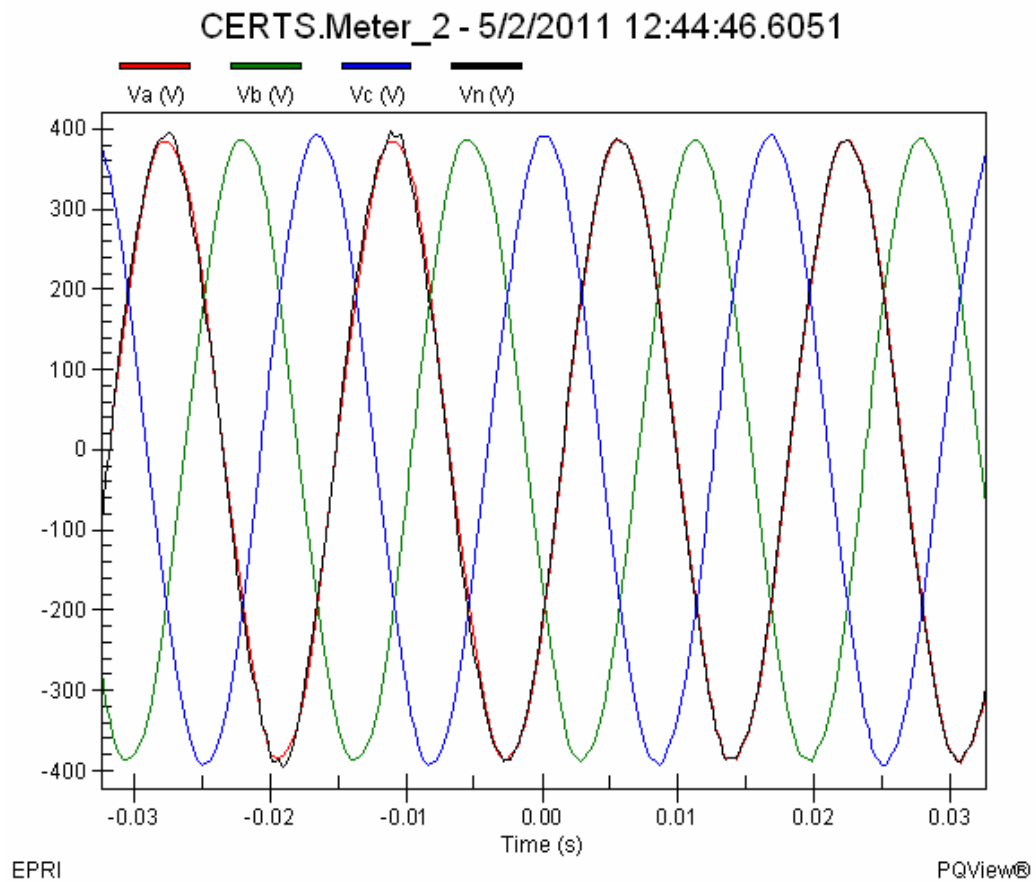
**Figure 19a: Voltage waveform data during synchronized closing event**

Figure 19a displays voltage waveform data for the same event at meter 2 on the grid.  $V_a$  represents the voltage on the utility grid and  $V_n$  represents voltage on the protected zone of the microgrid. Near the time of closing at  $t=0$  seconds there are no transients present indicating a smooth transition when the mechanical switch closes.

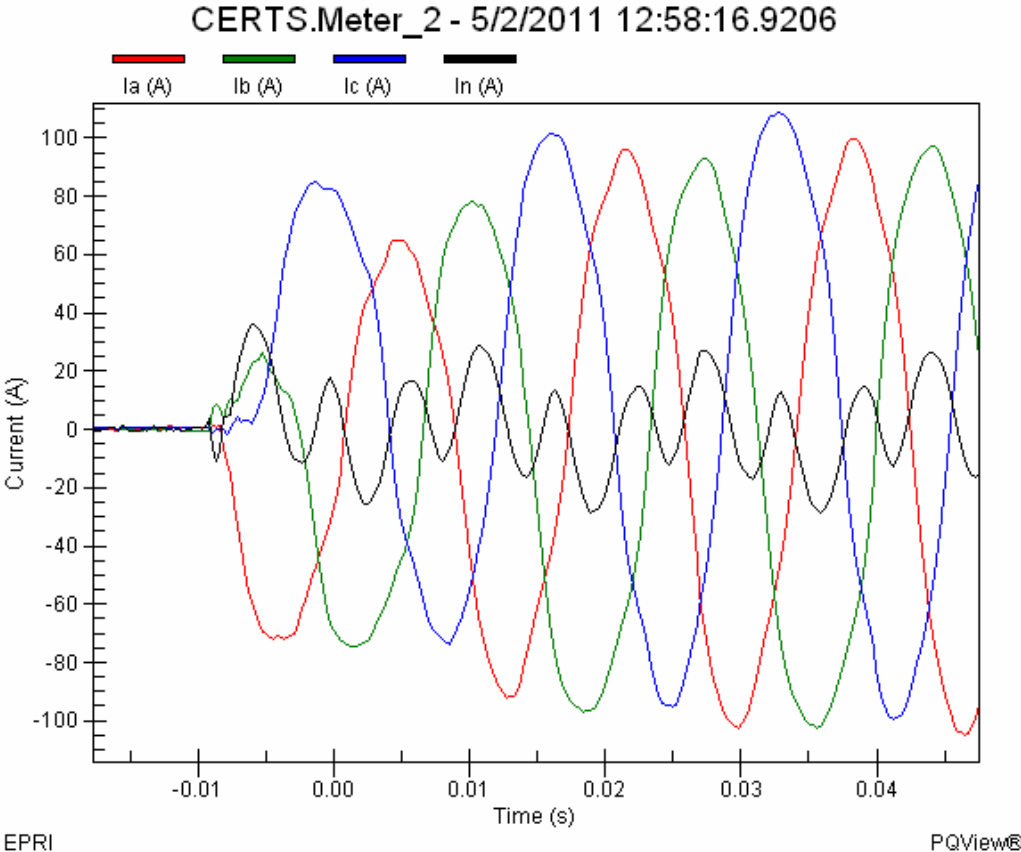
**Figure 19b: Current waveform data during synchronized closing event**

Figure 19b shows current waveform data for the same event. Again, there was no current flowing prior to closing. After the switch closed, the current increased as the genset decreased its output to the dispatched amount. Although the current increases rapidly, it does not reach the levels traditionally seen when distributed generation connects with a frequency deviation.

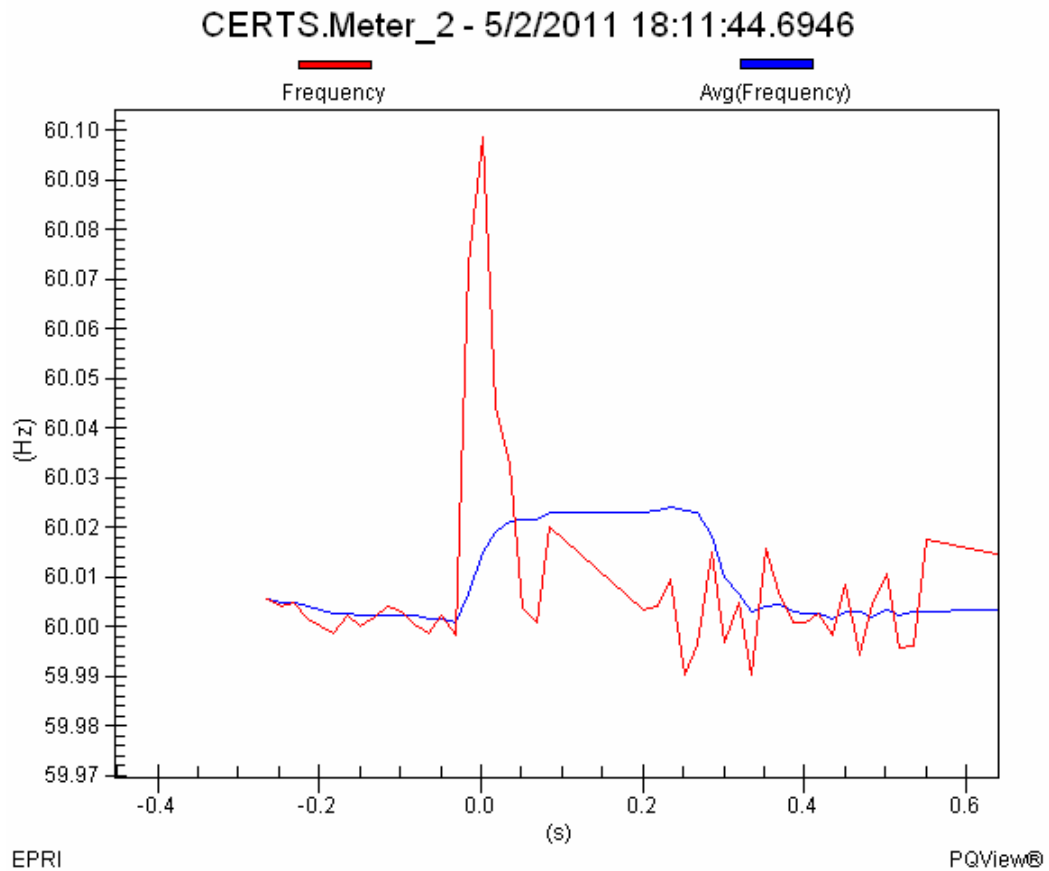
**Figure 20a: Grid frequency during synchronized closing event**

For the next test, to get an initial frequency of 60.5Hz in the protected zone of the microgrid prior to closing the genset was dispatched to 60kW. Also, 0kW added to the protected zone of the microgrid and 80kW was added to the unprotected zone. Figure 20a shows the grid frequency at 60.004Hz prior to closing and 60Hz after closing. This indicates the grid frequency was unaffected by the closing event.

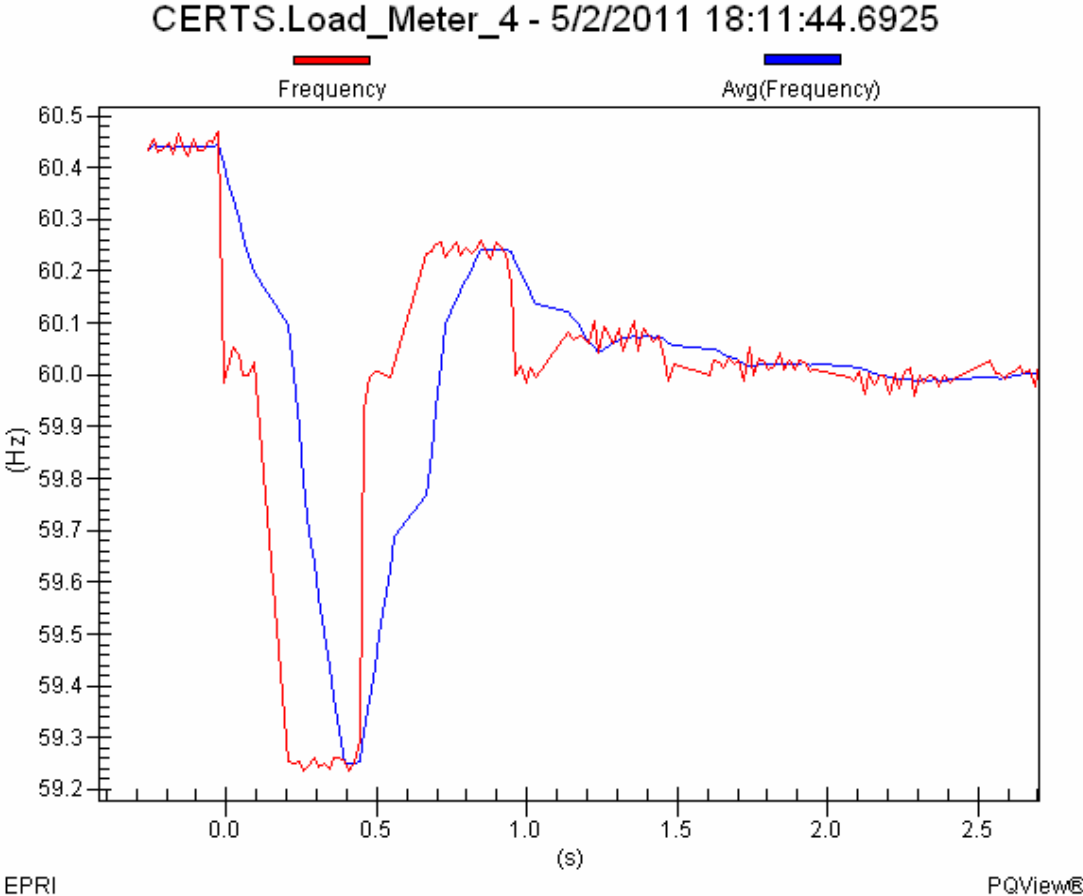
**Figure 20b: Microgrid frequency during synchronized closing event**

Figure 20b shows the microgrid frequency at 60.44Hz prior to closing and 60Hz after closing. This displays that although the frequency on the microgrid was near the maximum synchronism range (0.44Hz), the switch was able to close in and the frequency was adjusted to the ideal value.

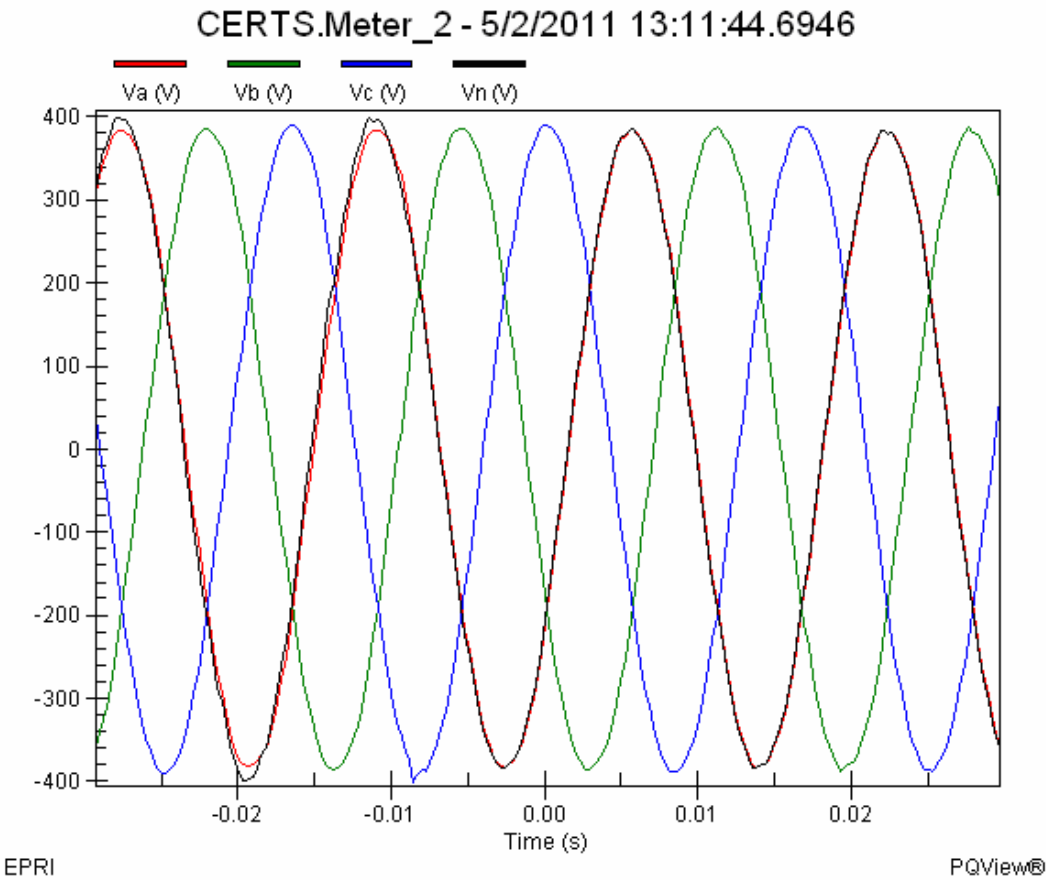
Figure 21a: Voltage waveform data during synchronized closing event

Figure 21a displays voltage waveform data for the same event at meter 2 on the grid.  $V_a$  represents the voltage on the utility grid and  $V_n$  represents voltage on the protected zone of the microgrid. Near the time of closing at  $t=0$  seconds there are no transients present indicating a smooth transition when the mechanical switch closes.

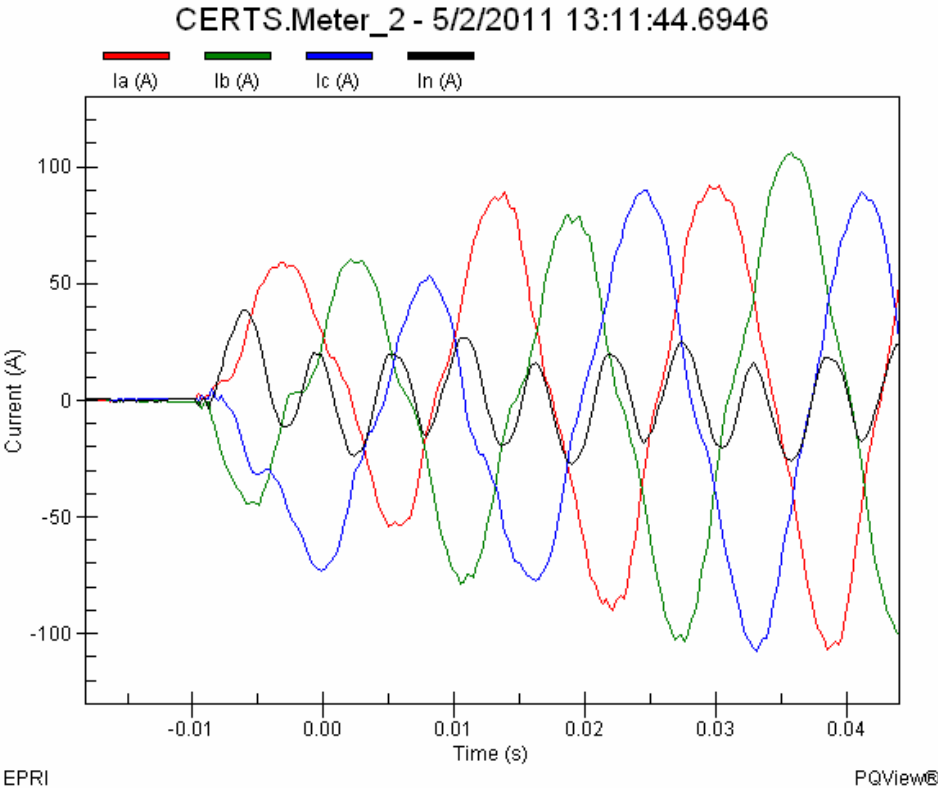
Figure 21b: Current waveform data during synchronized closing event

Figure 21b shows current waveform data for the same event. Again, there was no current flowing prior to closing. After the switch closed, the current increased as the genset increased its output to the dispatched amount. Although the current increases rapidly, it does not reach the levels traditionally seen when distributed generation connects with a frequency deviation.
