# **CERTS Microgrid Mechanical Switch Test Report**

**D. Klapp, R. Zimmerly, J. Howard**  
*AEP Dolan Technology Center*  
*Groveport, OH*

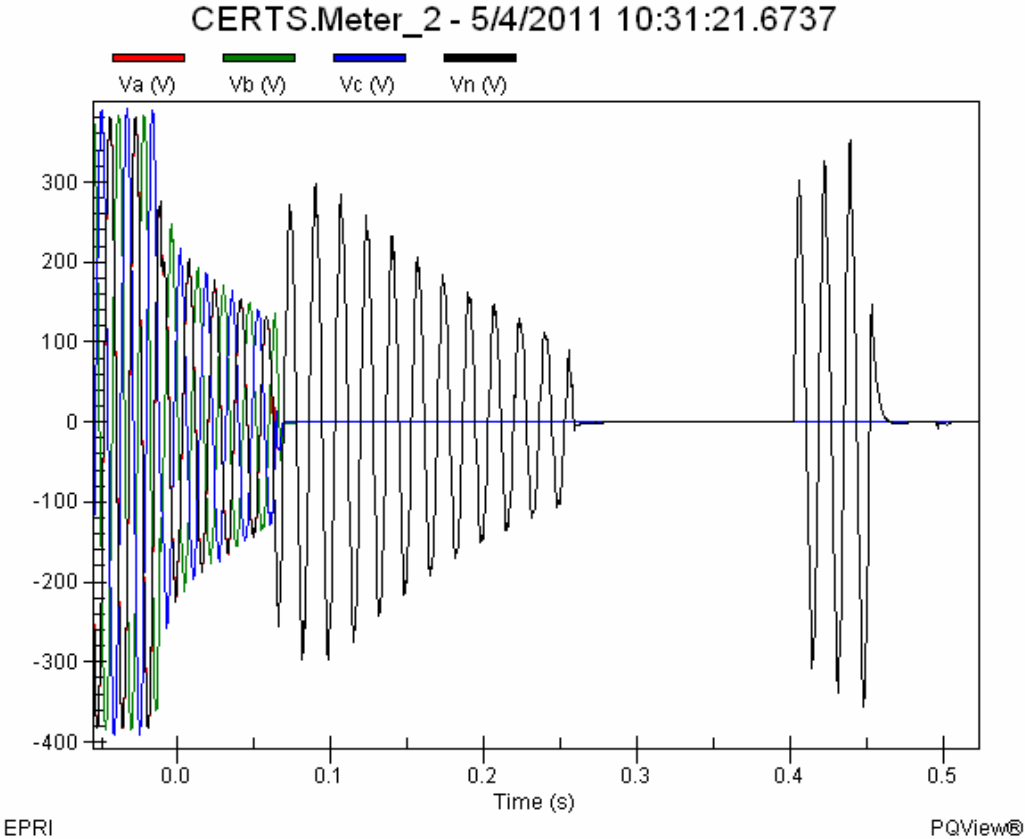
Figure 22a: Grid voltage waveform during anti-islanding event

The mechanical switch operated within 4.5 cycles, compared to the semiconductor switch's operating time of 1.5 cycles. This difference was large enough to cause the genset to stall, as it could not react fast enough to the large load.

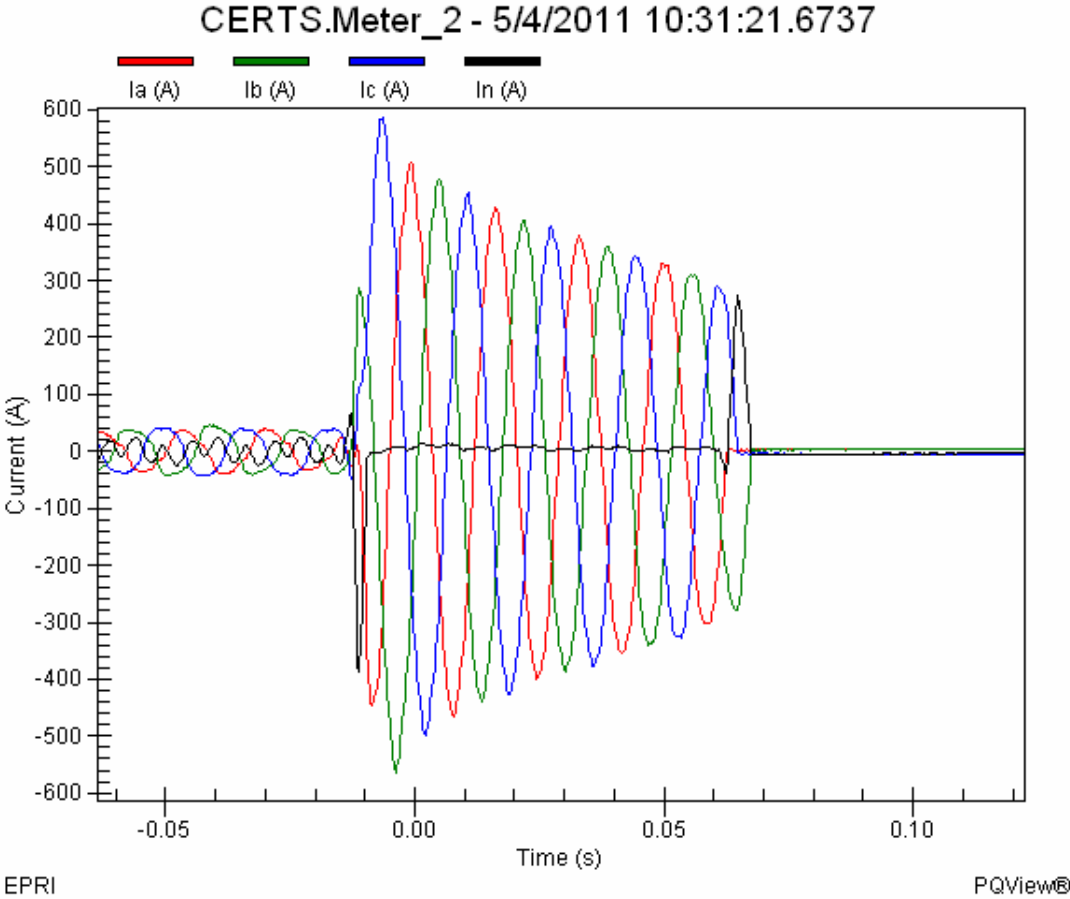
Figure 22b: Grid current waveform during anti-islanding event

Figure 22b shows current waveforms on the grid. All the currents stop flowing after the mechanical switch opened. This took place in the same time period as the voltage waveform in fig. 22a (0.7s).

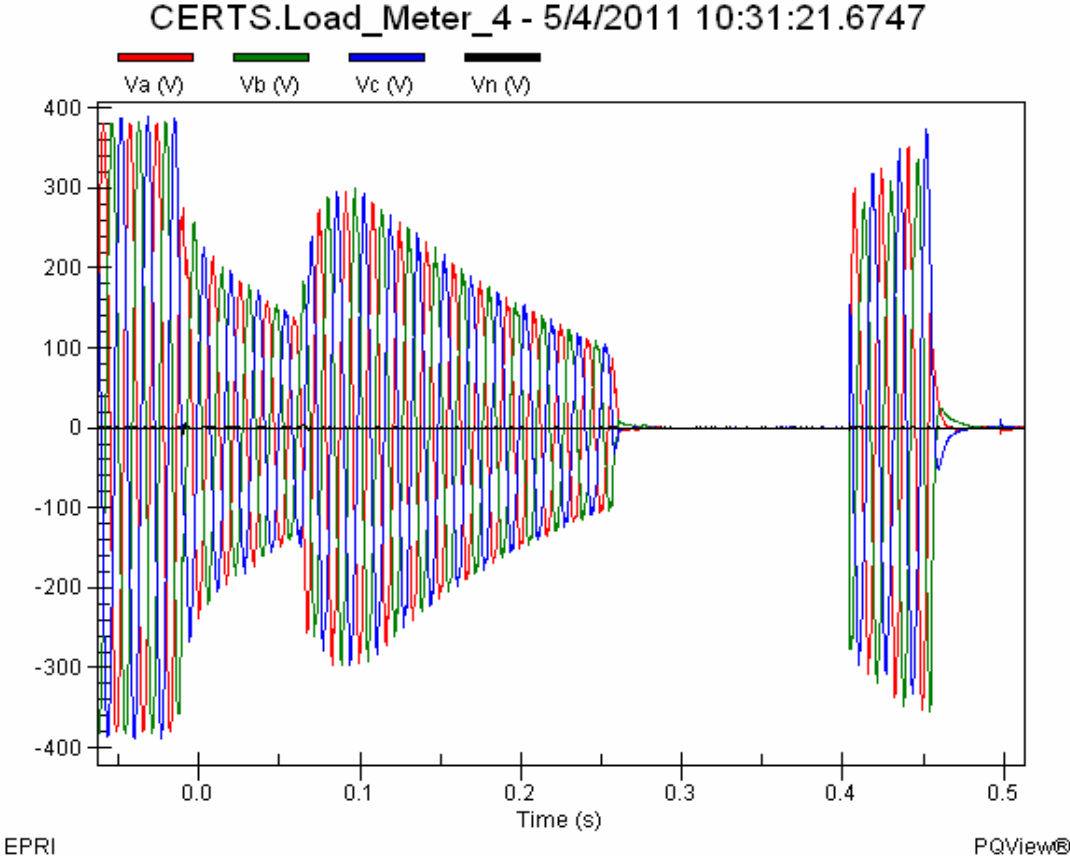
Figure 23a: Microgrid voltage waveform during anti-islanding event

In comparison, Figure 23a displays voltage waveform on the microgrid. The behavior of this voltage is the same as  $V_n$  measured at meter 2, showing the genset's attempt to restart and subsequent stall.

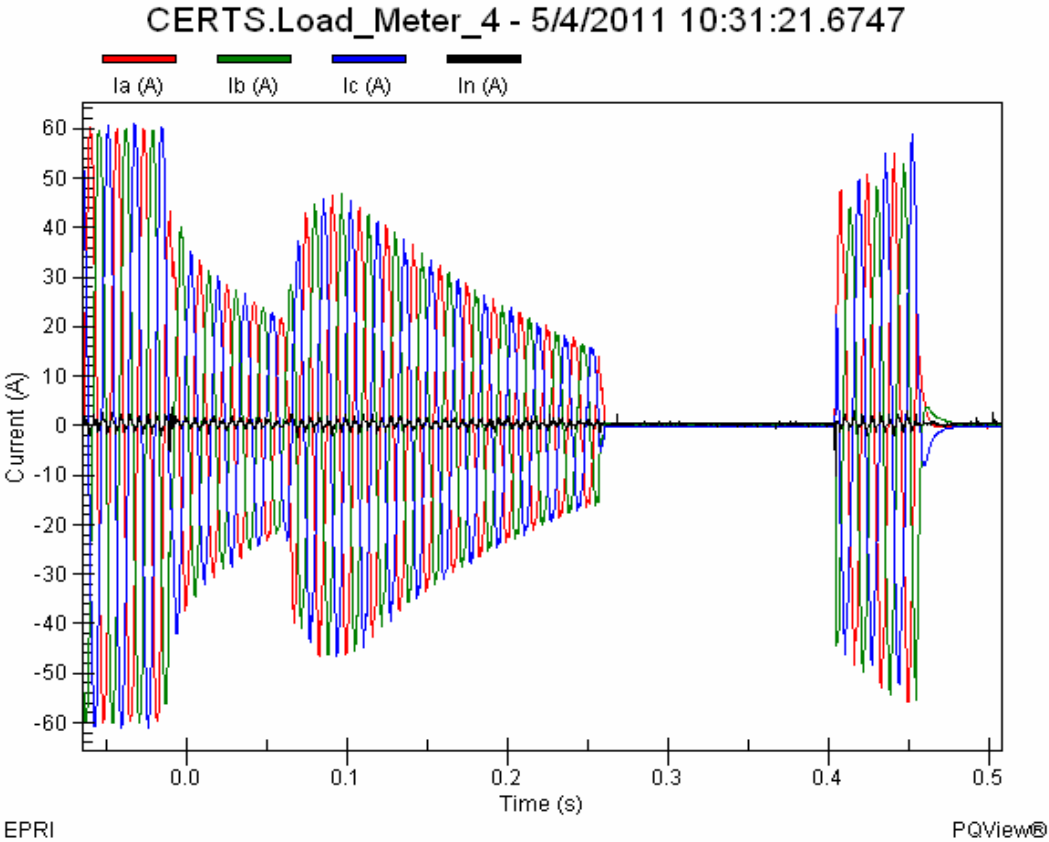
Figure 23b: Microgrid current waveform during anti-islanding event

Figure 23b displays current waveform data on the microgrid during the same event. This waveform is nearly identical to the voltage waveform, showing the power flow on the microgrid as the genset attempted to restart after picking up the load. During this event the genset had a peak current 60 amps and was 930% overloaded.

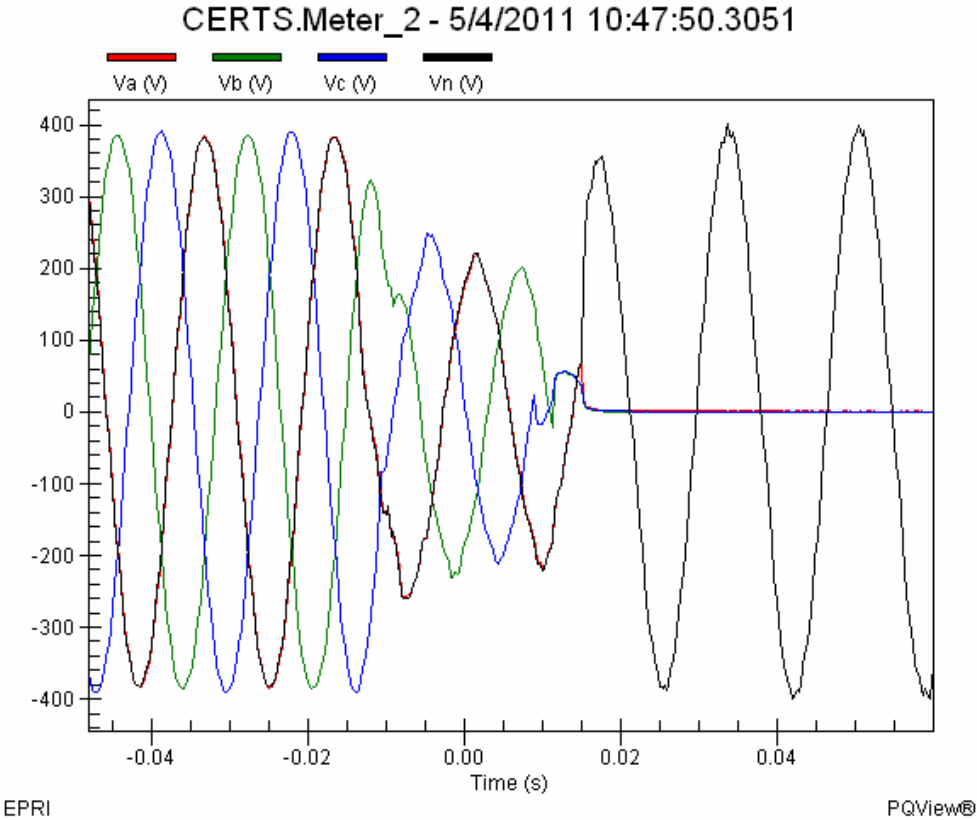
Figure 24a: Grid voltage waveform during anti-islanding event

Figure 24a shows voltage waveform data on the grid for this event. The 3 phase voltages on the grid drop to zero after the switch is opened, and Vn remains present as it is located on the protected microgrid zone. Vn was synchronized with Va until the static switch opened.

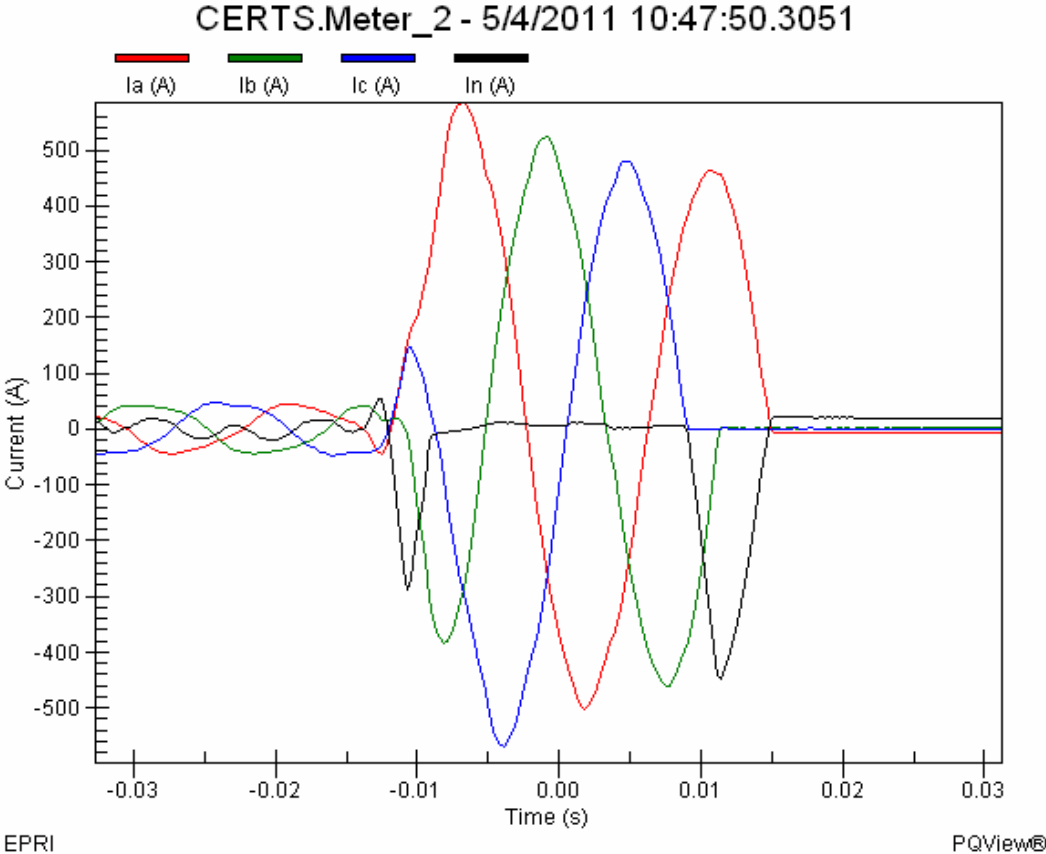
Figure 24b: Grid current waveform during anti-islanding event

Figure 24b shows grid current waveform data during the event. Current on all 3 phases initially spikes to 500A or above before dropping to zero within 0.02s, or the time in which the static switch operated.

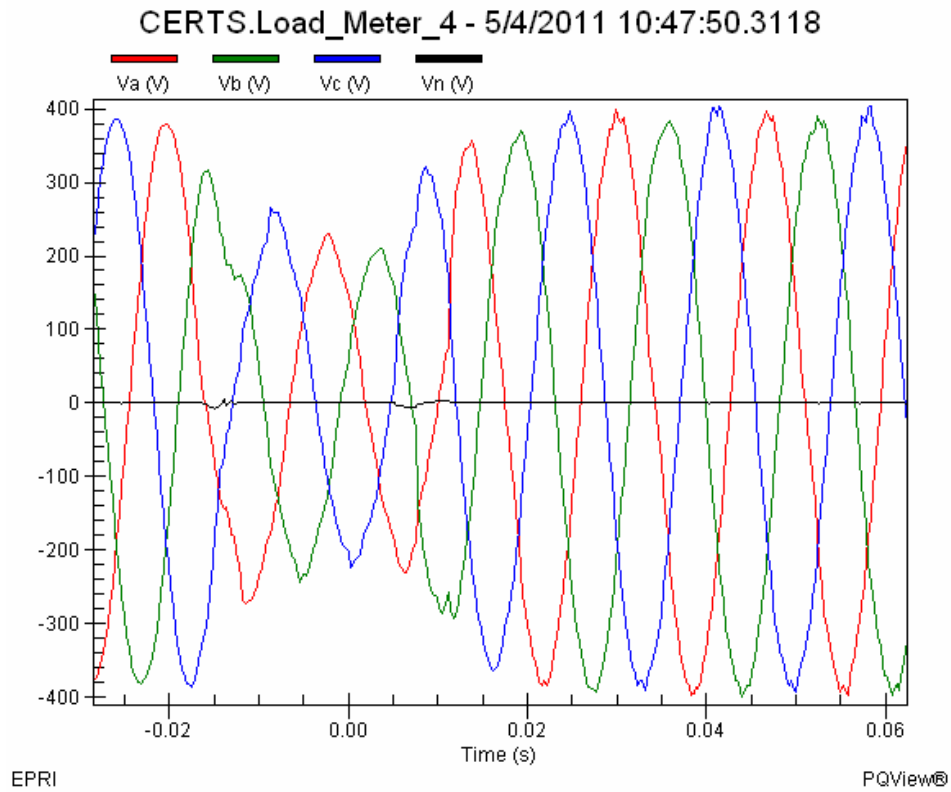
**Figure 25a: Microgrid voltage waveform during anti-islanding event**

Figure 25a displays voltage waveform data at meter 4 on the microgrid during this event. There was a dip in voltage for 1 cycle before the static switch operated and the genset picked up the load without stalling.

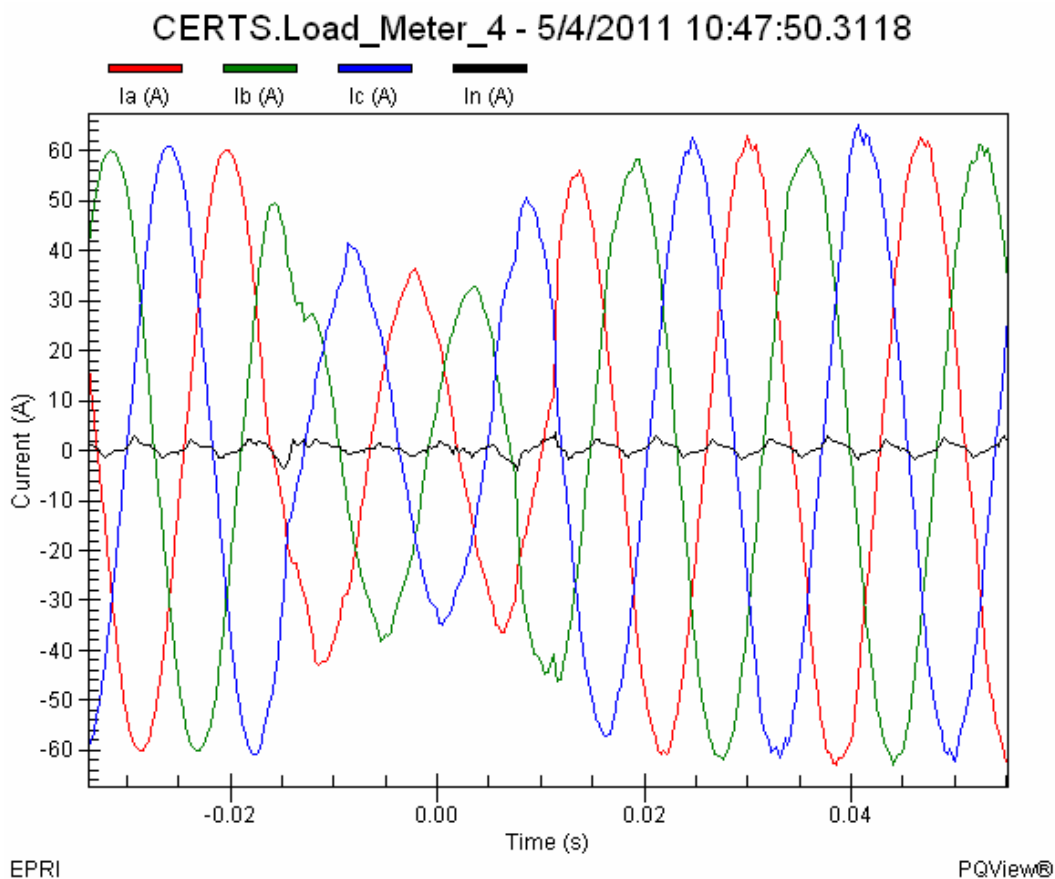
**Figure 25b: Microgrid current waveform during anti-islanding event**

Figure 25b shows microgrid current waveform data for the same event. The waveform is nearly identical to the voltage waveform, displaying a dip in power on the protected zone for 1 cycle on the microgrid before the genset could pick up the load.

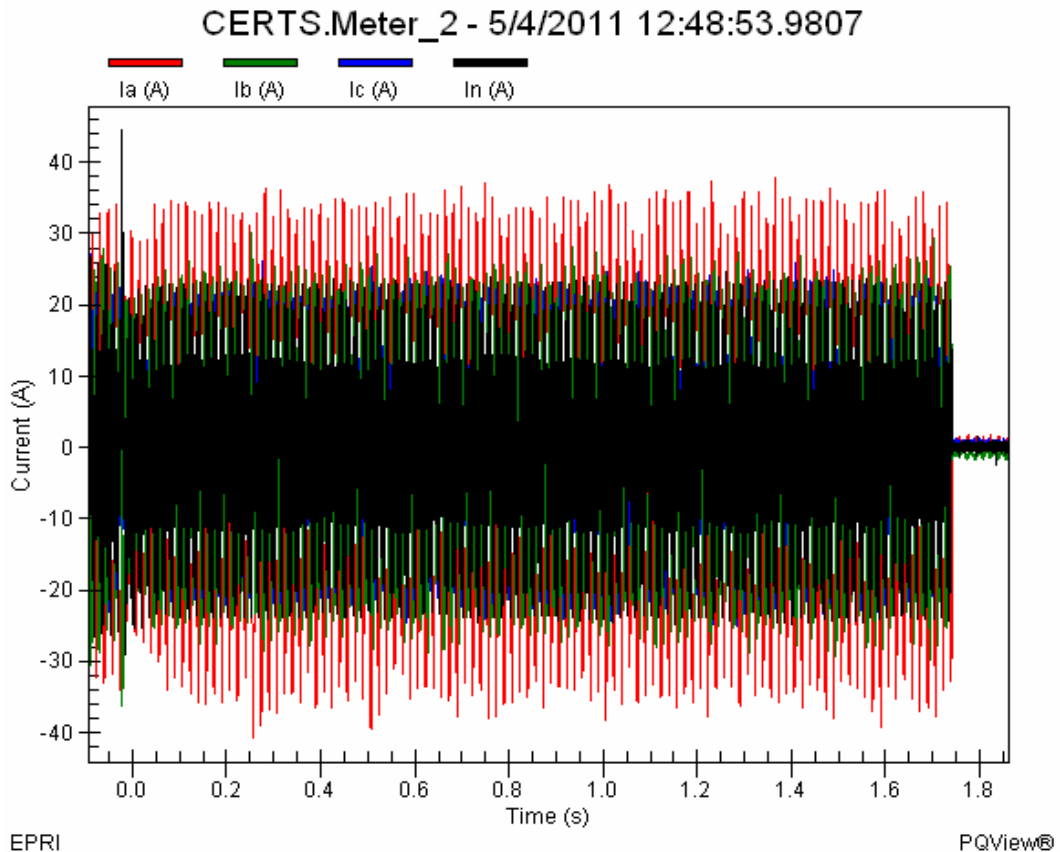
Figure 26: Grid current waveform during reverse power even

Figure 26 shows the current on the grid being reduced to zero after the reverse power element was engaged for 1.75s. This time delay is built into the relay settings.

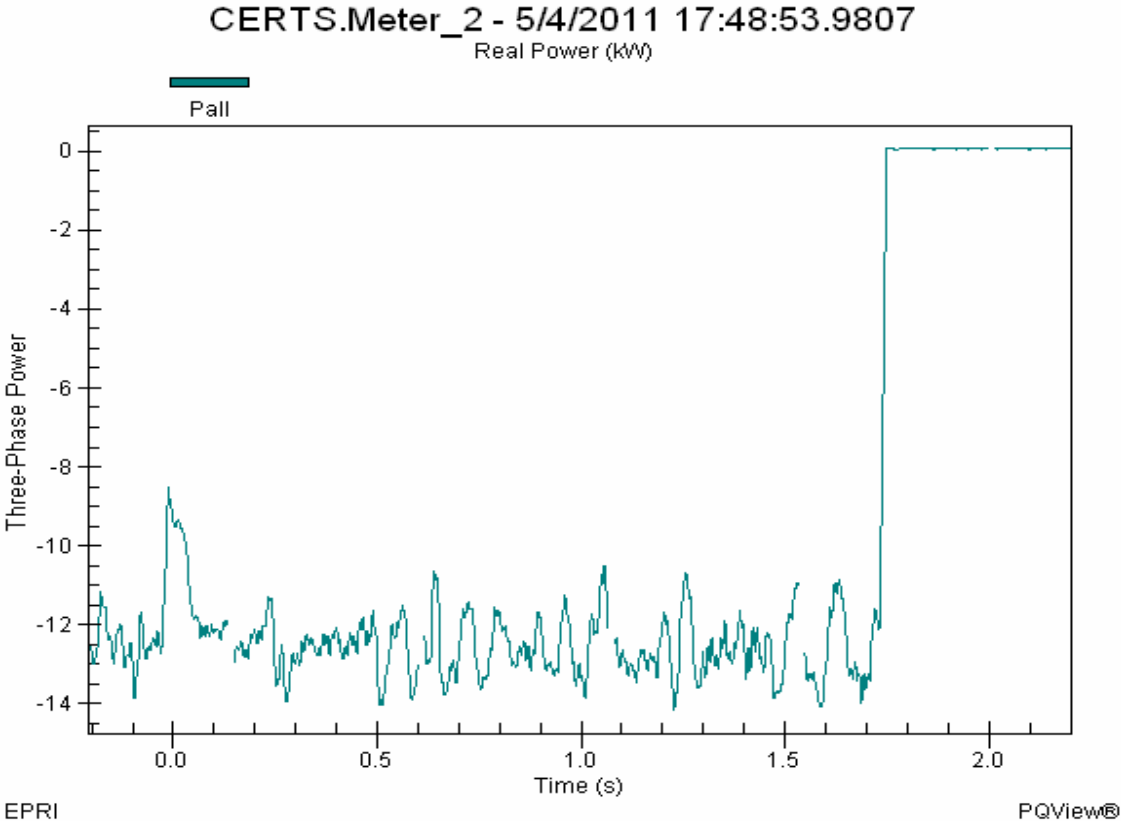
**Figure 27: Grid 3-phase real power during reverse power event measured at the mechanical switch**

Figure 27 shows the 3-phase real power at the mechanical switch reduced to zero in the same time period (1.75s). This reinforces the capability of the mechanical switch to operate before real power is allowed to be exported from the microgrid.

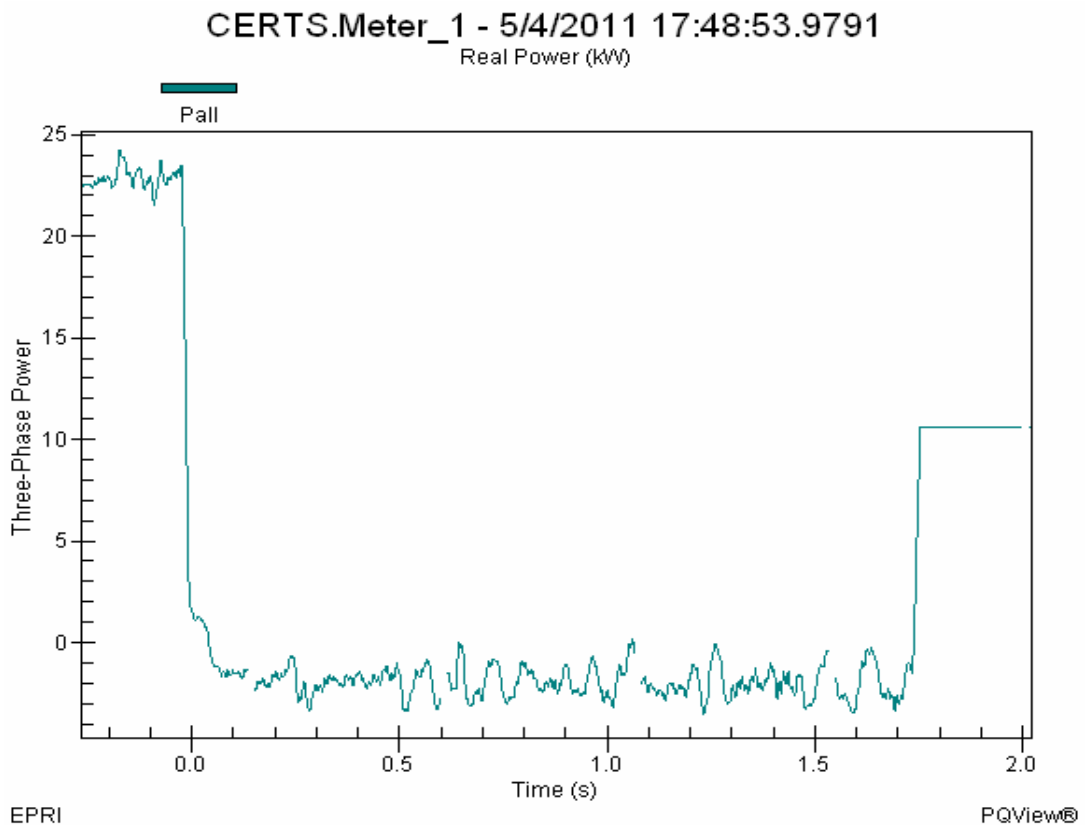
**Figure 28: Grid 3-phase real power during reverse power event measured at the PCC**

Figure 28 shows 3-phase real power measured at the PCC, upstream from the mechanical switch. The load in the unprotected zone of the microgrid was 10kW when the reverse power element engaged. After that, meter 1 at the PCC saw 0kW for the given time delay and then read 10kW when the mechanical switch opened. Throughout this event, which occurred in 1.75 seconds, the voltage remained constant.

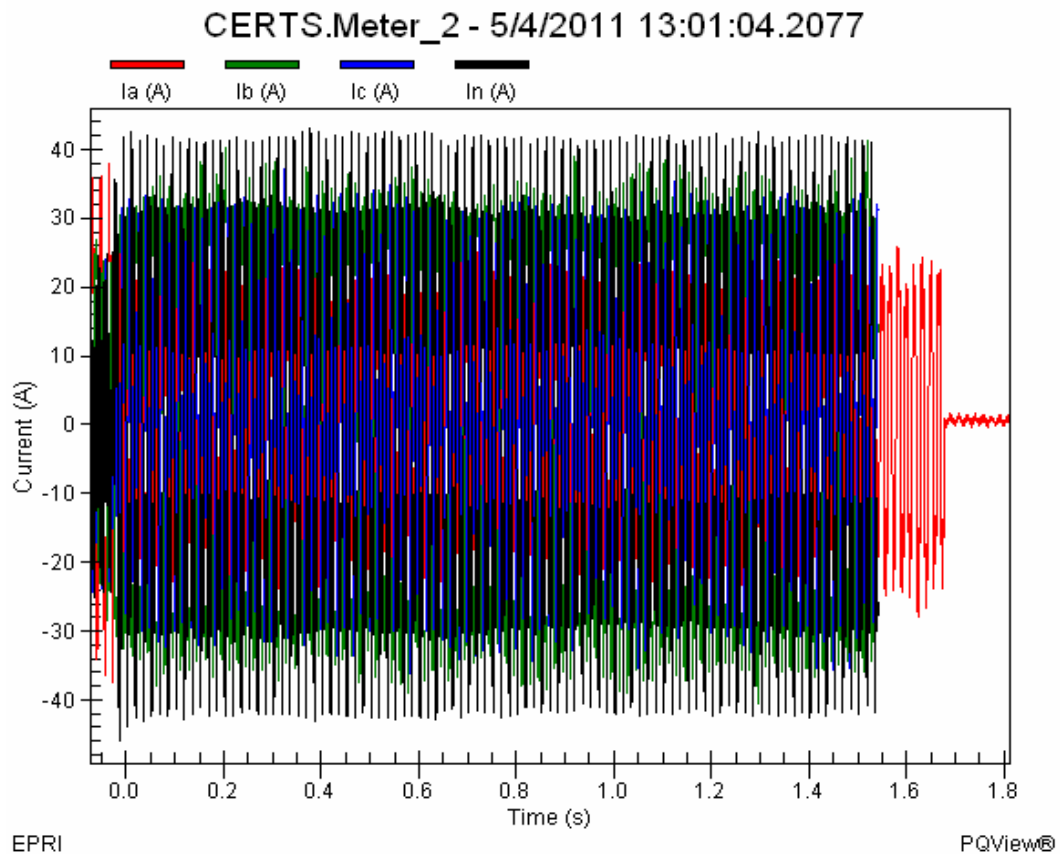
Figure 29: Grid current waveform during single-phase reverse power event

Figure 29 shows the current waveform on the grid side of the switch during this event. Only A-phase was reduced from roughly 38A to 20A, which caused the mechanical switch to operate.

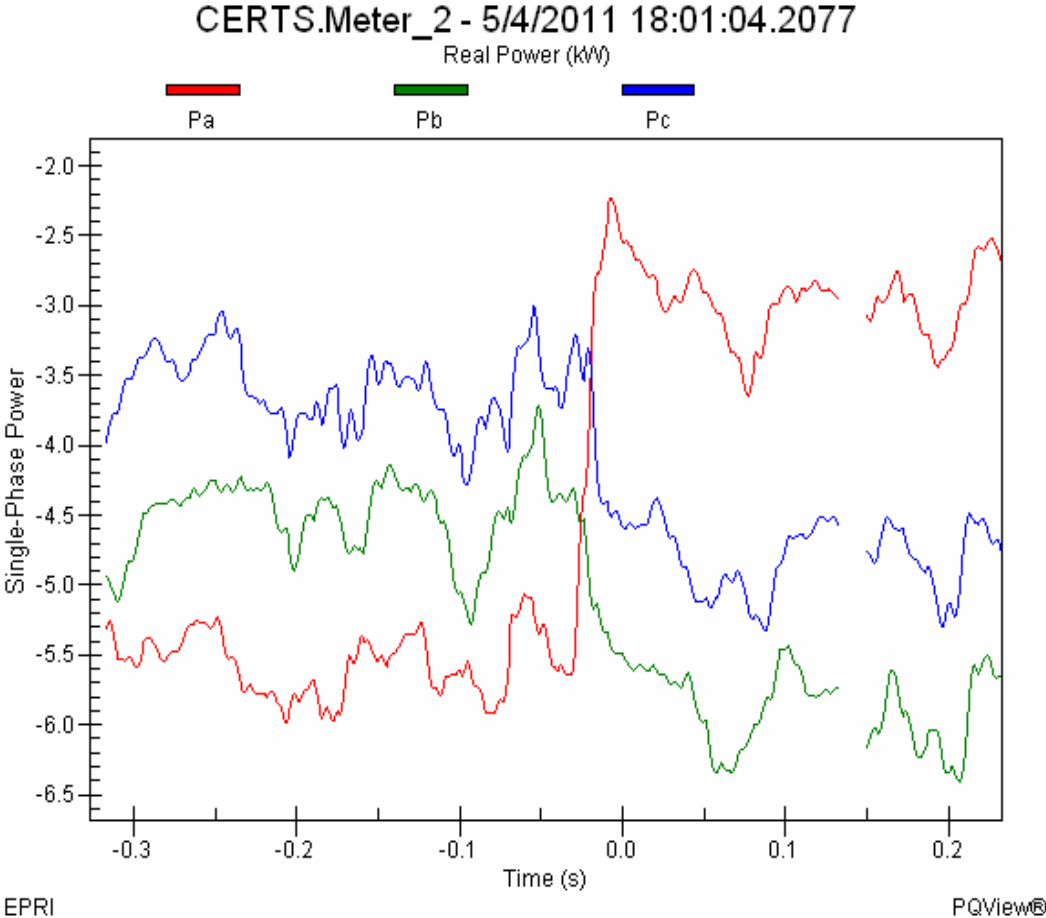
**Figure 30: Grid phase power measured at the mechanical switch during single-phase reverse power event**

Figure 30 shows how A-phase real power was measured on the grid side of the mechanical switch during this test.

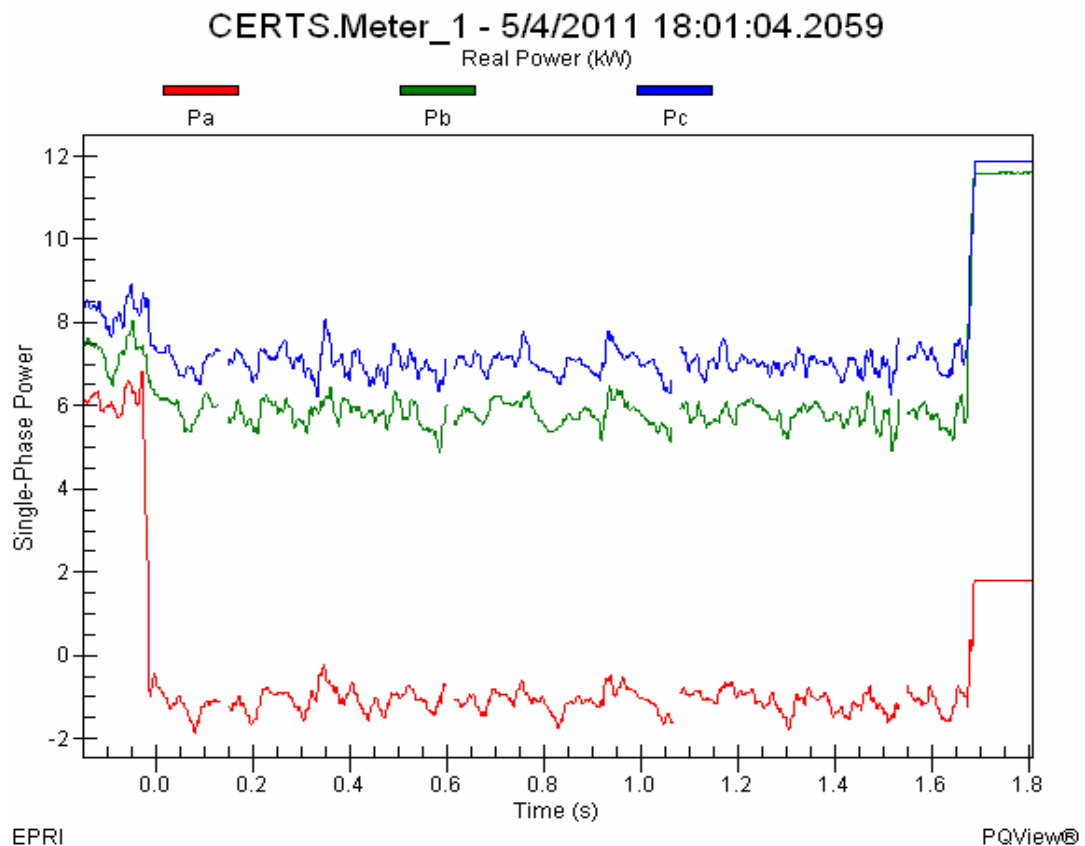
Figure 31: Grid phase power measured at the PCC during single-phase reverse power event

Figure 31 shows A-phase real power at the PCC reduced to zero for the given time delay, and then it reads 1.6kW on A-phase after the mechanical switch opened. This event occurred in 1.7 seconds, in which voltage on all 3 phases remained constant

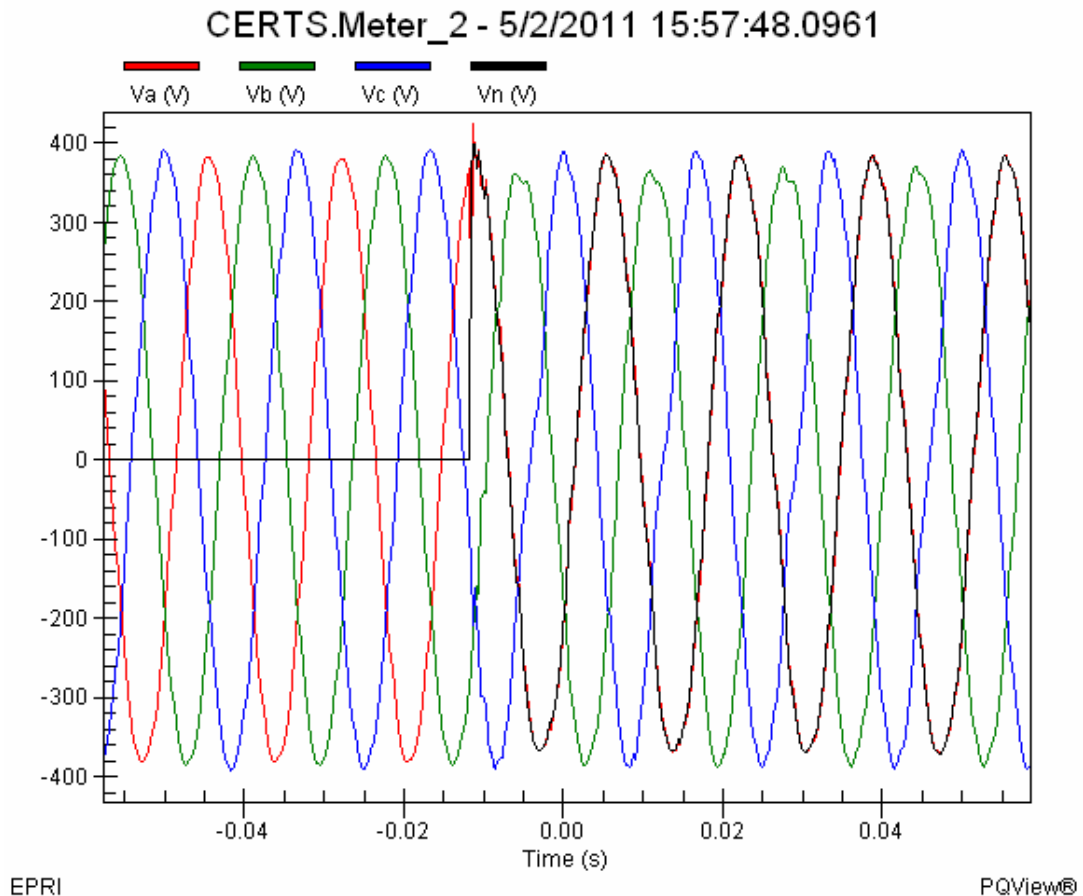
Figure 32: Grid voltage waveform during dead bus close event

Figure 32 displays the voltage waveform on the grid during this event.  $V_n$  is measured on the microgrid and remains at zero until the command to close is issued, at which point there is minimal transient voltage.  $V_n$  and  $V_a$  remain synchronized after closing occurs.

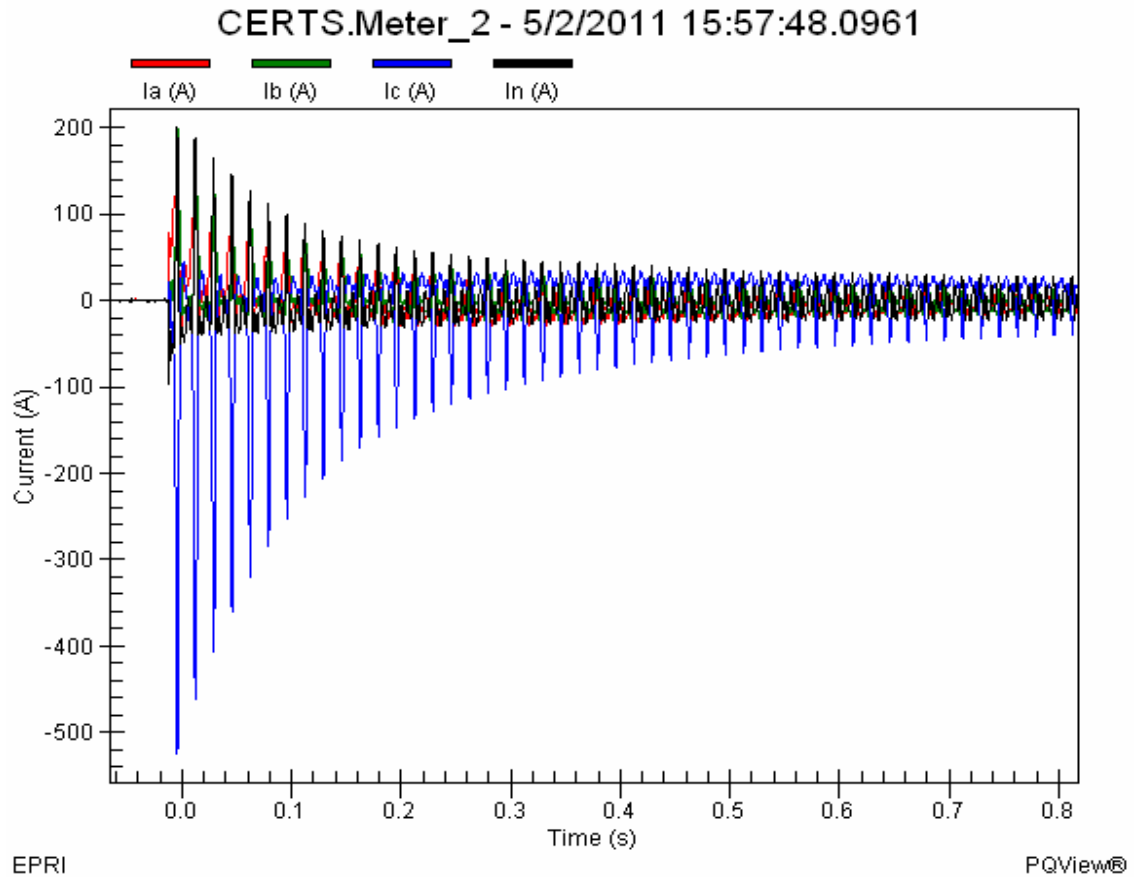
Figure 33: Grid current waveform during dead bus close event

Figure 33 shows the current waveform on the grid, in which C-phase spiked much more than the other phases. This is due to positioning of the C-phase waveform during the closing operation. Similar inrush current were seen when a dead bus close was performed with the semiconductor switch.

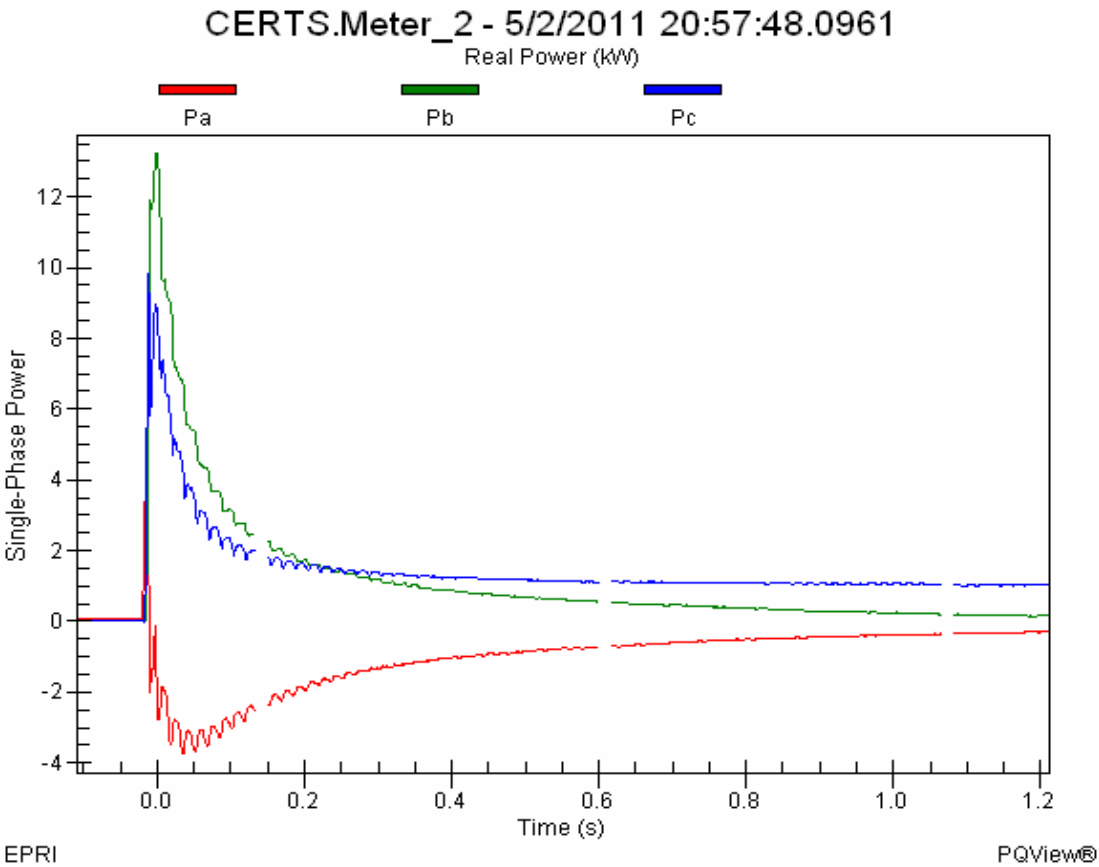
Figure 34: Grid real power during dead bus close event

Figure 34 shows real power measured on the grid, and displays similar behavior to the current waveform. Both of these graphs show that the lack of synchronization elements can result in erratic behavior during closing of the mechanical switch.
