ERNEST ORLANDO LAWRENCE BERKELEY NATIONAL LABORATORY

Air Corrosivity in U.S. Outdoor-Air-Cooled Data Centers is Similar to That in Conventional Data Centers

March 2011

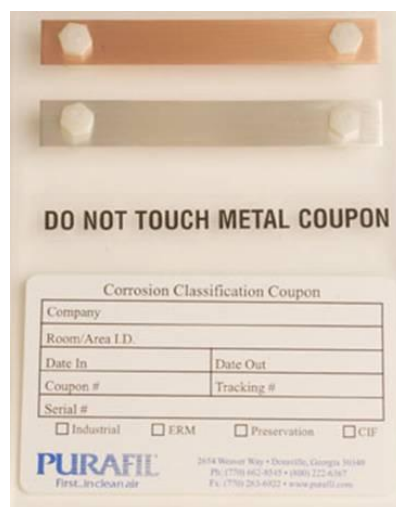
Figure 1 – Unexposed Corrosion Classification Coupon Containing Copper and Silver Metal Strips

The use of metal coupons is the best known and simplest of all corrosion monitoring techniques. At least two companies offer coupons and the required analysis; we selected Purafil. The method involves exposing a coupon specimen to the environment for a given duration (e.g. 30 days). Following exposure, the specimens were analyzed. The magnitude of corrosion film, or corrosivity, was quantified by corrosion growth rate as angstroms (\AA)/30 days. In addition the analysis can provide some information regarding what type of contaminate was the likely caused of most of the corrosion growth. Under the scope of this project, the research team was not able to analyze this information, but the data is available and this type of analysis is recommended for future studies. Each coupon set (copper and silver) is attached to a Plexiglas support (approximately 4" x 3" x 1/4") and coupon number, date, and location information recorded on the transmittal label (Figure 1). In order to minimize any background corrosion, coupons are provided packed in a zip-lock plastic bag with a Purafil Sachet that acts as a scavenger for any ambient contamination that may have been sealed inside the bag with the coupon. After the exposure period the coupons are repackaged in the original plastic bag with the Sachet and returned for analysis.

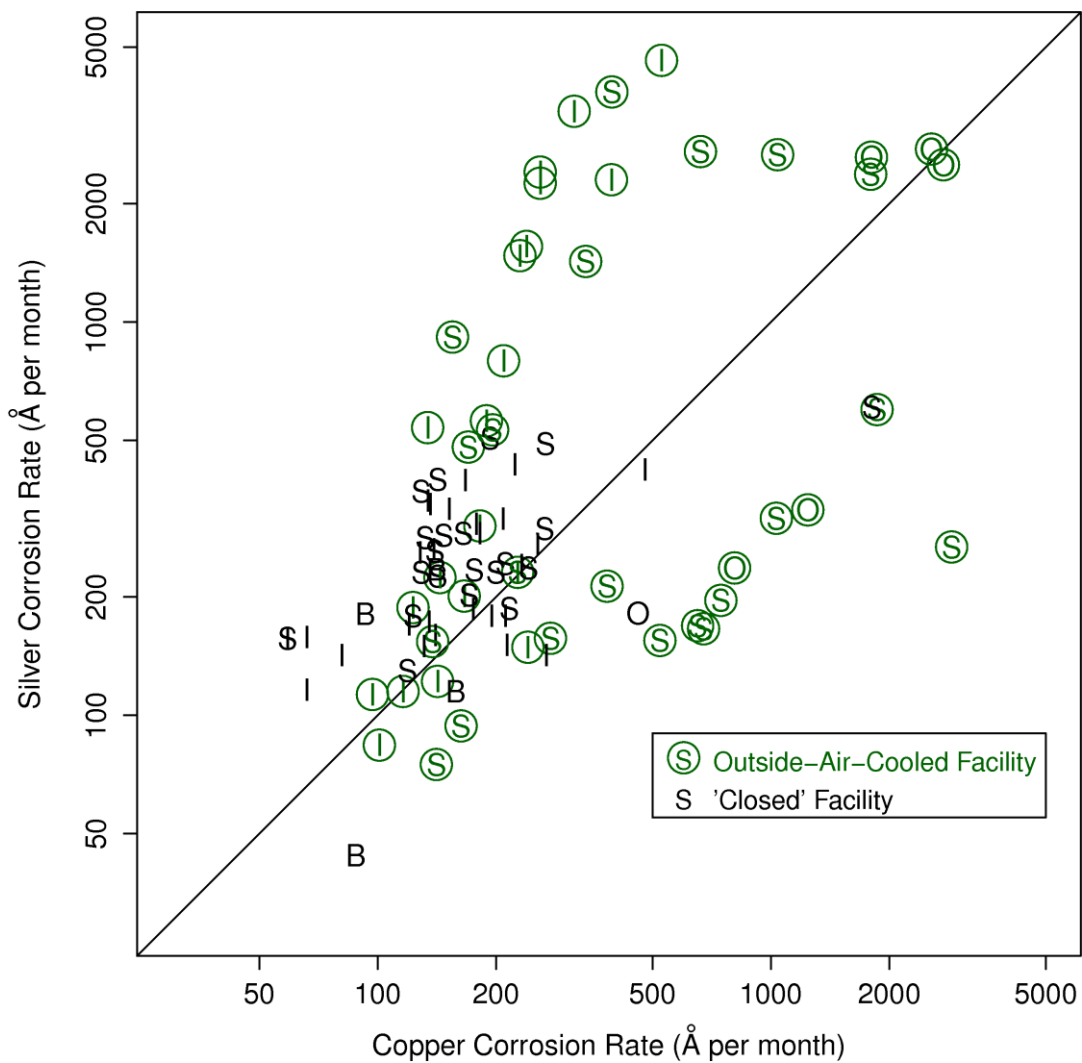
The results of analyzing the reactivity monitoring measurements from 21 data centers follow. Figure 2 shows the copper and silver measurement for all coupons used and recovered. The location type Outside, Supply or Inside is shown by letter O, S or I respectively. The “unexposed” or background measurements are indicated by “B”. The measurements from outside-air cooled data centers have a circle around the location type indicator. Observations are:

- Some measurements from coupons exposed in data centers for 30 days were below the background or unexposed coupon measurements.
- Large silver measurement ranges are associated with small copper measurement ranges.
- Large copper measurement ranges are associated with small silver measurement ranges.

Figure 2 - Measurements From All Data Centers Including All Location Categories, Measurements from Outside-Air Cooled Data Centers are Circled Background or Unexposed Indicated by “B”, Outside Indicated by “O”, Supply indicated by “S”, Inside Indicated by “I”

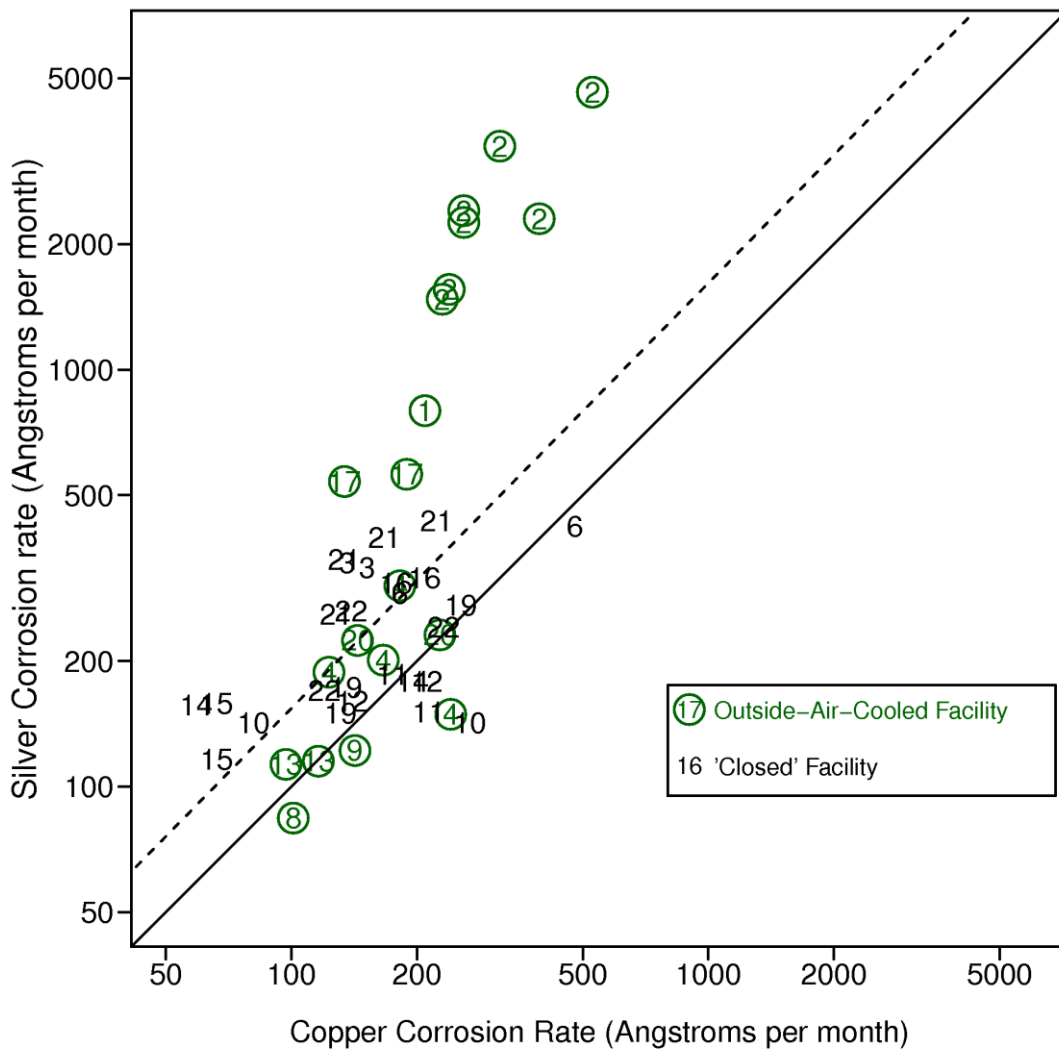
Figure 3 shows the "Inside" only copper and silver measurement for all coupons recovered. The data center identification number is plotted and indicates the measurement value for each coupon. Observations are:

- All copper corrosion rate measurements are below the levels thought to be problematic.
- The correlation between silver and copper corrosion "Inside" rate measurements is poor. The best-fit relationship is shown by the dashed line. Many points fall far off the line, implying that one cannot use a copper corrosion rate measurement to accurately predict the silver corrosion rate measurement in the same facility, or even on the same coupon. (Technical note: the best-fit power-law relationship is linear, and the silver corrosion rate is, on average, 1.4 times the copper corrosion rate. However, the value of R^2 for the fit in log space is only 0.33).
- Note: The highest 7 silver "Inside" measurements came from one (#2) United States data center.

Figure 3 - Measurements From "Inside" Only, Data Center ID Number Located to Indicate Copper and Silver Measurement For Each Coupon, Numbers are Circled for Data Centers Using Outside-Air Cooling, Data Center ID#5 was Not Assigned.

The correlation between silver and copper corrosion rate Inside measurements is poor, as can be seen in Figure 3. The correlation if all measurements location types are considered is much lower. The best-fit relationship for Inside measurements is shown in Figure 3 by the dashed line. Many points fall far off the line, implying that one cannot use a copper corrosion rate measurement to accurately predict the silver corrosion rate measurement in the same facility, or even on the same coupon. (Technical note: the best-fit power-law relationship is linear, and the silver corrosion rate is, on average, 1.4 times the copper

corrosion rate (indicated by the dotted line in Figure 3). However, the value of R^2 for the fit in log space is only 0.33).

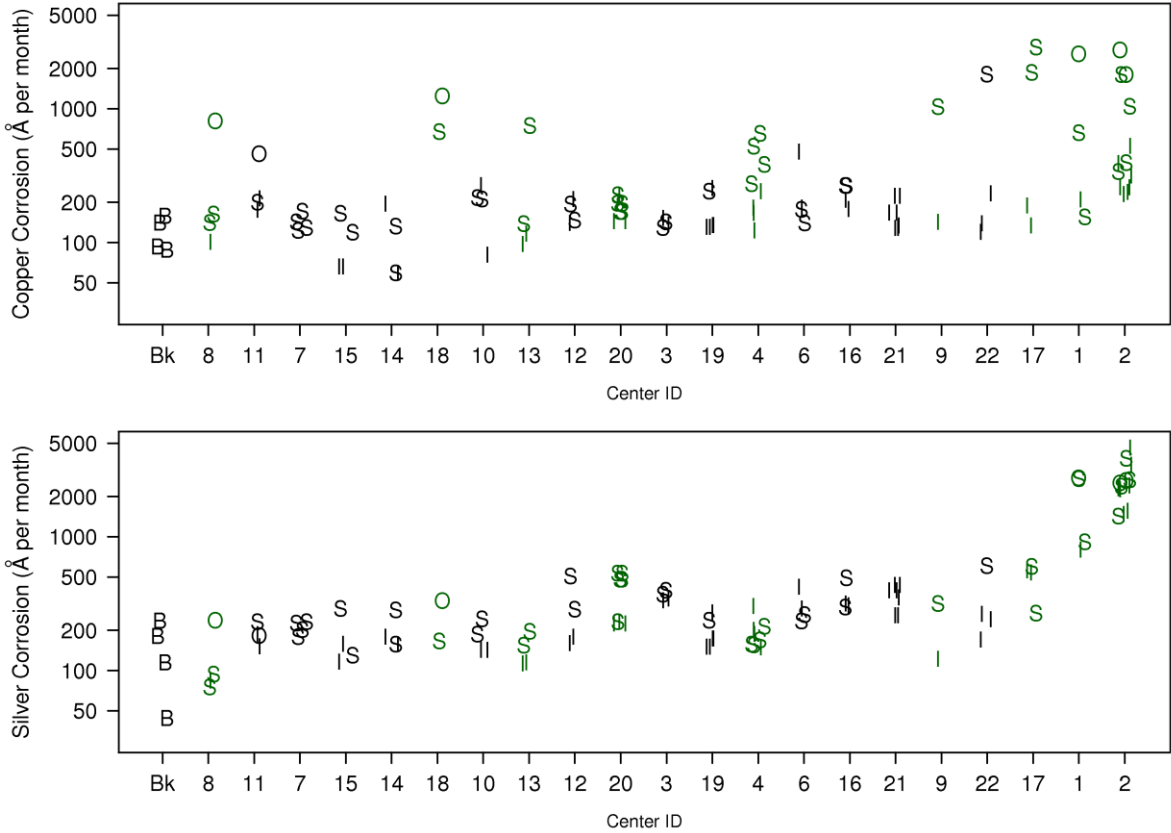
Figure 4 shows the copper and silver measurement for all coupons recovered listed by data center identification. The location type either Outside, Supply or Inside is shown by letter O, S or I. Background measurements are indicated with "B". Observations are:

- Outdoor (Outside) corrosion measurements were made at data centers 1, 2, 8, and 11. In all cases, the copper corrosion rate was much higher Outside than Inside: the ratio of average Outside to average corrosion Inside rate was 12, 7, 8, and 2.4. For silver, the ratio was 3.5, 1.0, 2.8, and 1.1.

- In 75% of data centers, the average copper corrosion rate was higher in the air Supply system than in Inside, and in half of the data centers the ratio of Supply-side to Inside corrosion rate exceeded 1.5; in 25% of centers, the ratio exceeded 2.8. Similarly, in 75% of data centers the average silver corrosion rate was higher in the Supply system than in the Inside, and in half the ratio exceeded 1.3; in 25% of centers, the ratio exceeded 1.8.

- The variation of copper corrosion rates among data centers is lower in the Inside than in the air Supply system: the standard deviation of copper corrosion rate is 63 angstroms/month in the Inside, and 590 angstroms/month in the Supply system. For silver, the standard deviations are 546 angstroms/month for Inside and 602 angstroms/month in the Supply system.

Figure 4 - All Measurements Sorted by Combined Average of Copper and Silver Measurements and Identified by a Data Center ID#, Background or Unexposed Indicated by "B", Outside Indicated by "O", Supply Indicated by "S", Inside Indicated by "I"; ID Number Does Not Correspond to Listing Sequence in Appendix A. Data Center ID#5 was Not Assigned.

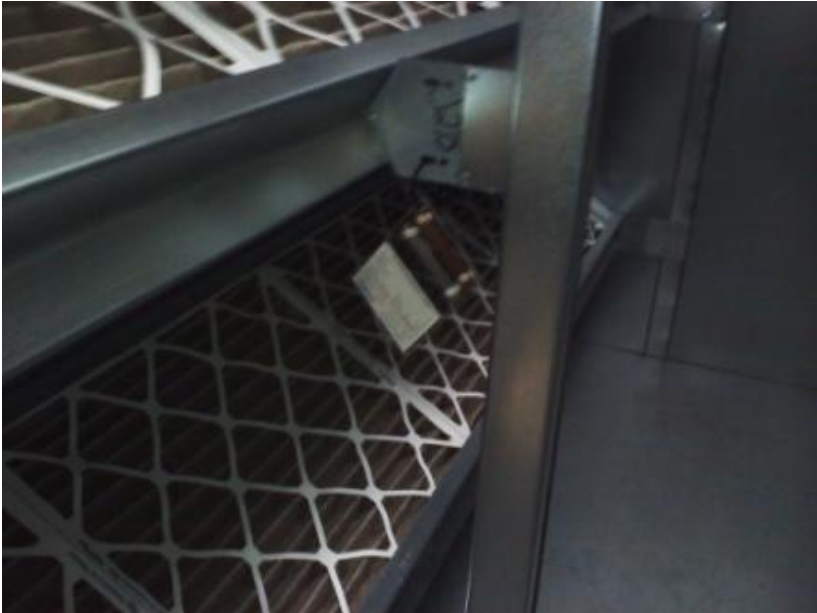
Figure 7 - Typical Coupon Mounting - Example Shown is Immediately Downstream of Supply Air Filters as Found in Large Roof Top Fan Units

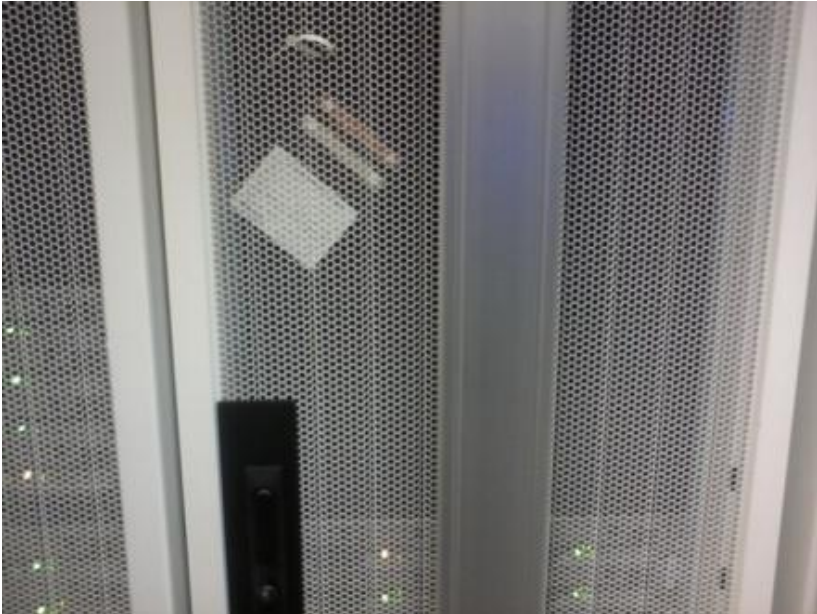
Figure 8 - Typical Coupon Mounting, Example Shown is Just Prior to Cooling Air Entering IT Equipment

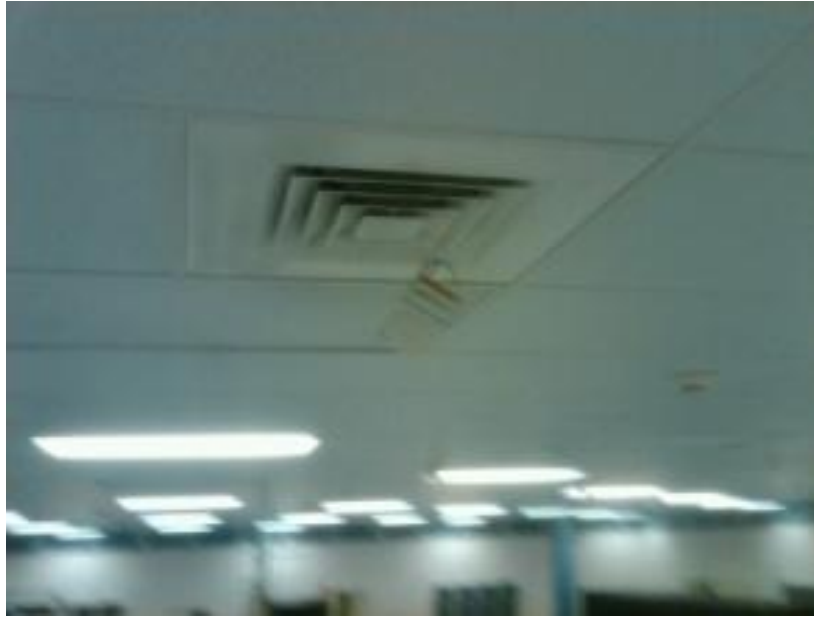
Figure 9 - Typical Coupon Mounting, Example Shown at Data Center Room Supply or Return Grill
