**CERTS MICROGRID PHASE TWO TEST REPORT**

The CERTS Microgrid Laboratory Test Bed project has undergone phase one testing at the Walnut test site by American Electric Power (AEP). Phase one testing demonstrated the stable operations of the CERTS control algorithms when transitioning between electrical utility connected and islanded operation, satisfying difficult loads such as motor starts while in islanded operation, and detecting faults within the microgrid and utility using a sequence component protection scheme. Each test from this phase one resulted satisfactory which prompted a new phase of testing to be performed. The next phase of testing deemed phase two testing included a continuation test for power quality, generator and load diversity, inverter fault current contribution, and protection tests moving the measurements closer to the gen-sets. Test descriptions, set-up, and results from the phase two testing are reported in this document.

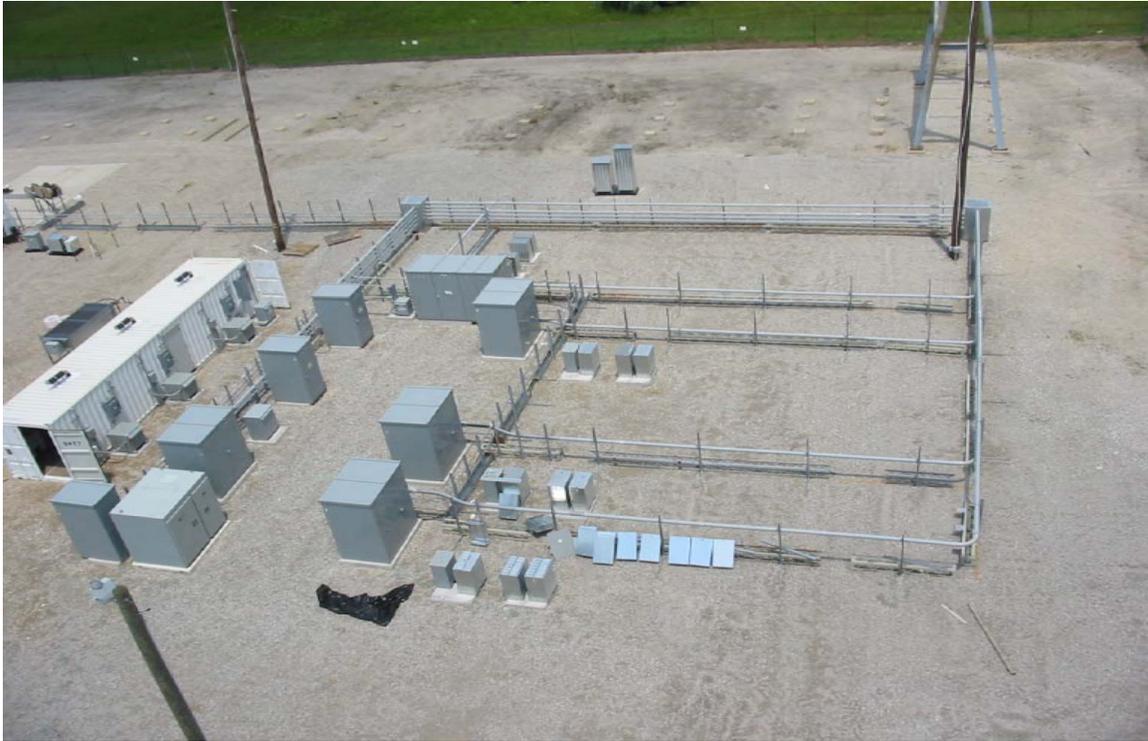
Figure 1 - CERTS Microgrid Aerial Photo

The CERTS Microgrid Test Bed is operated at 480/277 volts (i.e., three-phase, four-wire) and consists of three TECOGEN Generators at 480 volts capable of producing 60kW plus 60kVAr (Gen-set A1, Gen-set A2 and Gen-set B1) and four load banks (Load Bank 3, Load Bank 4, Load Bank 5 and Load Bank 6) capable of consuming 100kW plus 20kVAr each, as shown in Figure 2. Each of the generators are connected to an 112kVA isolation transformer and interfaced to the CERTS Microgrid through an inverter, developed by The Switch, where the algorithms for the CERTS Microgrid controls are embedded. . A semiconductor switch made by S&C Electric Company, known as the static switch, connects the CERTS Microgrid to the utility grid. Load Banks 3 – 5 are the local loads in zones located beyond the static switch; and Load Bank 6 is a customer load in Zone 6 located on the utility side of the static switch.

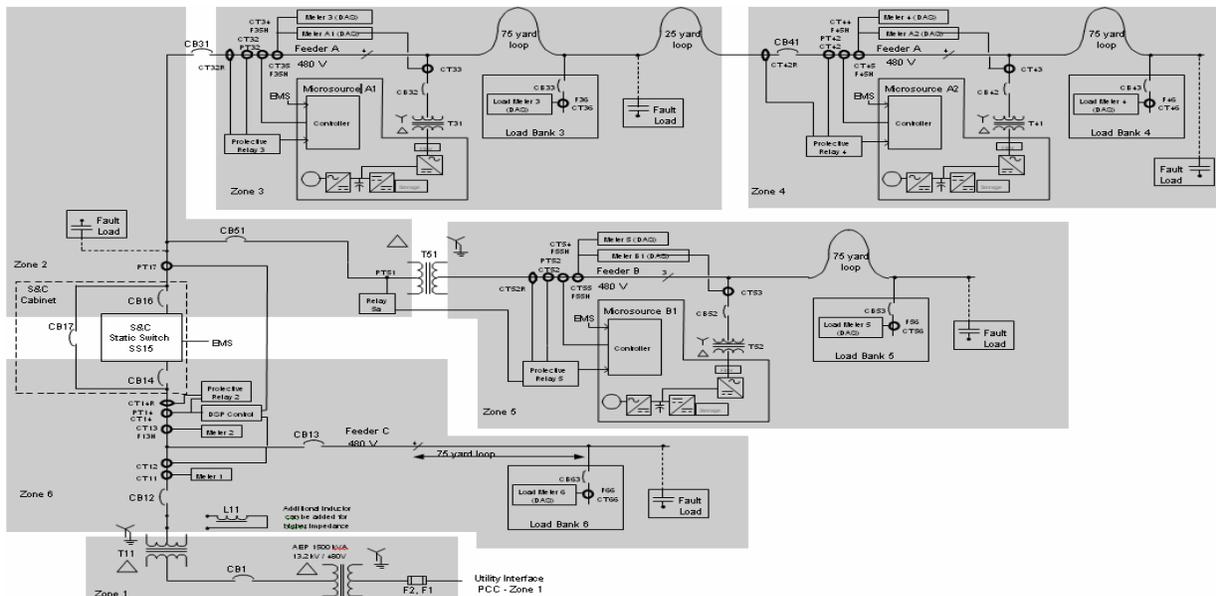
Figure 2 - One Line Diagram of CERTS Microgrid Test Bed

There are 6 zones in the Test Bed with Zones 2 - 6 contained within the CERTS Microgrid design and Zone 1 being the utility interface and referred to as the point-of-common coupling (PCC) to the grid. Each zone is protected by a Schweitzer SEL-351 relay. Faults of varying magnitude can be applied to each zone through an additional breaker which allows fault application and removal.

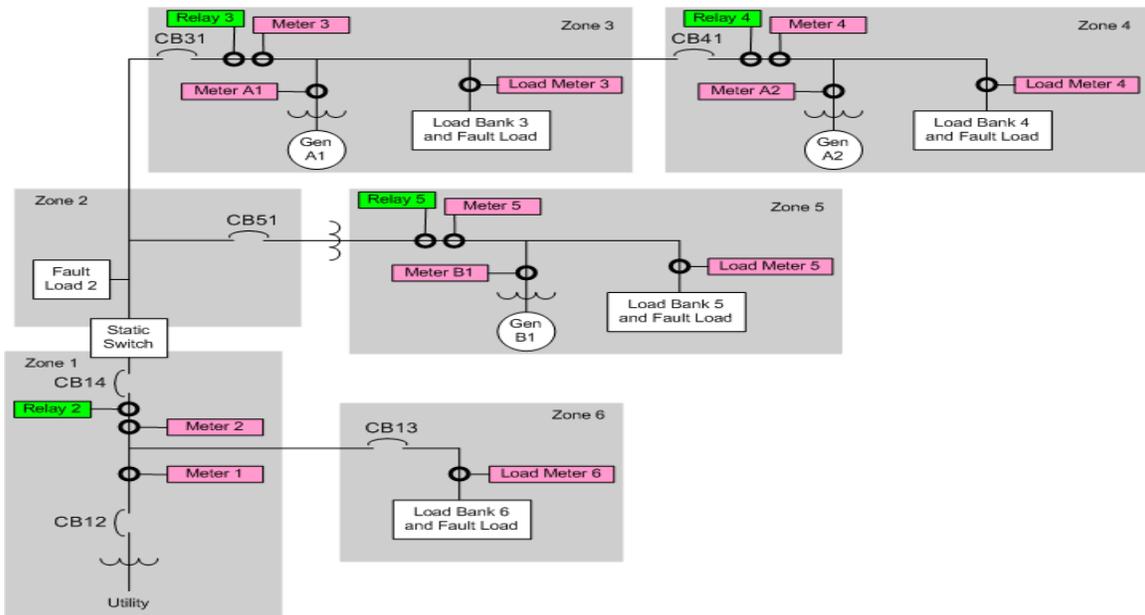
Figure 3 - Simplified diagram of Test Bed showing Meter and Relay locations

There are twelve PML ION 7650 meters placed through out the microgrid and shown in Figure 3, which monitor electrical system conditions, plus acquire phase current and voltage waveforms; and calculate RMS values of voltage, current, active power, reactive power, and frequency.

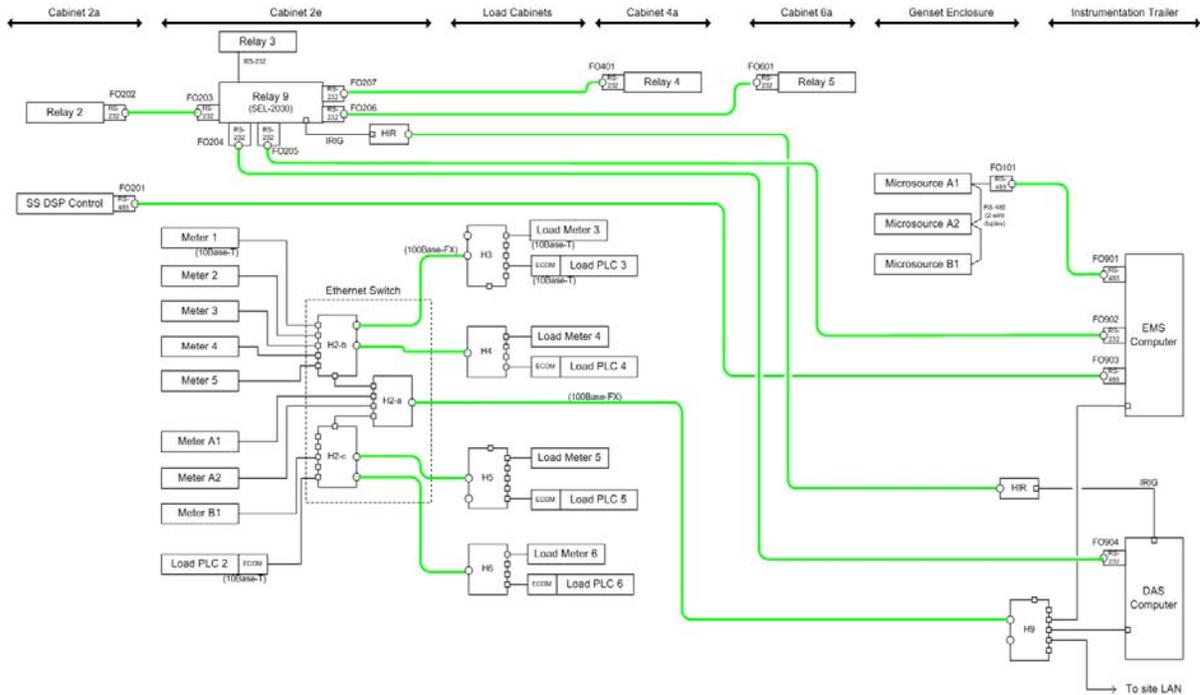
Figure 4 - Diagram of DAS & EMS Data networks

An Ethernet network was provided as shown in Figure 4, for communications between all meters, load control PLCs, and the Data Acquisition System (DAS) computer, using fiber-optic links and switches. The DAS and Energy Management System (EMS) computers were also networked into the local Dolan Local Area Network (LAN) and to a secure Website with user ID and password protection. Additional serial links, using fiber optic converters, connect all relays, static switch Digital Signal Processor (DSP) controller, and TECOGEN Gen-set controls to the EMS computer.

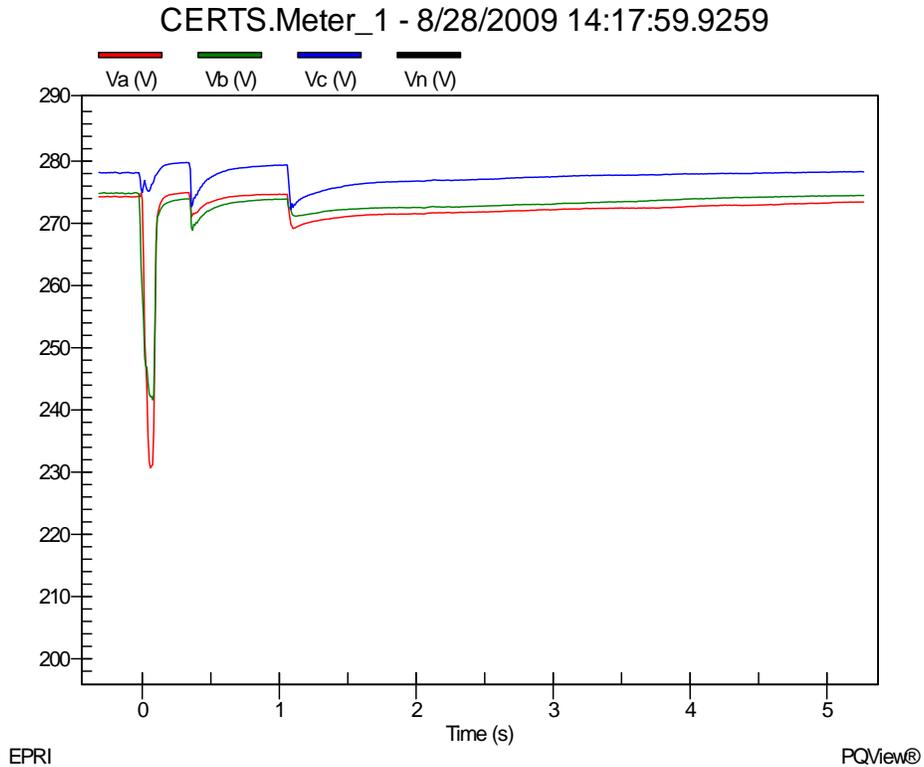
Figure 5: Distribution Sag Event Captured at Meter 1

One distribution disturbance event was captured on 8/28/2009 at 14:17. The event appears to be an A phase to B phase to Ground fault. The depth of the voltage sag is mild and the duration short term. The cause was either an intermittent fault like a tree contact or a distant fault which was cleared by a downstream recloser. To our knowledge no upstream distribution protection equipment operated to clear this fault. This fault resulted in an 83% Voltage sag to phases A and B of the distribution supply. Also an associated neutral current can be seen.

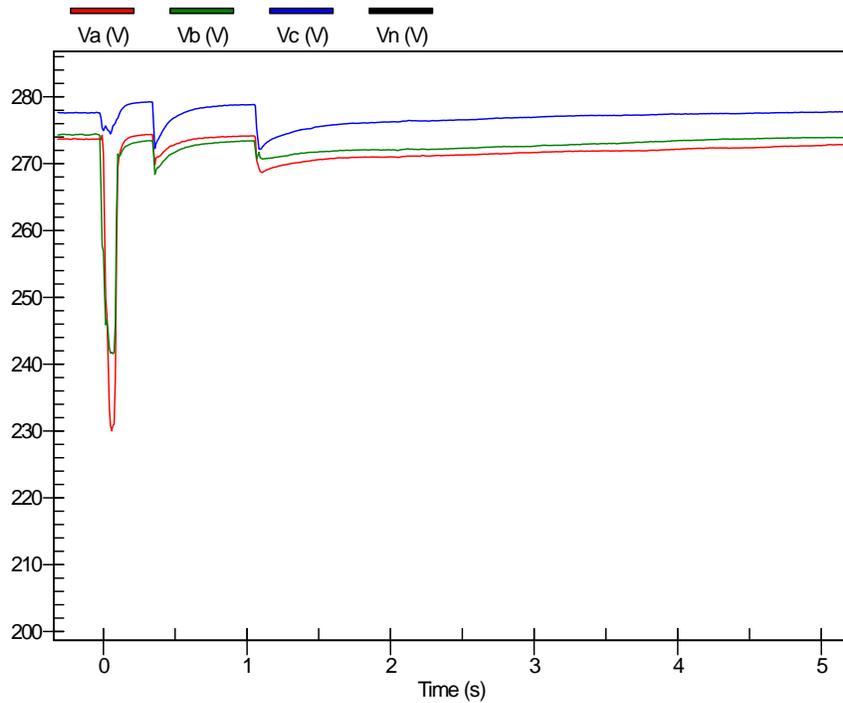
Figure 6: Distribution Sag Event as Experienced by Unprotected Load Bank 6

The unprotected load in Load Bank 6 of 18kW experiences the full 83% voltage sag event lasting over a 1.5 second window.

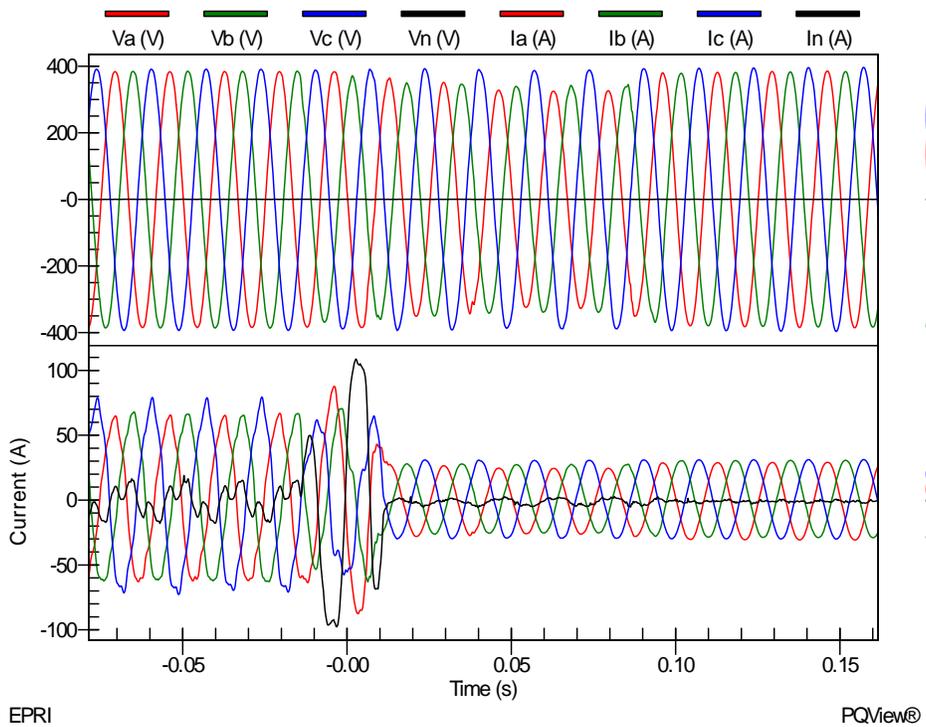
Figure 7: Voltage and Current at the PCC during the Distribution Sag Event

The time from fault, thru detection, to clearing appears to be ~25msec. At this point the voltage within the islanded microgrid recovers having only experienced 1.5 cycles of sag.

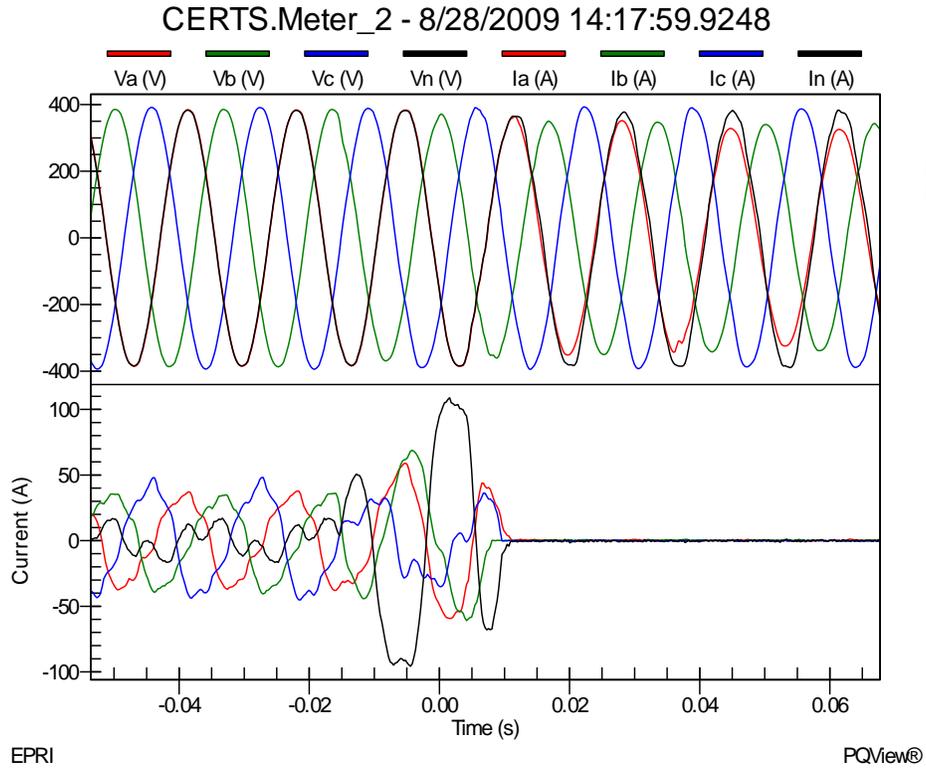
Figure 8: Voltage and Current at the Static Switch during the Distribution Sag Event

The load closest to the SS, Load Bank 2 of 8kW and 6kVar, experiences a voltage sag for approximately 1.5 cycles to 94%. The difference in sag percent from the utility entry point to the protected section of the microgrid bus is attributed primarily to the impedance of connection cabling and the Static Switch.

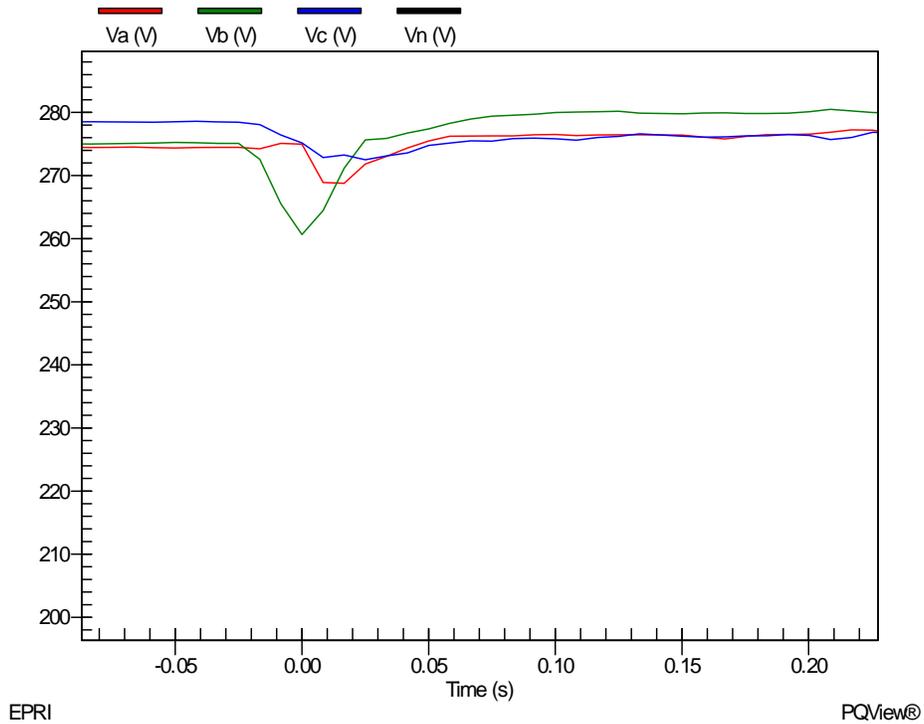
Figure 9: Close Up Examination of the Voltage Sag Experienced inside the Microgrid.

Load Bank 3 of 18kW, experiences a 95% voltage sag for 1.5 cycles. The load furthest from the SS, Load Bank 4 of 18kW, experiences a similar voltage sag for approximately 1.5 cycles to 95%. This 1% improvement over that of the protected section entry point can be attributed to cabling impedance and the microgrid source immediately adjacent.

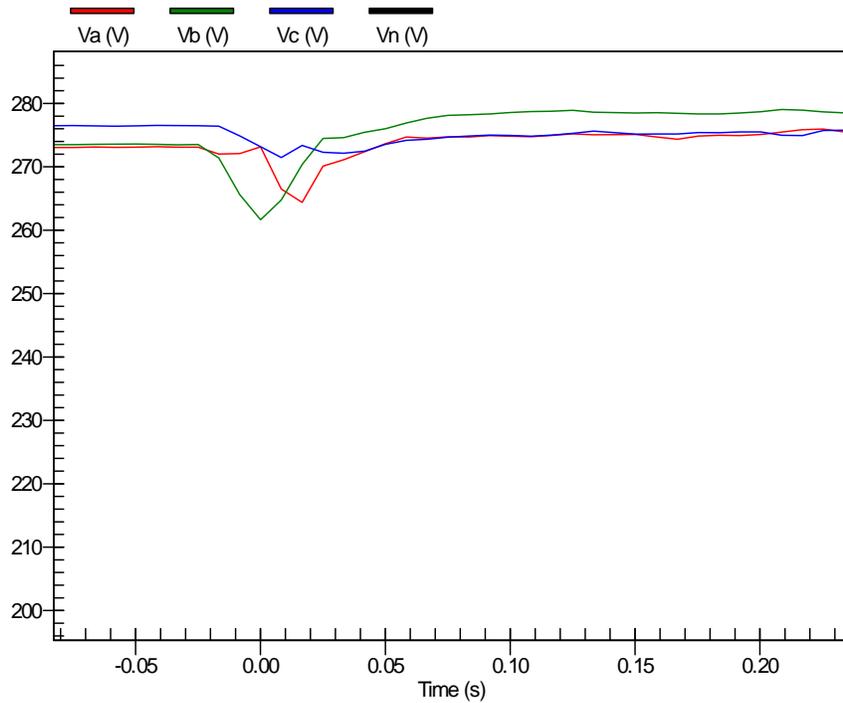
Figure 10: Close Up Examination of the Voltage Sag Experienced at Load Bank 4. Genset A2 was the only genset online at the time and it supported the microgrid bus once the SS opened.

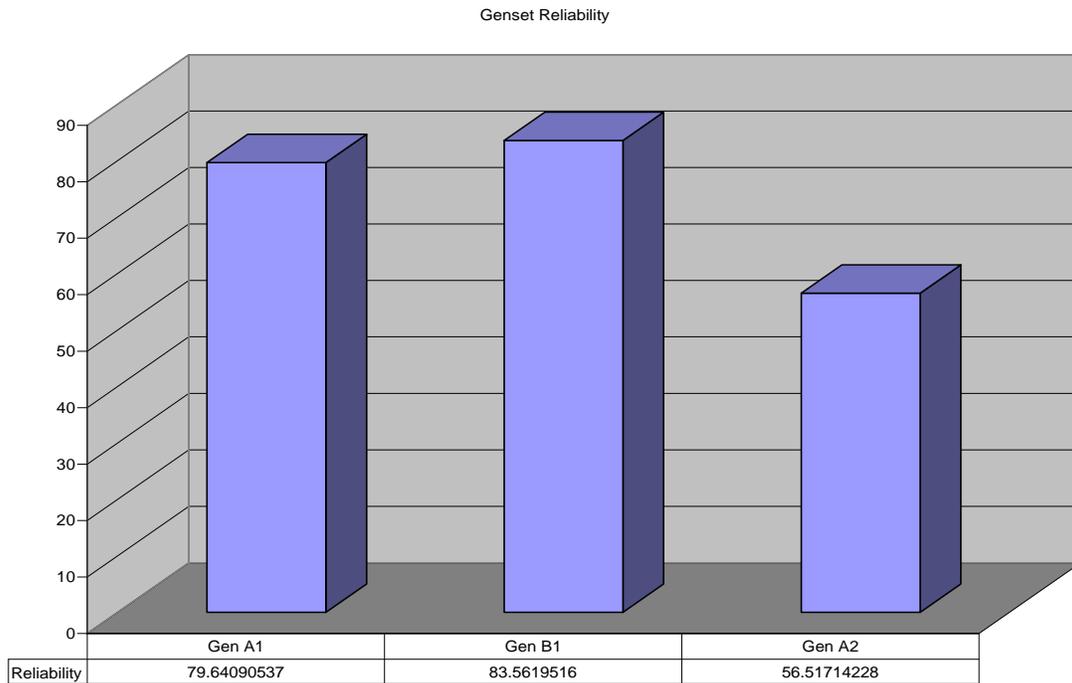
Figure 12: Genset Reliability Comparison

The genset equipment is considered prototypical and the reliability of the individual machines was not considered a top priority. Because of this the information collected is considered not representative of the commercialized version of this equipment, the Tecogen INV-100 Co-gen unit.

The generating equipment is considered identical in construction and programming, we have no explanation as to why Genset A2 is an outlier. The alarms from each forced outage were captured and tabulated below.

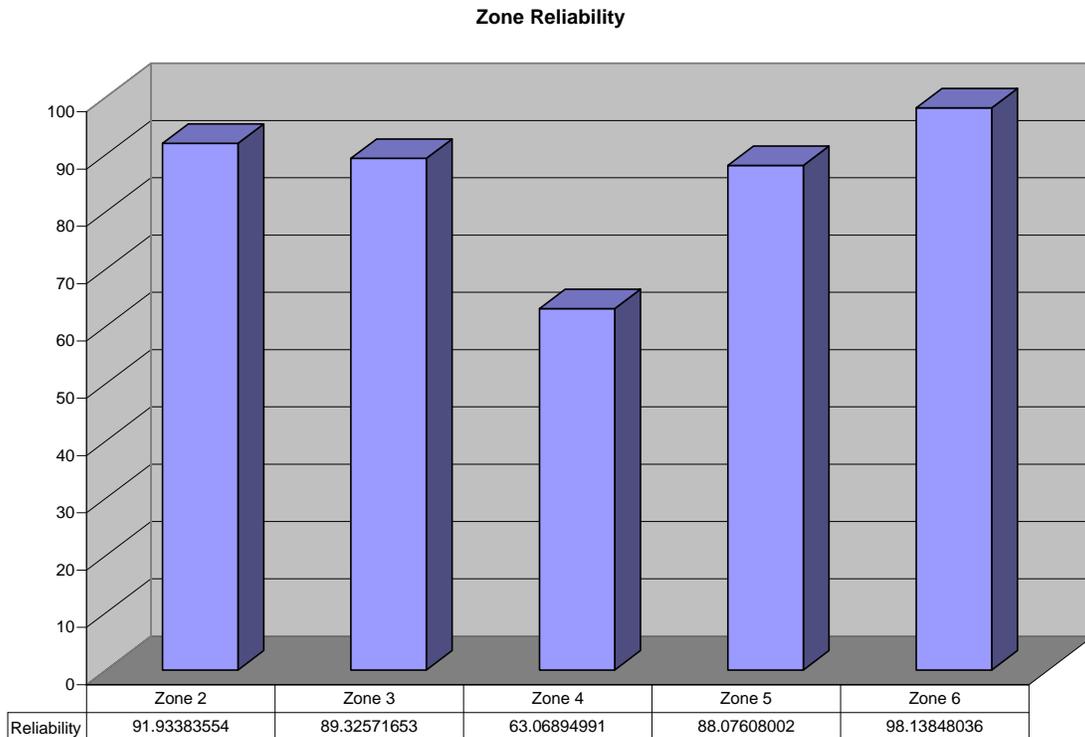
Figure 14: Zone Reliability Comparison

The reliability of each zone is a combination of the reliability of the utility and generating sources as well as the protection and load equipment within that zone. Because of this the zone furthest into the system is likely to be the least reliable.

Zone 6 is outside of the protected area of the microgrid and relies solely on the utility supply. This zone employs traditional phase over-current protection which is coordinated to remove faults with the least amount of interruption. Zone 2 has the best reliability of the protected areas. However due to the sensitive nature of the protection employed and the lack of a generating asset in this zone the reliability is less than that of the utility system. Zones 3 and 5 are both a level deeper into the protected area of the microgrid and display similar reduced reliabilities. Finally Zone 4 is the deepest zone electrically from the utility grid. This zone is the least reliable due to the protection scheme and the fact that it contains genset A2, which itself is dramatically less reliably. This is further compounded by an operational philosophy which requires downstream zones to be tripped off line to an upstream but separable fault. This is a requirement as the feeder breakers are presently not considered a point of resynchronization to the greater microgrid.

The sensitive protection scheme coupled with shunt trip feeder breakers is the primary contributor to the overall reduced reliability. This type of protection is effective at clearing both major and minor faults quickly but is not properly coordinated with downstream minor protecting devices. The sensitive, fast feeder protection operates not only clearing the fault but also needlessly de-energizing large sections of the electrical bus.

Typical downstream protection is of a phase over-current design, generally due to its inexpense and insensitivity to inrush and unbalance. This type of protection is less sensitive to low grade faults and requires more fault time to operate. Because the majority of faults occur in connected equipment, these lesser breakers are the expected clearing devices of choice. Feeder breaker protection is typically reserved for major faults, such as bus faults, which occur less frequently. The sensitive, fast feeder protection operates not only clearing the fault but also needlessly de-energizing large sections of the electrical bus. Because of this an alternative method for protection is recommended.

Before beginning this testing, the initial hypothesis was that the protected areas of the microgrid would have superior reliability, above that of the utility system. This turned out to be incorrect and therefore a predictive calculator of the various reliabilities was constructed. This tool incorporates a very basic reliability calculation which can be further refine to contain greater detail of the CERTS microgrid. It does, however, provide an approximate result to reflect how adjustments in individual variables can affect the entire system.

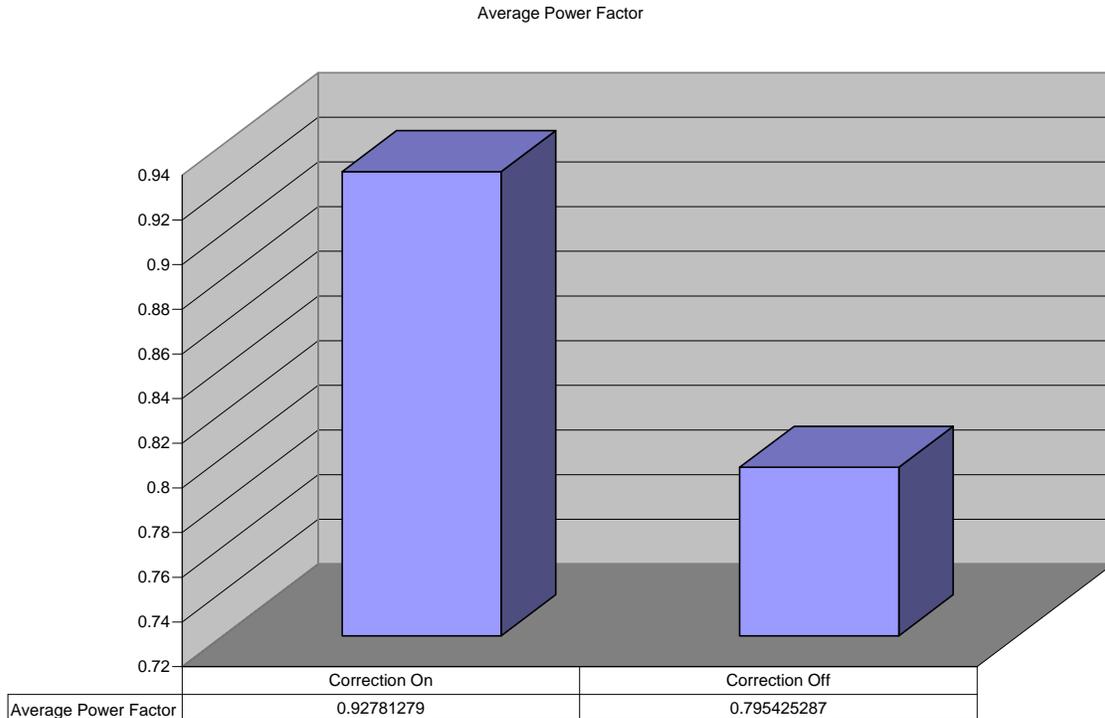
Figure 16: Power Factor Correction Comparison

Because kVar usage is measured on 15 minute intervals this is a good fit for the global intelligence of the Energy Management System and it timing also does not require high speed correction. The EMS system can make the decisions of how many kVars are required and from where they should be generated. The below graph compares two periods of time; one with power factor correction enabled and a second without. The average power factor improved to 0.928 from 0.795, approximately 16.7%. It is also worth noting that a common trigger point for the requirement of customer power factor correction is 0.9.

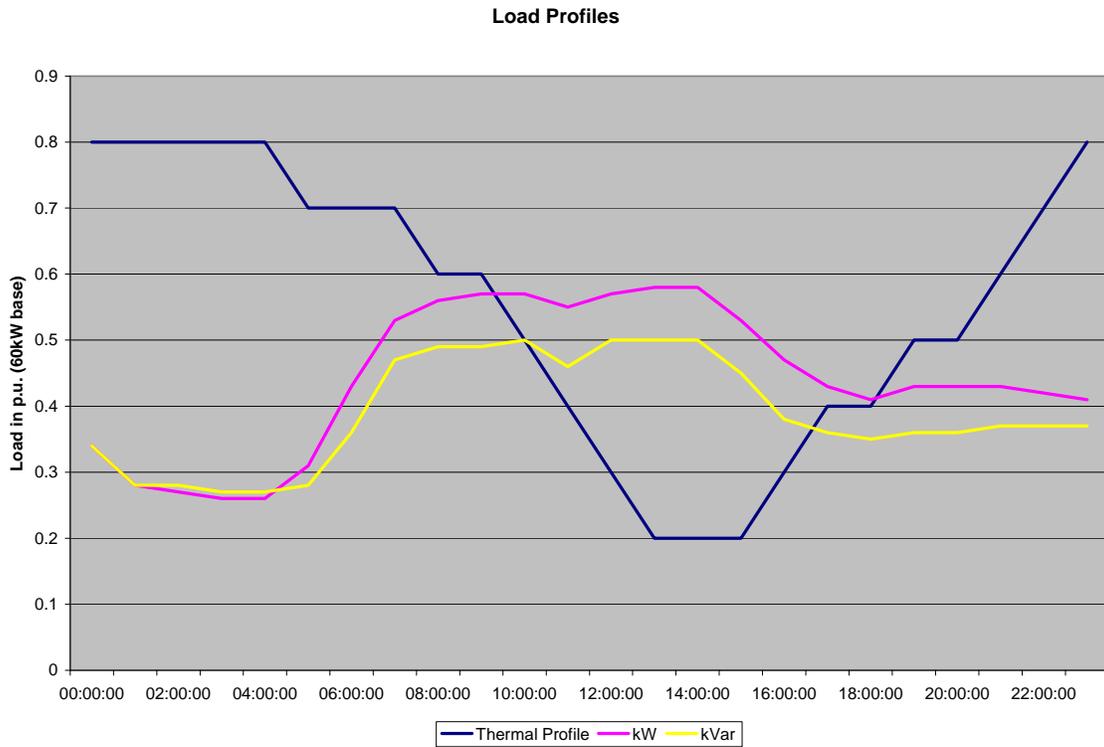
Figure 17: The Base Load Profiles for Thermal, kW, and kVar Demand.

The final area of interest deals with the automation of the load and genset equipment. During this continuous run period these systems were automatically operated by individual agents. These agents were given a base load profile for electrical kW, kVar and thermal demand. They were also given the freedom to deviate from this base profile by a certain amount. This allowed for the bounded, random generation of a large number of load flows within the microgrid. In total the system operated through approximately 27, 300 load changes and approximately 5,800 generation dispatches.

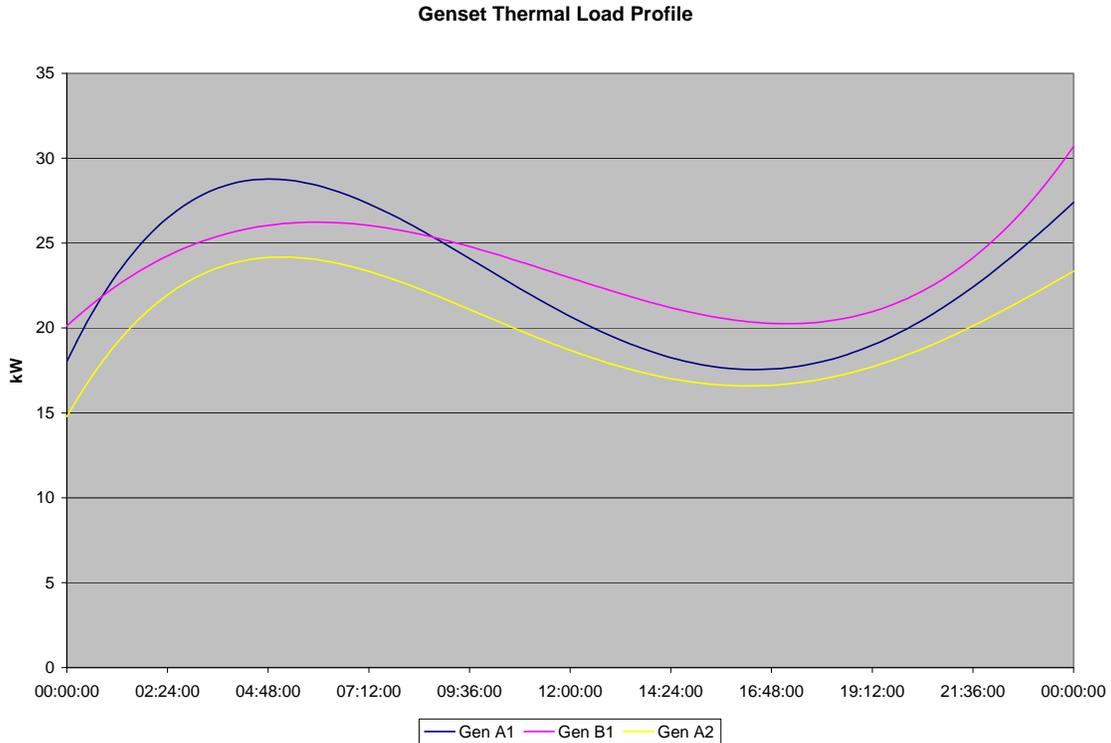
Figure 18: Averaged Measured Thermal Load Profile for each Genset

A general deviation from the base profile can be seen in the early morning hours of operation by all three gensets. This was characteristic was inadvertently caused to maintain compliance with the IEEE 1547 standard at the point of common coupling. The base thermal demand profile was constructed around a customer with higher thermal demand in the late evening and early morning hours, similar to a customer space heating requirement in the winter season. The thermal generation and therefore electrical generation was high enough to frequently offset the entire electrical demand at the point of common coupling. Because the chosen technique for anti-islanding detection within the CERTS microgrid is a minimum real power import the static switch would open each time power was exported to the utility for more than two seconds. Finally the static switch was automated to re-dispatch the generators to a lower set point and resynchronize to the utility system. This effectively lowered the generation dispatch to match that of the electrical load in the late evening and early morning hours of interest. As a consequence, a customer with this particular thermal and electrical demand would need to make adjustments to their system operation to ensure there energy demands were met continuously.

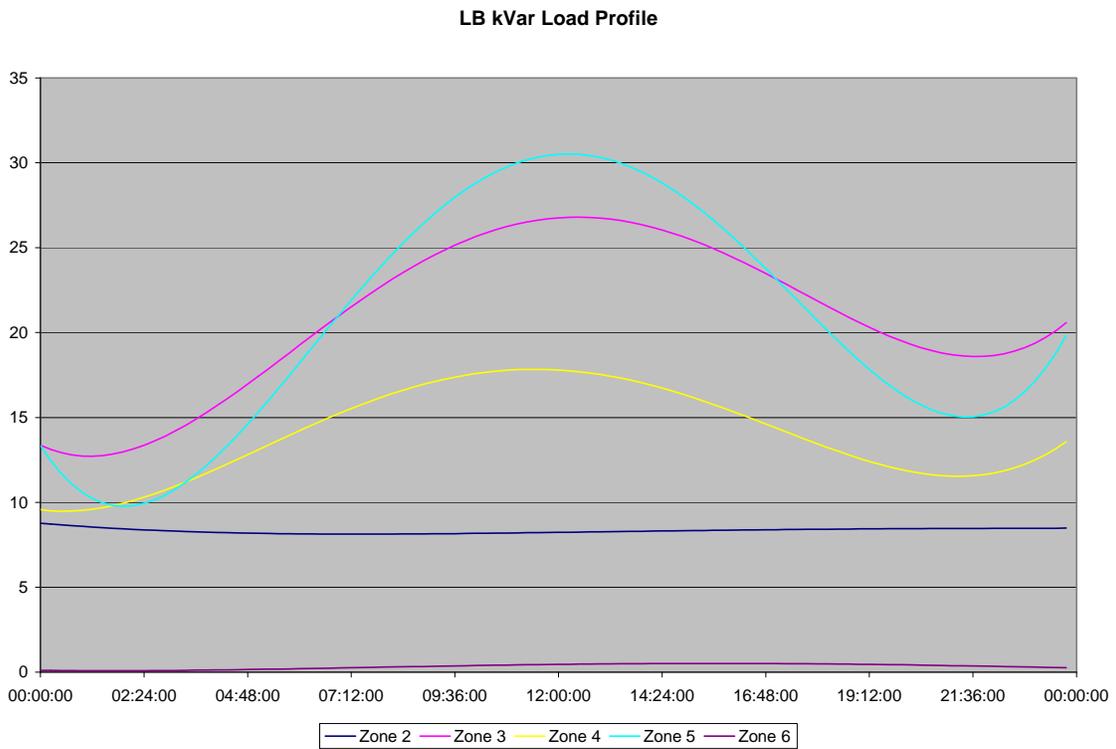
Figure 20: Averaged Measured kVar Profiles for each Load Bank

As point of interest, the averaged measured kVar profile shows the kVar demand of Load Bank 6 is flat at near zero for the entirety of the continuous run testing. This problem was tracked to an open breaker on the reactive load bank which went unnoticed during the testing.

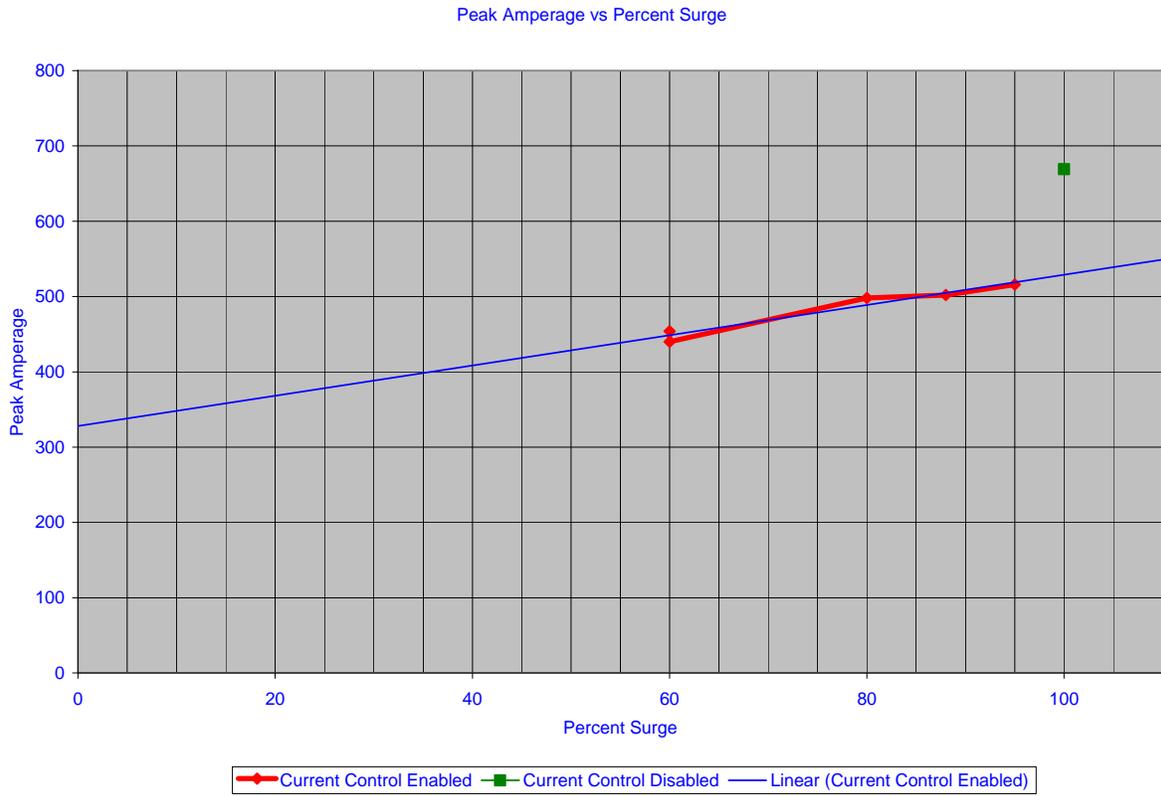
Figure 21: Peak Current vs Percent Surge

The results of these tests indicate that the fault current contribution can be controlled by the genset equipment. They also demonstrate an approximately linear relationship between the Percent Surge and the fault current contributed. However if the value for Percent Surge is projected to 0, the fault current contribution is projected to be approximately 325 amps, not 0 amps as intuition would suggest. A similar relationship may exist past a Percent Surge value of 100. In this case the term Percent Surge is misleading and should be better connected to a deliverable value of fault current contribution.
